# Reliability Improvement of Narrow Down-border TED Product Based on LTPS-TFT LCD Technology

<sup>1</sup>Research and Development Center, Xiamen Tianma Microelectronics Co., Ltd., Xiamen, China

## ABSTRACT

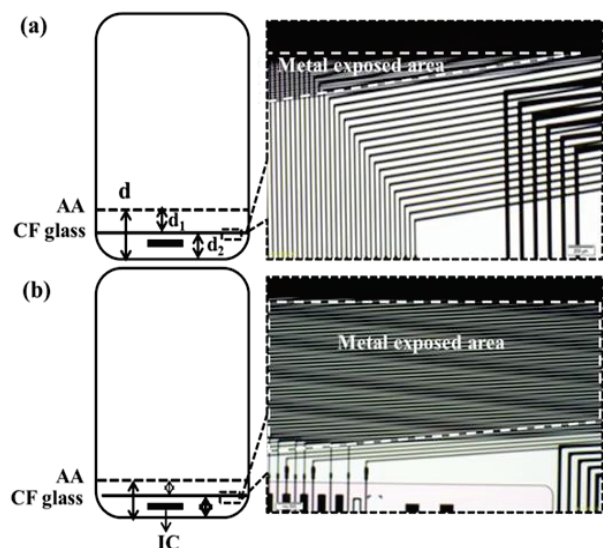
As the development of the display technology and the eagerly visual demand for full-screen-display from consumer, the size of down-border in LCD device is getting smaller. While the size of down border decreases, the distance of AA (Active Area) to CF (Color Filter) glass,  $d_1$  as shown in Figure 1(a), and the distance of CF to panel,  $d_2$  as shown in Figure 1(a) decrease too. Limited by IC (Integrated Circuit) size and bonding technology,  $d_2$  cannot be compressed so much. In other words, narrowing down-border is mainly compressing  $d_1$ . As a result, the exposed area ratio of metal line of fanout to CF glass is increasing, as shown in Figure 1(b). Consequently, the narrow down-border TED (Touch Embed Display) product will face more severe challenges of reliability issues after environmental testing, especially metal corrosion.

Fig. 1 The comparison of metal exposed area ratio of different size bottom border display: (a) normal screen display; (b) full-screen-display

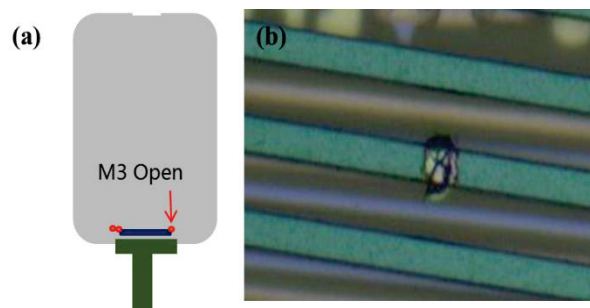
Through preliminary OM (Optical Microscope) examination, we found that capacitive touch failed and grid defect appeared after RA came from touch line lead open, as shown in Figure 2. Soaking RA failed glass in red ink for 12h, and we observed that red ink entered into the glass through UV seal cracks from the surface layer, and then crossed through passivation cracks into metal defective position. This is also the path of water vapor into the display during RA's process.

Fig. 2 (a) The defect area; (b) The morphology of touch line (Mo-Al-Mo) lead open

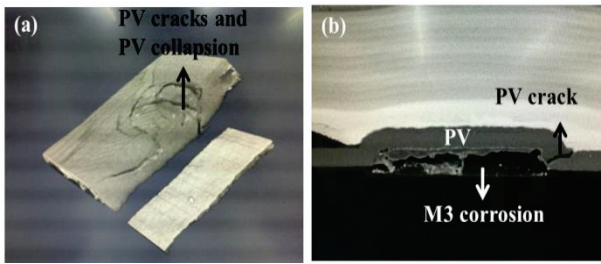
After a further study of 3D OM, obvious cracks could be seen on the PV (passivation layer, SiNx) surface and PV had collapsed completely. With assistance of FIB (Focused Ion beam), we verified that metal under defective PV had been corroded and the middle layer Al had disappeared, as shown in Figure 3(a) & (b). By comparing the different positions of metal morphology, we found that defective metal side wall exist undercut. We suspected this is the main reason of PV crack. In the subsequent stress, such as bonding IC process, PV prone to fracture strongly. By deteriorating undercut experiments, we validated the correctness of the suspicion.

**Fig. 3 (a) 3D morphology of defective area; (b) Observation of touch line (Mo-Al-Mo) film morphology from cross section by FIB**

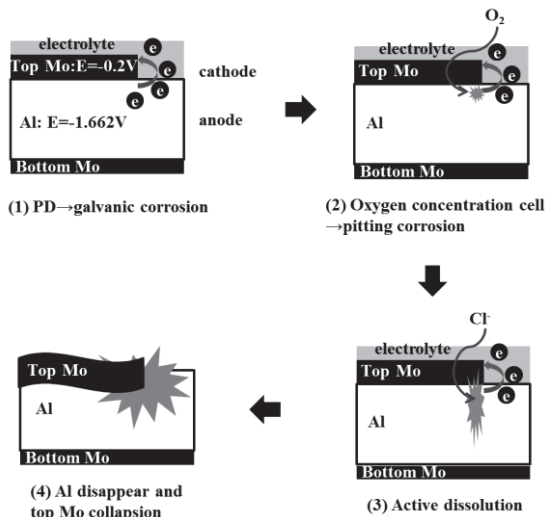
On the basis of corrosion mechanism, the factors which affected corrosion in Mo-Al-Mo were analyzed. The literatures suggest that when PD is greater than 0.25 V, galvanic corrosion is more serious. The detailed process is showed in Fig.4. First, PD (Al/Mo) = 1.462V >> 0.25V, strong potential difference (PD) between Mo and Al would easily lead to the galvanic corrosion. Second, oxygen-rich environment promoted the formation of oxygen concentration cell, causing pitting corrosion. As cathode area contacted with the electrolyte is larger than the anode, the anode current is greater than the cathode current. So Al pitting corrosion is more severe. After environment oxygen was consumed, the chloride ion or other anion from electrolyte migrated into Al pitting. Finally Al<sup>3+</sup> hydrolyzed to form the acid environment, Al active dissolved further, accelerating the metal corrosion. If there were chlorine ion or other anion as catalysis in the electrolyte, corrosion rate will be accelerated. Otherwise, high temperature can also accelerate the corrosion process. Moreover, galvanic corrosion also promoted stress corrosion. The two corrosion promoted each other, and eventually lead to Al disappear and the collapse of PV upon metal.

**Fig. 4 The process of metal corrosion**

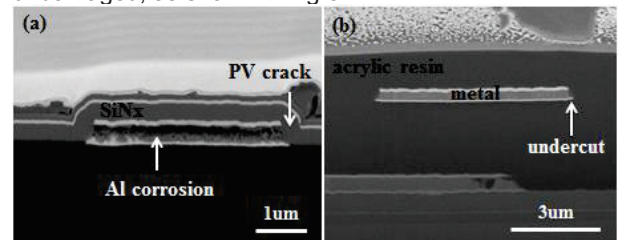
**Fig. 5 The morphology of metal that changing PV film from (a) SiNx to (b) acrylic resin**

First, isolate the water vapor intrusion path to metal into the electrolyte. We can strengthen the UV sealant for better vapor isolation, to ensure the water vapor cannot enter into metal surface, especially Mo-Al-Mo side wall. But it mainly depends on the UV seal's sealing ability and coating technology. Without changing the UV material, increasing the coating thickness of UV can limitedly improve defective rate, as showed in NO.2. For some products, defective rate even became worse. So simply changing the thickness of UV seal is not a good improvement method. On the other hand, increasing coverage or thickness of passivation on the metal seems like good choices, but it is also a difficult work if metal undercut morphology isn't solved well. So the source to improve the passivation coverage is to improve the metal etching condition. While, Mo-Al-Mo etching mainly uses wet etching, undercut of metal is unavoidable. Actual experimental results were validated our speculation, as showed in NO.3 and NO.4. However, changing rigid SiNx to acrylic resin material is actually a better selection, as acrylic resin material has nice ductility. Hence resin passivation wouldn't crack with subsequent stress or external force, even below metal had slight undercut. After the experiment of 36h, metal (Mo-Al-Mo) morphology below passivation was undamaged, as shown in Fig.5.

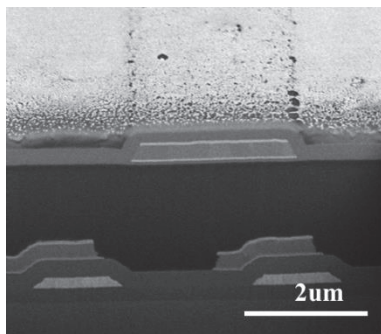
**Fig. 6 The morphology of metal that changing touch line from Mo-Al-Mo to Ti-Al-Ti after saturated salt boiling experiments**

The other solution is change metal to lower potential difference, such as Ti-Al. Specific reasons are as follows. As PD (Al/Mo) is higher to 1.462V, much greater than 0.25 V, galvanic corrosion is more severe.

Obviously, PD (Al/Ti) is lower to approaching to 0V. Predictably, the Ti-Al-Ti is less likely to corrode. As we expected, the touch function of display used Ti-Al-Ti were fine after 144h boiling in saturated salt solution. Observing all the exposed area, we didn't find metal corrosion, as shown in Fig.6. From the cross SEM of metal, we also found Ti-Al-Ti has better sided morphology than Mo-Al-Mo after etching. Consequently, passivation coverage is also improved. This method has excellent performance of metal reliability in the TED product, reducing the metal corrosion defective rate to less than 0.1%.
