Building Damage in the Mashiki-town for the foreshock and mainshock of the 2016 Kumamoto earthquake

*Masumi Yamada¹, Junzo Ohmura², Hiroyuki Goto¹

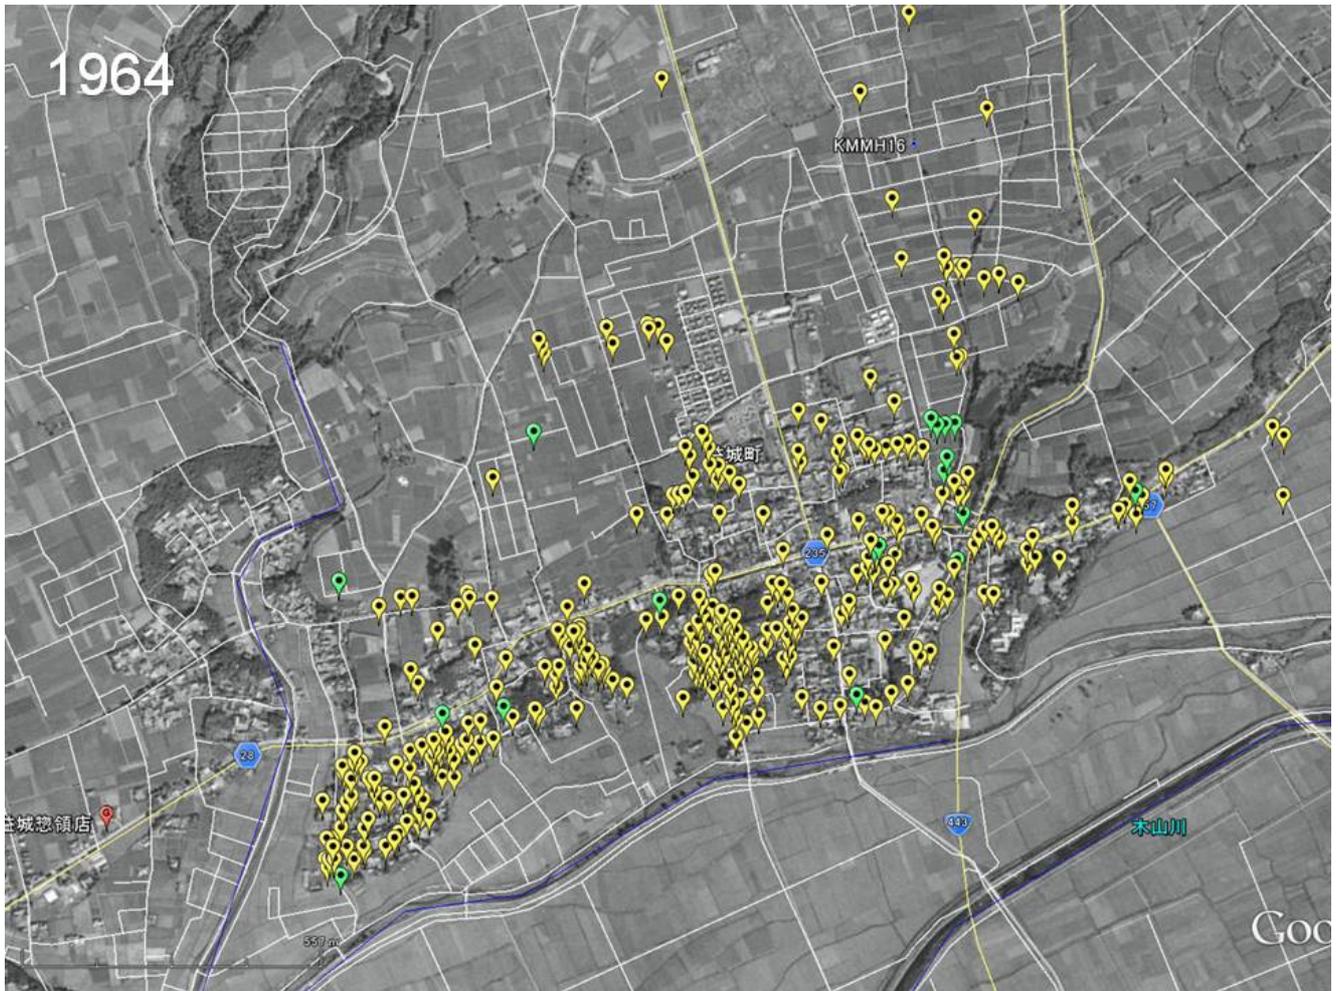
The distribution of the damaged buildings after the mainshock has a good correlation with the distribution of the village 100 years ago. The region around the village was originally floodplain and river terrace of Akitsu river. The village was developed at the edge of the river terrace, and the floodplain was used as a rice field. In 1970s, the village was expanded to the upper river terrace and floodplain. The floodplain is in general considered to be softer soil condition, but for this particular area, damage on the floodplain was much less than that on the river terrace. We need further survey to classify the effect of the subsurface soil structure and seismic performance of the buildings for the better understanding of the damage distribution.

Figure: Damage distribution after the mainshock and aerial photo in 1964.
