# Characteristics of sediment deposition distribution in debris flow disasters in caused by heavy rain in August 2014 Hiroshima, Japan

\*Shoichiro Uchiyama<sup>1</sup>, Toshihiko Sugai<sup>2</sup>

1. National Research Institute for Earth Science and Disaster Resilience, 2. The University of Tokyo

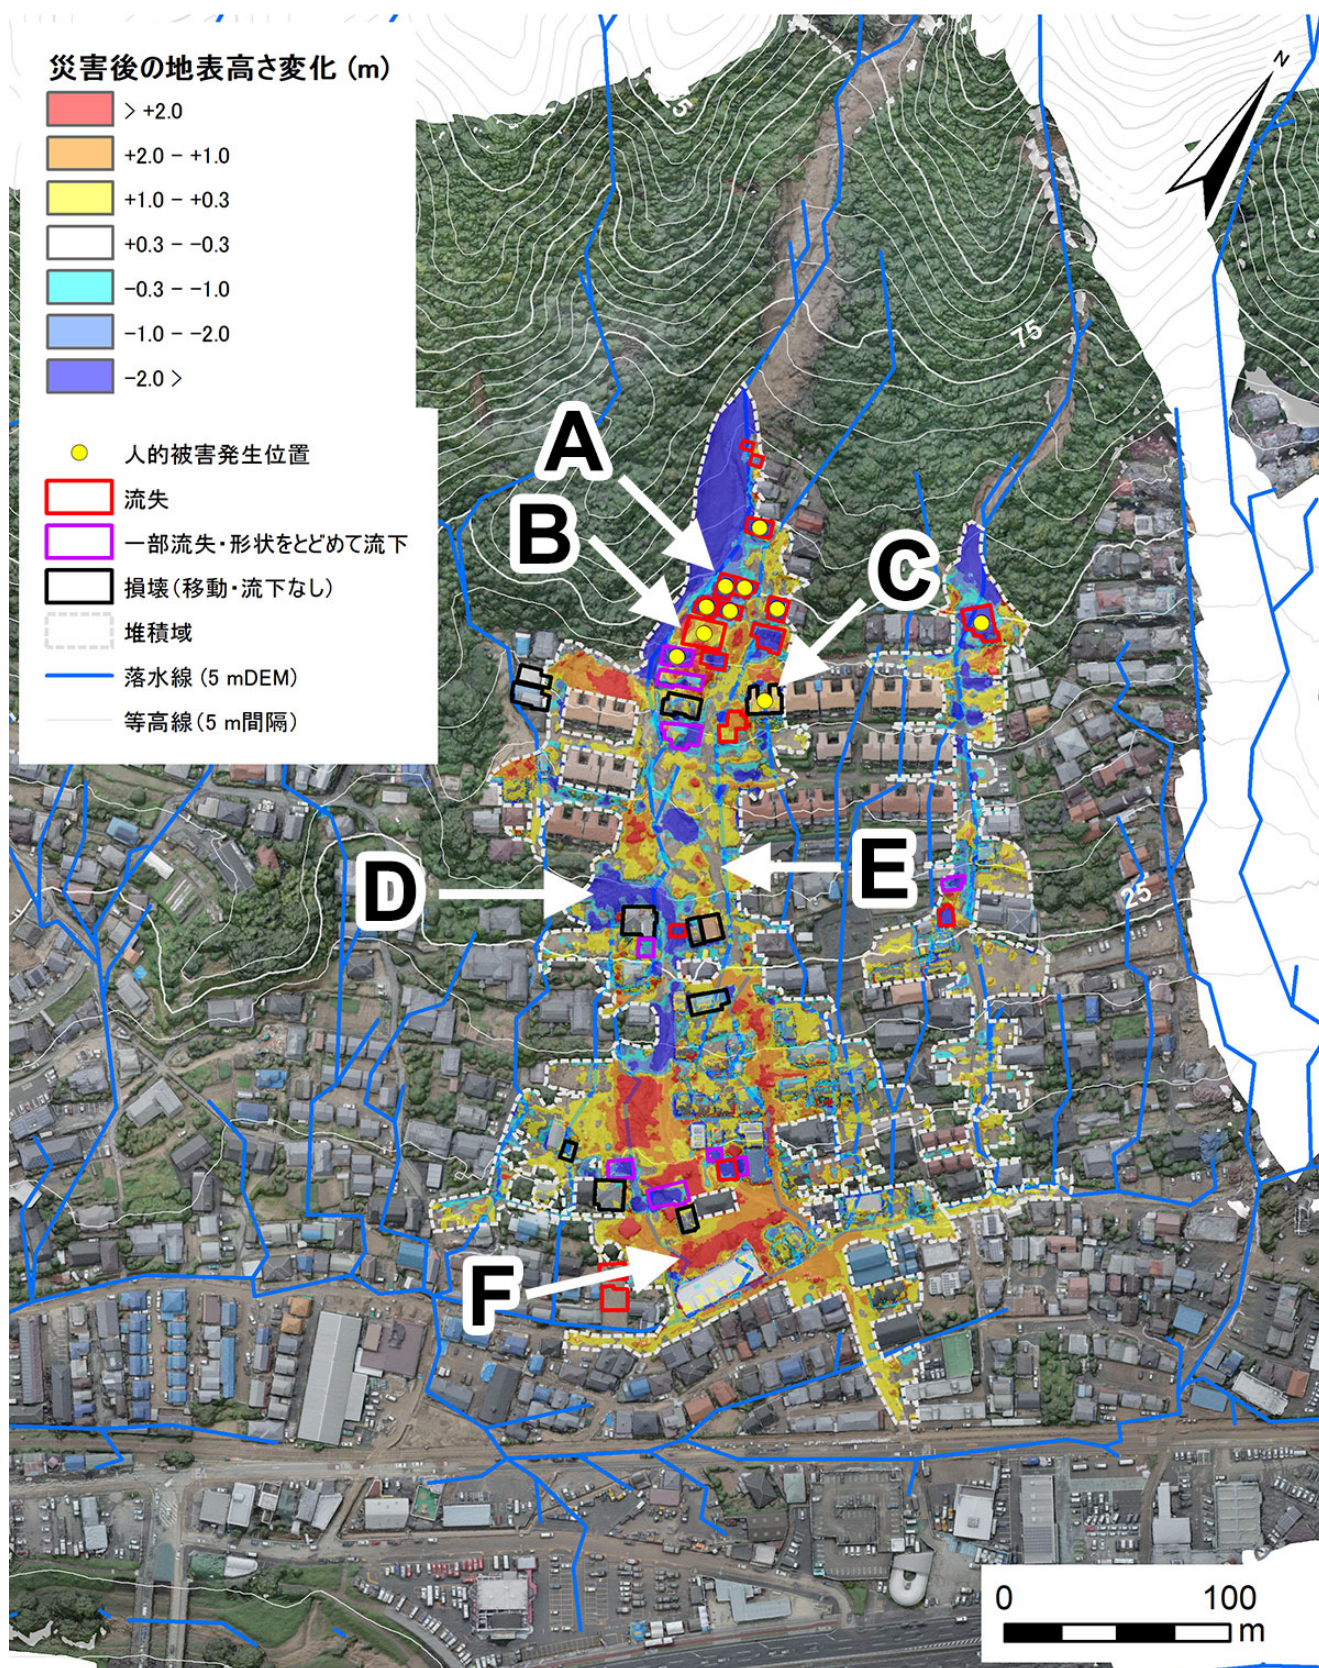
Of the results obtained, Yagi 3 districts were figured. There were two blue falling water lines near the center, and the main flow path widened to approximately 25 m. Within the range 70 m above and below the flow path, seven buildings were lost, resulting in 20 casualties (A). In the housing at the most downstream part of this row, a portion of the building moved downward while remaining intact, resulting in two casualties. In addition, the apartment that was in the center of this row of houses was lost in the debris flow; however, because it was a vacant lot in the pre-disaster aerial photograph, the apparent

change in the DSM appears to be sedimentary (B). In the public housing building located on the falling water line, sediment flowed, resulting in one casualty (C). Among the vegetation growing adjacent to the main flow path, the side close to the flow path was eroded (D). There was an area in which the sediment deposition thickness was in the main flow path thin (E). A sediment layer exceeding 2 m in thickness accumulated in the parking lot at the end of the main flow path. In the orthorectified images, the sediments exhibited a mud-like texture (F).
