高感度エミッション顕微鏡とシンクロトロン X 線トポグラフィーによる HVPE (001) β 型酸化ガリウム SBD のリーク電流の起源になるキラークラックの同定

Killer Defects Responsible for Leakage Current in HVPE (001) β -Ga₂O₃ SBD Observed by Emission Microscopy and Synchrotron X-ray Topography

佐賀大院工¹, (株) ノベルクリスタルテクノロジー²

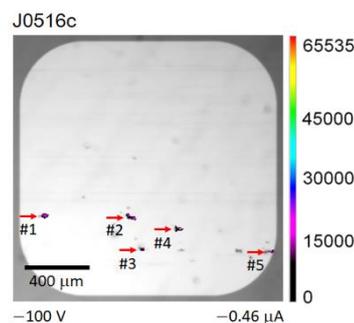
Figure 1 shows emission microscopy image of SBD #J0516c at a reverse bias of -100 V the leakage current of -0.46 μ A. Here, five emission patterns were observed and indicated by the arrows which corresponds to the reverse leakage path.

Fig. 1. Emission microscopy image of SBD #J0516c.

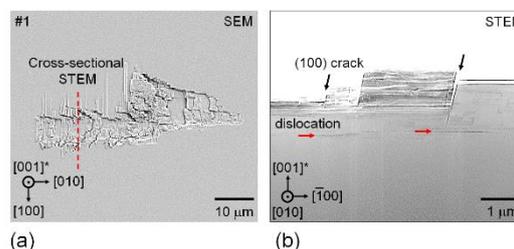
Figure 2 (a) shows SEM image of #1 of the emission pattern. Here, a surface defect accompanies (100) cracks with a straight line along [100] was observed. Same type of defect was also

observed at #2–#5. Next, cross-sectional STEM was performed as showed in Fig. 2(b). Dislocations propagate along [100] direction at a depth of 0.5 μ m below the surface were observed.

We have found a killer defect which contains (100) cracked as leakage current path in HVPE (001) β -Ga₂O₃ SBD. This defect contains (100) cracks and dislocations along [100] direction.

Fig. 2. (a) SEM image of emission spot #1 and (b) its cross-sectional STEM observation.
