FIB Bit Marking Technique for XTEM Analysis of Megabit Memory Failures

N.Nishio, K.Shiotani, M.Kitakata, and M.Mikoshiba
NEC Corporation. 1120 Shimokuzawa, Sagamihara, 229, Japan

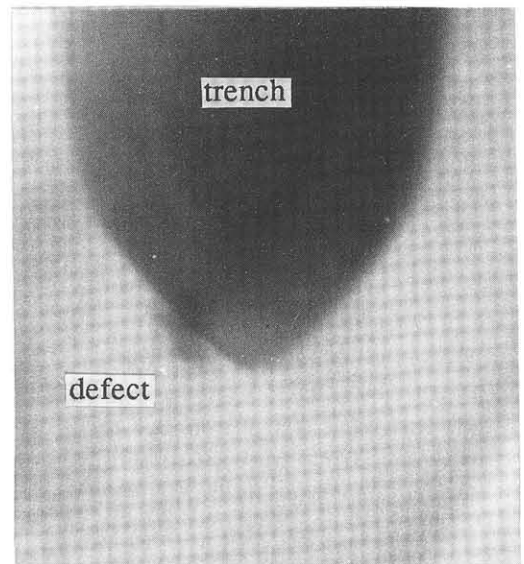
Figures 2 and 3 show XTEM photograph of two types of retention failure cell-A and B. Defects are observed at or near the bottom of the trenches in the both cells.

Fig.2. XTEM photograph of failure bit-A. Defects exist at the bottom of the trench capacitor.

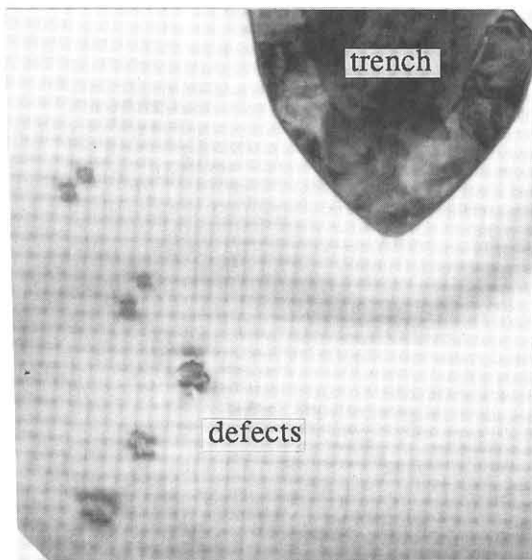
Fig.3. XTEM photograph of failure bit-B. Defects exist adjacent to the bottom of the trench capacitor.
