Thermal and Bias-Temperature Stress Induced Leakage Current Failure of Cu/BCB Single Damascene Integration

Sang U. Kim*, Taiheui Cho+, and Paul Ho+

Advanced Technology, SEMATECH, 2706 Montopolis, Austin, Texas 78741-6499, USA

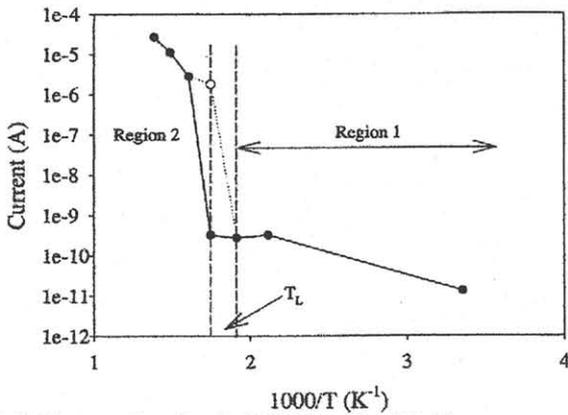
The leakage current was measured using a large area (1.2cm²) comb test structure with 7 meters long comb lines. The Cu line to line spacing is ~ 0.35 μ m and Cu line width is .4 μ m. Cu thickness is .7 μ m. Ta barrier with 20 nm is used. The test structure was capped with a 10 nm thick nitride layer. Cu/BCB single damascene process was used. The Cu line to line leakage current, I_L , was very low, less than 10 nA at room temperature, but it failed under thermal stress. The bake temperature was raised from 200C to 450C in 50C increments. I_L-1/T is shown in Fig.1. Devices fails at $T_L \geq 250-300C$. The curve can be divided into two regions. 250-300C is a transition temperature of the leakage current, dubbed T_L . I_L surges abruptly at $T \geq T_L$ or it fails.

Fig. 1; I_L-V_L was plotted as I_L-1000/T at $V_L=3V$. The curve can be divided into two regions: region 1 (low temperature, 25-250C) and region 2 (high temperature, 300-450C). 250-300C is a transition temperature of the leakage current, T_L . The leakage current surges above T_L or it fails.

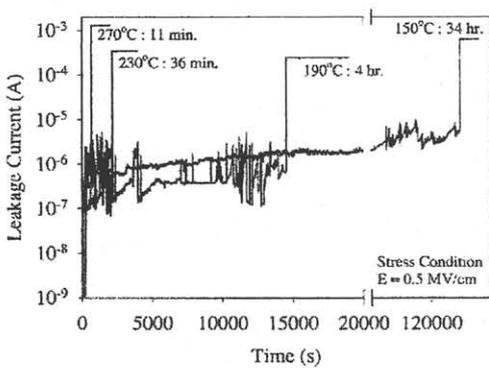
Time to Breakdown under Bias Temperature Stress

The following B-T stress conditions were used: a constant electric field equal to .5MV/cm and four temperatures; 150C, 190C, 230C and 270C. The B-T stress was continuously on until device became breakdown. The breakdown current was defined as $I_L \geq 100\mu$ a at $V_L=1V$. Breakdown characteristics are shown in Fig. 2. Breakdowns occur at 34 hr for 150C, at 4 hr for 190C, 36 min for 230C, and 11 min for 270C. The breakdown occurs rather rapidly. From Arrhenius plot, thermal activation energy equal to .91eV, associated with the B-T stress induced leakage current failure for Cu/BCB, was obtained.

Fig. 2; B-T stress induced breakdown characteristics. Breakdown occurs from 34 hr for 150C to 11 min for 270C.

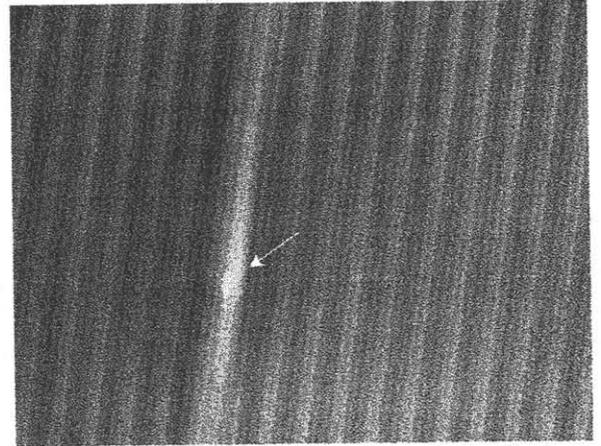
One of the B-T stress induced broken down devices was EBIC analyzed. A high magnification of EBIC emission site is shown in Fig. 3. It is clearly seen that the hottest emission site occurs between the two Cu lines. FIB X-section was performed across the brightest emission site. This is shown in Fig. 4. The thin nitride layer between the affected two Cu lines is partly melted away due to excessive Joule heating caused by the high current flow as a result of B-T stress induced breakdown. Enormous current flows at the breakdown of the very small, localized defect site. The BCB film between the two Cu lines, however, appears to be intact. It means that the damage seen is caused by the surface leakage current flowing along the nitride-BCB interface, not by the bulk leakage current inside the BCB film. The Ta barrier at the top surface edge of the Cu line at the top right hand corner as pointed by an arrow looks partly missing or damaged. Such damages in Ta barrier may have occurred during the Cu/BCB damascene process.

Fig. 3; A high magnification of EBIC emission at a localized, small defect site. The hottest emission occurs between two Cu lines.

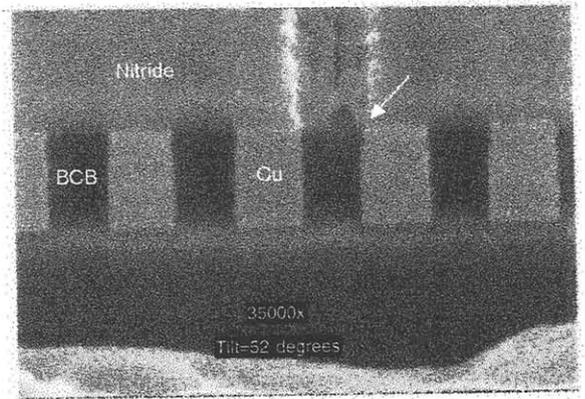
Fig. 4; FIB X-section across the emission site. The thin nitride layer between two Cu lines is partly melted away. BCB between the two Cu lines looks intact. Ta barrier looks partly damaged or missing at the top Cu/BCB interface.

The transition temperature of leakage current failure, T_L equal to 250-300C for Cu/BCB under thermal stress is too low to be compatible with advanced CMOS technology. The rapid degradation of B-T stress induced breakdown failure poses a potential reliability exposure. In order to alleviate the leakage current failure, the localized surface defects must be under control. Thermal stability of Cu/other low K material warrants further study to validate the similar T_L behavior.

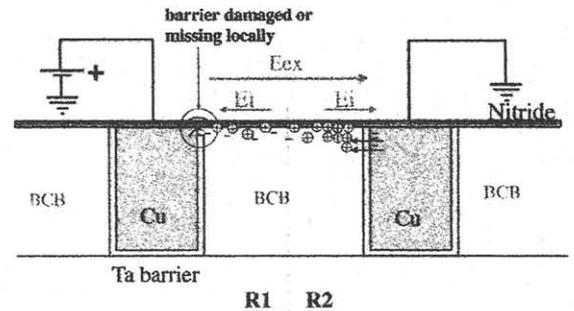
A proposed leakage mechanism model for B-T stress induced leakage current failure is schematically shown in Fig.5. Cu ions are initially injected from the positive Cu electrode through a localized surface defect as shown by EBIC, and drift towards the ground electrode under the bias field and temperature, and accumulate near the electrode. This results in an internal field, E_i to develop. As a result, two field regions, R1 and R2 are being developed. In R2, the external and internal fields enforce each other, resulting in a stronger field, while in R1, they oppose each other, resulting in a weaker field. Cu ions initially drift very rapidly and then slow down because of build-up of the retarding field. The leakage current results from electrons injected from the ground electrode because of the high field in region R₂. The electron injection mechanism is most likely due to trap assisted tunneling through grain boundaries of Ta barrier layer. As electrons drift towards the positive electrode, the retarding field in region R₁ is reduced through charge neutralization. This causes an enhanced Cu⁺ injection to occur, which in turn leads to more electron injection in R₂. The regenerative process continues until the breakdown occurs. The model is similarly applicable to the case of thermal stress except that the process is much slower.

Fig. 5; A proposed model for B-T stress induced leakage failure mechanism.
