Analysis and Improvement on the Abnormal alignment At Au conduction points in Narrow border Product

¹ Shenzhen China Star Optoelectronics Technology Co., Ltd, ShenZhen, 518107, CHN

Keywords: Abnormal alignment degradation, Au Point, Blue Color resist

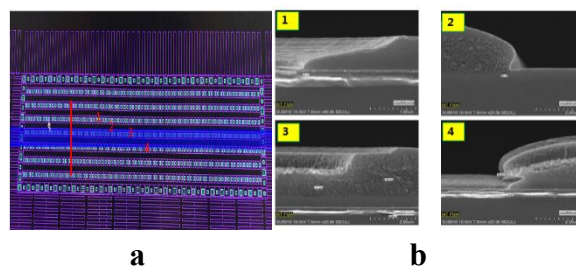
Fig.3 Location description and SEM of Damage area

Through in-plane analysis, it is found that the defect is located at the Au conduction point, as shown in Figure 2, and there are obvious damage marks at the ITO via. Fig. 3a is the design diagram of the corresponding area. The injured part is adjacent to the metal line of Blue resist wall, and there is no

abnormality at other conduction parts ;

Further SEM detection is carried out, and the detection position is shown in Fig. 3b. Position 1 is at the normal through hole of row 4, position 2 is at the edge of Blue resist wall, position 3 is at the through hole covered by Blue resist wall, and position 4 is at the junction between the lower edge of Blue resist wall and ITO Via hole. From the SEM results, it can be found that there is a slight undercut on the Blue resist wall at position 2 and the ITO at position 4 is disconnected, which is speculated to be the main cause of poor alignment ;

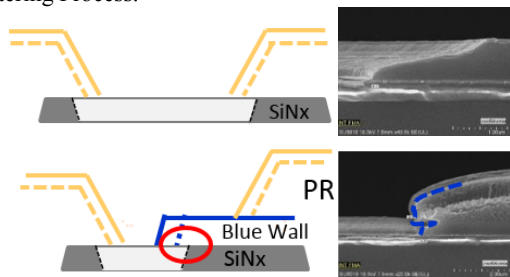
Fig.4 Illustration of Dry etching Process

Through further analysis of ITO disconnection, it is found that the dry process etches part of the PR that plays a protective role. With Blue resist in the Via area, due to PR is finally stripped, the dry etching rate does not affect the ITO connection. Then, With respect to those area with Blue resist Wall, there is a certain undercut in taper due to the Blue resist itself, and dry etching is slow due to complete crosslinking reaction of Blue resist, forming the chamfer of the Blue resist

wall, and ITO disconnection occurs In the subsequent ITO Sputtering Process.

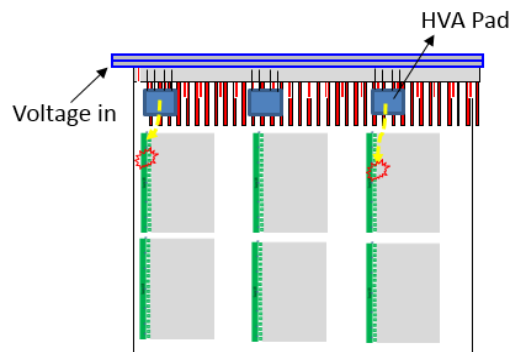
Fig.5 Abridged general view of ESD discharge path

Based on the analysis of the injury performance and the subsequent process involving voltage, it is speculated that the injury occurred at the HVA UVM site. The site needs voltage and UV light irradiation to make the reactive monomer in the liquid crystal material react and complete the liquid crystal alignment process. Due to the application of high voltage, the charge will be released according to the principles of conductivity, low voltage and proximity, The ITO disconnection leads to a large increase in resistance. At the same time, due to the undercut resistance of the color barrier wall, the charge is not easy to transfer quickly, resulting in charge accumulation and injury.
