# Explanation of Mo Undercut and Cu Loss during LCD Panel Fabrication

Jing Liu<sup>1</sup>, Huang-zheng Liu<sup>1</sup>, Zhi-wei Tan<sup>1</sup>

liujing8@tcl.com <sup>1</sup> R&D Center, TCL China Star Optoelectronics Technology Co., Ltd., Shenzhen, Guangdong Province, China Keywords: Mo undercut, Cu loss, Galvanic corrosion, Crevice corrosion

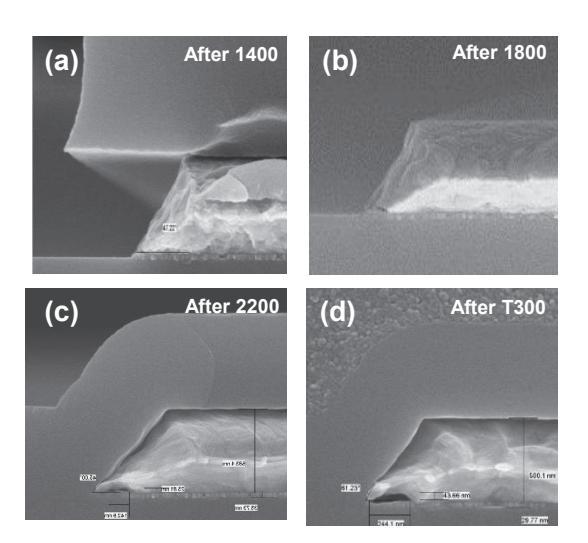
Recently, the formation of Mo undercut and Cu loss have been found during the panel processing with their forming process shown in Fig. 1. After the one-step wet etching of the Mo/Cu layers (1400 station), a seemingly small gap was formed between Mo and Cu layers. After the stripper process of the photoresist (1800 station), the gap becomes larger with more severe Mo and Cu loss. Then after the coverage of the metal layer by the gate insulator (2200 station), the gap expands and the small Cu loss hole shows up with the beneath Mo also be corroded thinner. As the glass experiences the following panel fabrication process, the loss hole becomes larger and the remaining Mo becomes thinner as shown in Fig.1d.

**Fig. 1** The formation of Mo undercut and Cu loss during manufacturing process of LCD display with the respectively taper morphology after (a) wet etching (1400 station), (b) stripper of photoresist (1800 station), (c) gate insulator deposition (2200 station) and (d) array test (T300 station).

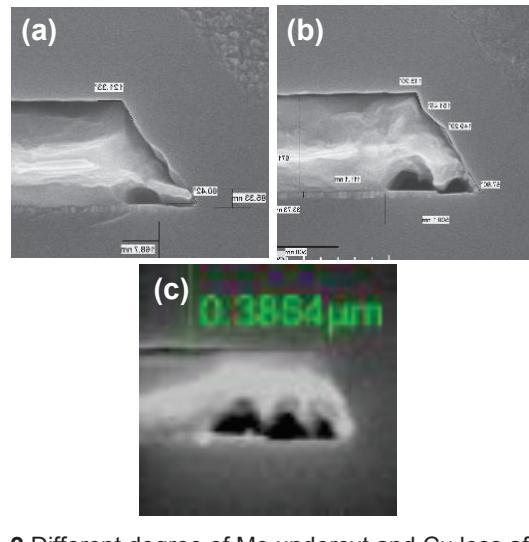
More metal line sites are cut after T300 station (array test) as shown in Fig. 2. To our surprise, different forms of Cu loss holes are found. Some metal lines only exhibit one

Cu loss holes while some lines experience two continuous Cu loss holes. Surprisingly, even three Cu loss holes are found in some sites as shown in Fig. 2c. Here comes the question that how to contribute to these typical forms of Cu loss and why some sites exhibit only one Cu loss hole while other places show two or even three holes.

**Fig. 2** Different degree of Mo undercut and Cu loss after T300 station with (a) one Cu empty hole, (b) two Cu empty holes and (c) three Cu empty holes.

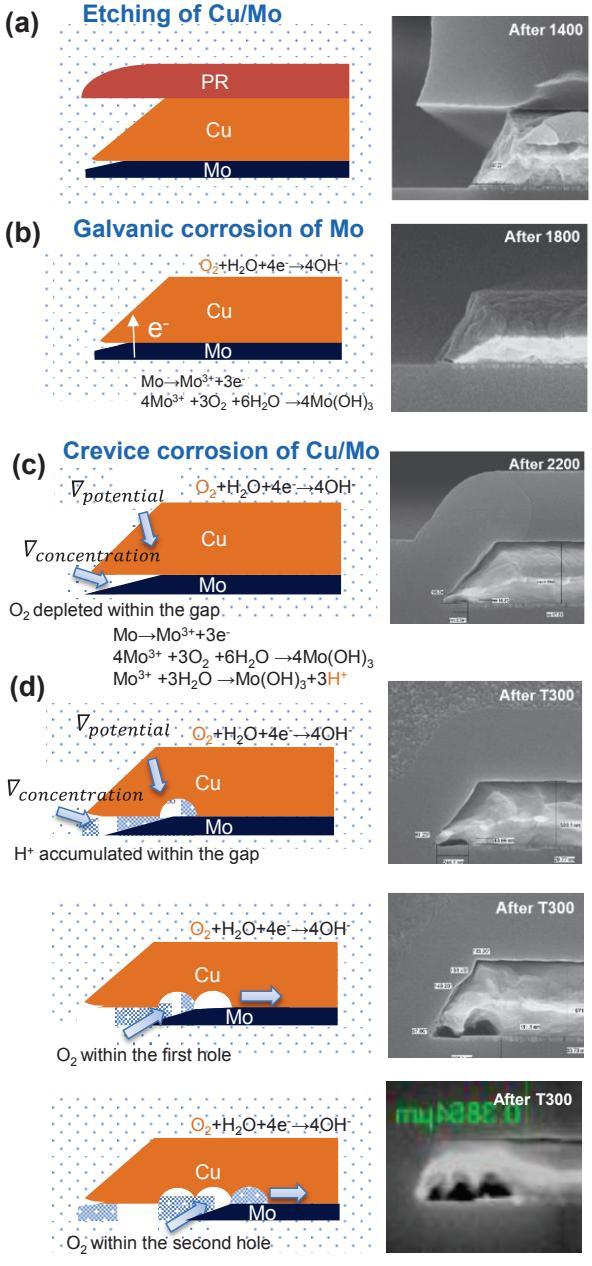
A corrosion mechanism is proposed as shown in Fig. 3 in aim to explain the Mo undercut and Cu loss phenomenon in our system. In the environment of etching acid, both Mo and Cu exhibit the general corrosion, leading to a tiny gap between Cu and Mo layers. Then the substrate with patterned Cu/Mo layers undergoes the removal process of the photoresist, where the removal solvent is alkaline. As Mo is an amphoteric metal, the stripper solvent could corrode Mo easily. Just like the schematic diagram in Fig. 3b, Mo/Cu layers form a galvanic cell where Cu acts as the cathode and Mo is the anode.<sup>[1]</sup> As a result, Mo is oxided inside the gap and the compound Mo(OH)3 is formed with the help of oxygen. On the outer surface of the Cu layer, the reduction reaction happens with the formation of hydroxyl ion. Then the gap between two metal layers

becomes larger due to the galvanic corrosion<sup>[1]</sup> of Mo. As the corrosion goes on, the oxygen is depleted within the gap that induces the concentration difference of oxygen inside and outside the gap. The oxided Mo ion also begins to hydrolyze to produce H<sup>+</sup>, contributing to the acid environment within the gap. Simultaneously, the reduction reaction continues on the outer surface of Cu while no reaction happens on the inner Cu surface inside the gap, leading to the potential drop along the Cu layer. The concentration difference of oxygen and the potential drop are two perfect driving force that induce the crevice corrosion<sup>[2]</sup> of Cu layer, creating the hole loss as depicted in Fig. 3d. Gradually, H<sup>+</sup> is accumulated within the gap and the loss hole expands (Fig. 3d). As the hole and the gap become larger, the driving force of crevice corrosion decrease along with the decrease of the concentration difference of oxygen inside and outside the gap. However, the deepest side inside the gap exhibit the highest inner and outer concentration difference of oxygen, which highly possibly acts at the new starting point to induce the new hole-type crevice corrosion (Fig. 3d). Finally Cu loss with two holes or even three holes could be observed after the T300 manufacturing station.

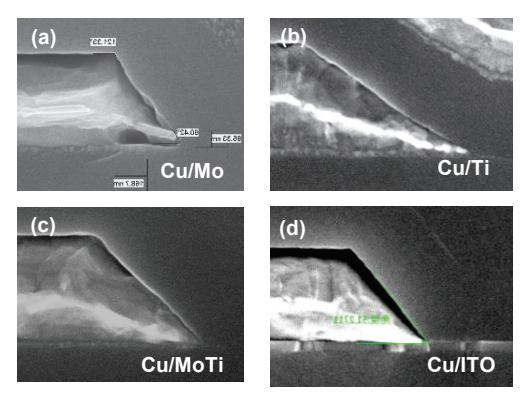
With the aim to weaken Mo undercut and Cu loss, the barrier layer of Cu is intentionally replaced with titamium (Ti), molybdenum-titamium alloy (MoTi) and indium tin oxide (ITO) (Fig. 4). Similarly, the glass of these samples after T300 station are cut to compare their corrosive status with the Cu/Mo system. To our surprise, all the Ti, MoTi and ITO based samples exhibit perfect metal taper morphology without undercut and Cu loss. It could be interpreted that Ti, MoTi and ITO exhibit good resistance to both acid and alkaline and thus there will be no gap between Cu and the barrier layer. As a result, the following

Fig. 4 Undercut and Cu loss phenomenon with the barrier material (a) Mo, (b) Ti, (c) MoTi alloy and (d) ITO.

galvanic corrision and the crevice corrosion exhibited by Cu/Mo layers could be refrained fundamentally. As a result, the corrosion problem could be solved by replacing the barrier material Mo with another antioxided and anticorrosive material during panel manufacturing.
