# The Novel Technology Development of 7mask for LTPS-LCD

Research and Development Center, Xiamen Tianma Microelectronics Co., Ltd., Xiamen, China

*Liquid Crystal Display with 7mask was developed and fabricated successfully for production. We found and solved three key questions, which include the M2 taper, the short circuit of M2 and the thorn-like residue in PV1 and PV2 hole.*

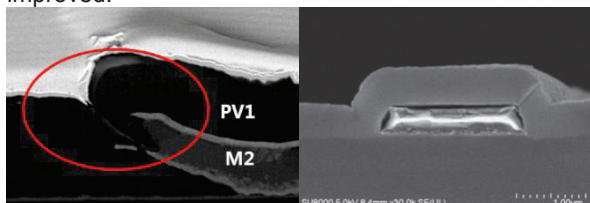
**Fig.2 the appearance of cracked and good film**

Figure 2 is the defect of the PV1 film. As shown, the significant PV1 cracks appear at the location of the M2 climb, which morphology is close to that of M2 taper, showing concave M2. This defect leads to high contact resistance, which is harmful for the quality and the reliability of products. Therefore, the process needs to be improved.

Section diagram of cracked film (a) and good film (b)

In order to clarify the cause of the defect, it is necessary to analyze the structure of the films. The metal M2 are Ti/Al/Ti below the PV1 film. We investigated the structure of the normal PV1 film and found its topography is determined by the M2 taper topography. When the M2 taper is greater than  $90^\circ$  or the Al is lateral etched, the PV1 is more prone to cracks. As the PV1 film layer is uniformly deposited on the top of substrate, when the M2 taper exceeds  $90^\circ$ , the PV1 layer at the M2 taper position cannot be formed continuously by the normal process, resulting in PV1 cracks.

second etching process, the physical etching of  $\text{SiO}_2$  by chlorine gas. As the  $\text{SiO}_2$  under the M2 film is not easy to be etched, the etching rate needs to be low, leading most of the chlorine gas to chemically react with the lateral metal. Because the etching efficiency of Al is faster than that of Ti, the M2 taper has a concave morphology after the second step of etching (Figure 2 (a)). Two methods have been used in 7mask. 1. The structure of ILD deposition was changed from  $\text{SiN}/\text{SiO}_2$  to  $\text{SiN}/\text{SiO}_2/\text{SiN}$  under the M2. 2. The bias power of M2 etching was increased.

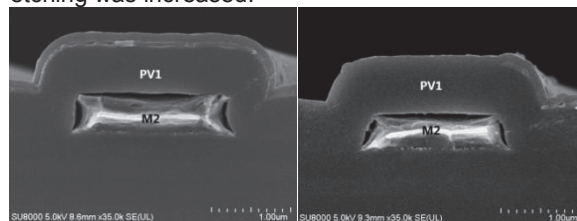
**Fig.3 The appearance of the PV1 film**

Section diagram of PV1 for (a) adding  $\text{SiN}$  layer and (b) increasing bias power of etching

It can be seen from Figure 3 that adding  $\text{SiN}$  layer on the  $\text{SiO}_2$  can effectively reduce the lateral etching degree of M2 taper, and the positive effect on the PV1 cracks reducing is obvious. No relevant defects are detected by VT electrical test. The increasing bias power of etching shows that the M2 taper is decreased from  $79^\circ$  to  $70^\circ$ , which is significant to the improvement of PV1 cracks.

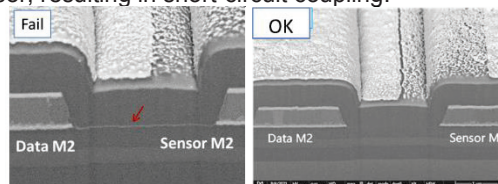
**Fig.4 the appearance between data and Sensor**

7mask products appear defective at the first lighting for the VT electrical test. It was showed that the gray screen appearing purple. The failure mode was analyzed. There is metal residue between M2 data and Sensor, resulting in short-circuit coupling.

The (a) right location and (b) bad location

The FIB diagram shows that there is a metal-like line between M2 DATA and Sensor. The material of the M2 film is Ti/Al/Ti, and the reaction of Ti during the etching process is as follows: There may be a small amount of  $\text{TiCl}_3$  and  $\text{TiF}_3$  on the surface of the sample after M2 etching. It is known that  $\text{TiCl}_3$  or  $\text{TiF}_3$  is very easy to react with water to form titanium dioxide (reaction equation such as formula 8 & 9). Titanium dioxide is non-conductive and chemically stable, it has good stability in many inorganic and organic media, and is insoluble in water and many other solvents.

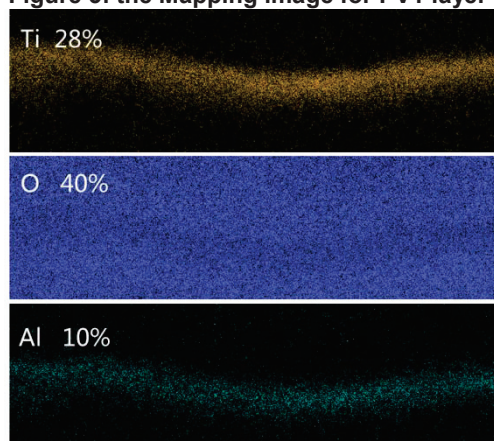
**Fig.6 the mapping of image for PV1 layer**

In order to clarify the composition of the metal between M2 DATA and Sensor, morphology with PV1 layer was investigated. Ti-like substance (Fig.5) was found between DATA and Sensor under the PV1. The failure of “gray screen appearing purple” in the PV1 product demonstrates that some chemical reactions have been occurred after PV1 deposition, which makes it conductive.

For the PV1 product, the substance generated after M2 DET should be non-conductive  $\text{TiO}_2$ . However, the composition between DATA and Sensor after PV1 film formation was characterized by EDS, and it was found that the ratio of Ti and O elements in the compound was greater than 1:2, indicating that  $\text{TiO}_2$  had undergone chemical changes during PV1 film formation, generating substances with weak conductivity, resulting in short circuit between M2 data and Sensor. We analyzed the PV1 film-forming parameters, the  $\text{SiO}$  film-forming gas is only silane and  $\text{N}_2\text{O}$ . It is speculated that the ionized H ion in silane reacts with titanium dioxide to reduce part of titanium to metallic titanium, which makes it conductive and leads to confused display.

M2 etching and PV1 deposition were researched to solve this problem. Reducing the reaction pressure of fluorine and chlorine during the M2 etching process can reduce the  $\text{TiCl}_3$  and  $\text{TiF}_3$  formed during the etching process. Reducing the flow rate of gas containing H atoms in PV1 film forming process is also necessary. Both of

methods could avoid the generation of reduced Ti. If  $\text{SiN}_x$  is used as the PV1 layer, the  $\text{SiN}_x$  film forming gas are silane, ammonia and nitrogen, it is also necessary to reduce the ammonia gas flow rate.

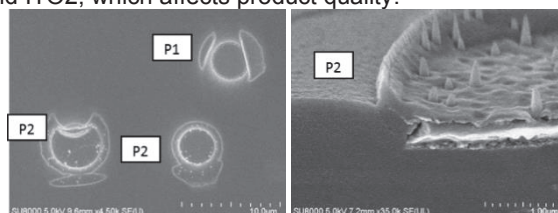
**Figure 7: (a) Surface of PV2 hole and (b) Section of PV2 hole**

The thorn-like residues were found after the etching of PV2. It can be seen from Figure 7 that PV2 has three holes, two of which have thorn-like residues. The SEM cross-section confirms that the height of the thorn-like residues is close to the height of the  $\text{SiO}$  film layer, resulting in an increase in the contact resistance of M2 and ITO2, which affects product quality.

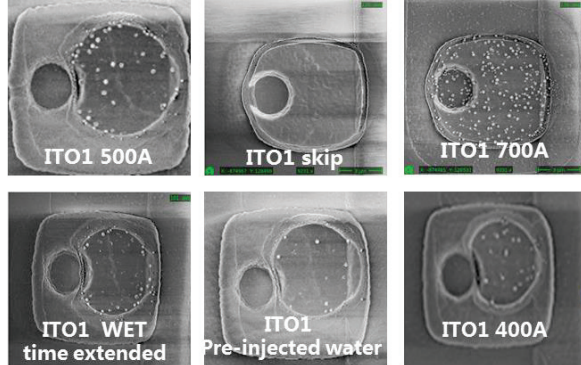
**Figure 9: The SEM surface images of different ITO1**

The ITO1 was removed and thickness of ITO1 was decreased, which were used for the 7mask layer. The SEM after PV2 etching is shown in the figure 9. After the removal of ITO1, the thorn-like residue in the P2 hole completely disappeared, and at the same time, the thorn-like residue in the P2 hole became worse when ITO1 was thickened. Therefore, the thorn residue for P2 hole is strongly correlated with the ITO1 layer. When the chamber temperature increases during the film formation process, ITO1 crystals are formed above the film layer. In order to reduce the amount of ITO crystal, three methods were verified. The SEM after etching is shown in Fig.9. Firstly, increasing the water treatment

process in advance in the process of ITO film formation ensures the crystallization of ITO. Secondly, reduction of ITO1 thickness also obtained the lower crystallization of ITO. Thirdly, extending the etching time makes the ITO crystallization reaction more sufficient. The improvement of ITO1 crystallization significantly improves the P2 porethorn residue, but it still cannot be resolved.

Aiming at the poor columnar shape caused by ITO crystallization, try to etch and react the remaining ITO crystals by improving the etching gas ( $\text{CF}_4/\text{O}_2 \rightarrow \text{SF}_6/\text{O}_2$ ), so as to form a clean through-hole morphology, the through-hole morphology is clean, and the poor columnar shape is significantly improved.
