## Building Damage on Surface Faulting of 2016 Kumamoto Earthquake, and Counter Measures

## \*Yoshiaki Hisada<sup>1</sup>

## 1. Kogakuin University, School of Architecture

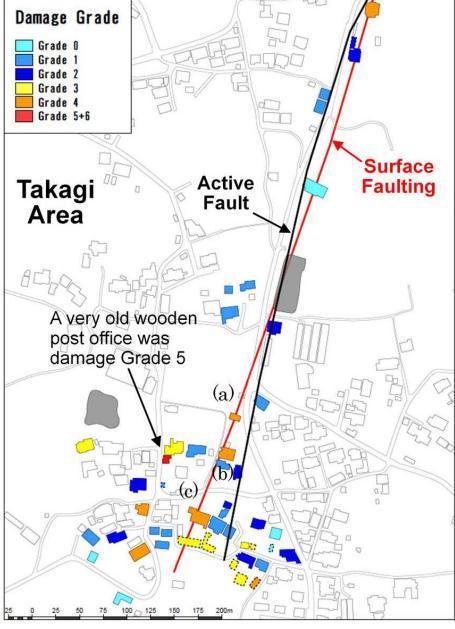
図1 地表地震断層近傍の建物被害分布(高木地区)

This paper reports the results for investigating building damage near the surface faulting of the 2016 Kumamoto earthquake, and counter measures of building. The results of the building investigation indicated that most of severe damage occurred in those directly above the surface faulting, because of its slip deformation. And, almost all severe damaged buildings were very old wooden houses/apartments, whereas new wooden or RC buildings showed very minor damage. In the Shimojin area, for examples, the ground motion was probably not strong enough to cause severe damage, and thus, the highest damage was Grade 3. All of them were very old wooden buildings and directly above the surface faulting. Even though the best counter measure for buildings near active faults is to avoid them, it is unrealistic to prohibit regular buildings in such areas shown in this study, because the exact locations of the surface faulting are very difficult to identify. In fact, they differed from those of the actual surface faulting, because of the young alluvial/volcanic sediments and the artificial land development. In addition, the recurrence intervals of the active faults are extremely long (usually several thousand years), as compared with the lifetime of a building. And the most importantly, various safety counter measures are effective, even for the building directly above the surface faulting. For example, the new wooden houses with the mat foundation of RC could prevent the slip deformation from reaching the building, and the combinations of the shear wall and light roofs prevented severe damage. On the other hand, the old Japanese traditional houses generally suffered severe damage, but their structural flexibilities could prevent collapsing by following the slip deformation. The collapsed buildings were generally very old and lacked both the sufficient earthquake-resisting structural members and the effective connections among them.

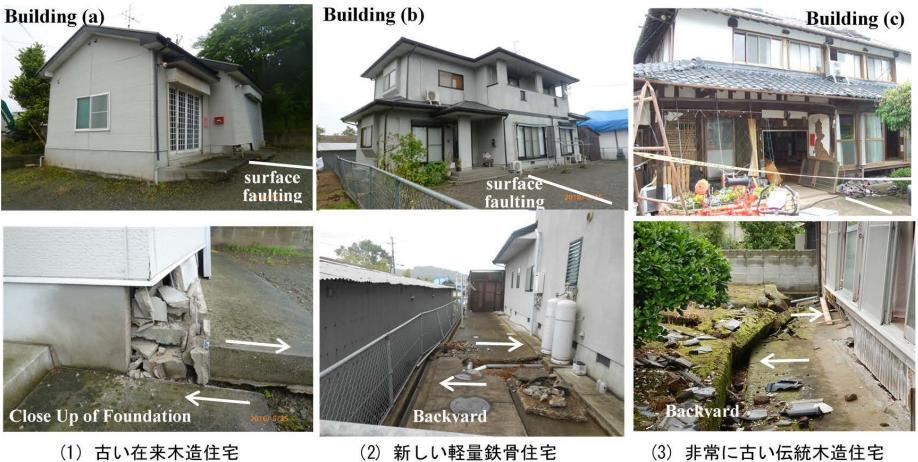
生来木造住宅 (2)新しい軽量鉄骨住宅 (3)非常に古い伝統木造住宅
写真1 御船町高木地区における地表地震断層直上の建物被害の例
