Consideration of existence of active faults in the Reconstruction Plan of Mashiki Town

益城町市街地内における活断層の位置

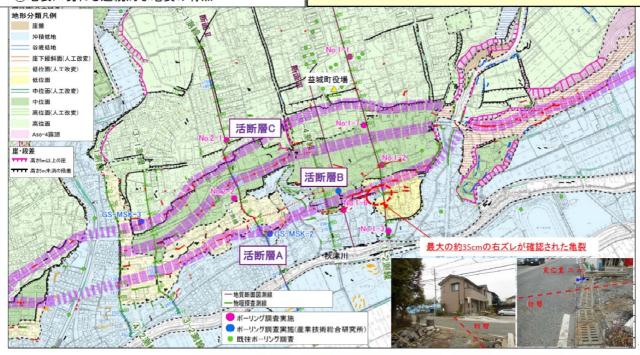
- 益城町市街地において、3本の活断層(A·B·C)が存在。
- 今回の地震では、<u>活断層Aが主体に活動し、益城町市街</u> <u>地では、最大35cmの右ズレ及び最大15cm程度の上下変</u> 位(南落ち)を確認。

(活断層B,Cのズレは活断層Aに比べて微量)
