Gate Oxide Deterioration Caused by Organic Contamination onto the Oxide

Koichi HASHIMOTO, Kyoko EGASHIRA, Miki SUZUKI, Daisuke MATSUNAGA

ULSI Development Division FUJITSU LIMITED 1015, Kamikodanaka, Nakahara-ku, Kawasaki 211, Japan

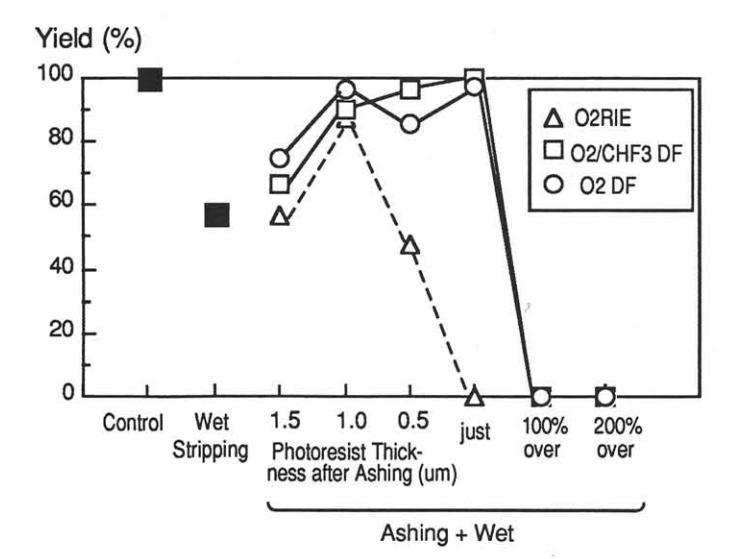
Fig.2 shows the yields of MOS diodes having

$150\,\mu$ m square areas fabricated with various ashing/stripping conditions. In the over ashing region (two rightmost of Fig.2), the yields are very low as we expected.

Metal contaminations from the photoresist⁵) is one possible cause since the penetration of some metal elements into gate oxide reduces its breakdown voltage * . A charge-up damage is another possible cause, though the breakdown of MOS capacitors have been reported only for plasma processing after the gate electrode definition^{6, 7}). In any case, these ashing processes should be categorized into damaging process ⁸).

The problem of the main subject exists in the wet only and under ashing region (the center of Fig.2). In this region, the yield becomes lower as the photoresist to be wet stripped becomes thicker, except for O_2 RIE, which could inflict a damage before reaching to just ashing.

This dependence suggests that the deterioration originates in residual materials, which were neither detected with optical microscope nor with SEM. The materials should remain because of a removal ability insufficiency of the wet stripping treatment.

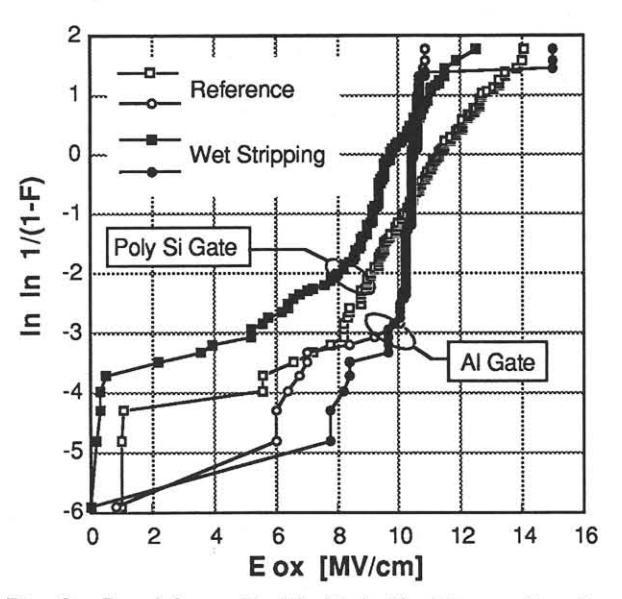
Fig.3 Breakdown field distributions of poly-Si gate and Al gate MOS diodes. Eox is oxide field at which each diode broke, F is cumulative failure.

Fig.3 shows the breakdown voltage distributions of the polySi gate and the Al gate MOS diodes, with 6.9cm² oxide area each. The Al gate diodes were not deteriorated by the wet stripping of photoresist while the polySi gate diodes were. In other words, the actual deterioration did not occur during the photoresist stripping, but occured during the polySi gate formation. Consequently, ESD cannot be the cause.

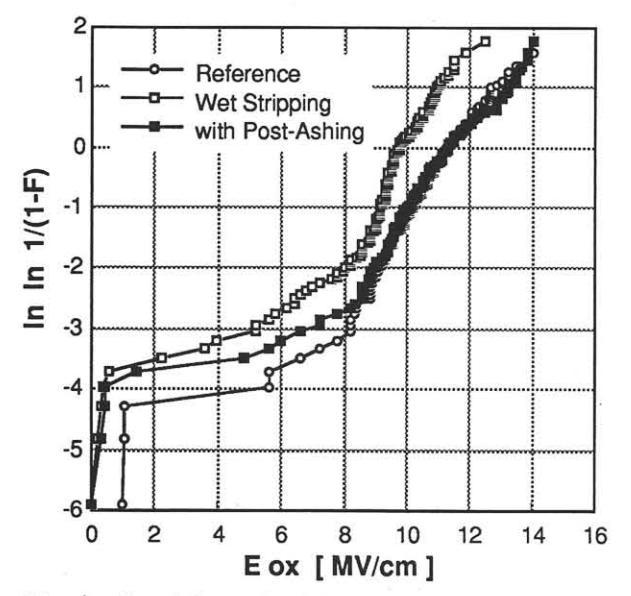
Fig.4 Breakdown field distributions of poly-Si gate MOS diodes. Eox is oxide field at which each diode broke, F is cumulative failure.

Fig.4 shows the results. The ashing treatment added after the photoresist stripping ("with Post-Ashing") recovered the breakdown characteristics in some degree. This means that the residual material responsible for the deterioration can be decreased with the ashing, and hence metal contamination cannot be the cause of the deterioration.

Consequently, the gate oxide deterioration should be caused by the residual organic material from the photoresist on the oxide. In fact, as shown in Table 1, total organic were much more detected from the wet stripped wafers than others.
