Liquefied sites during the 2016 Kumamoto Earthquake

*Shigeki Senna¹, Wakamatsu Kazue², Kyoko Ozawa¹, Hiroyuki Fujiwara¹

1. National Research Institute for Earth Science and Disaster Prevention, 2. Kanto Gakuin Univ

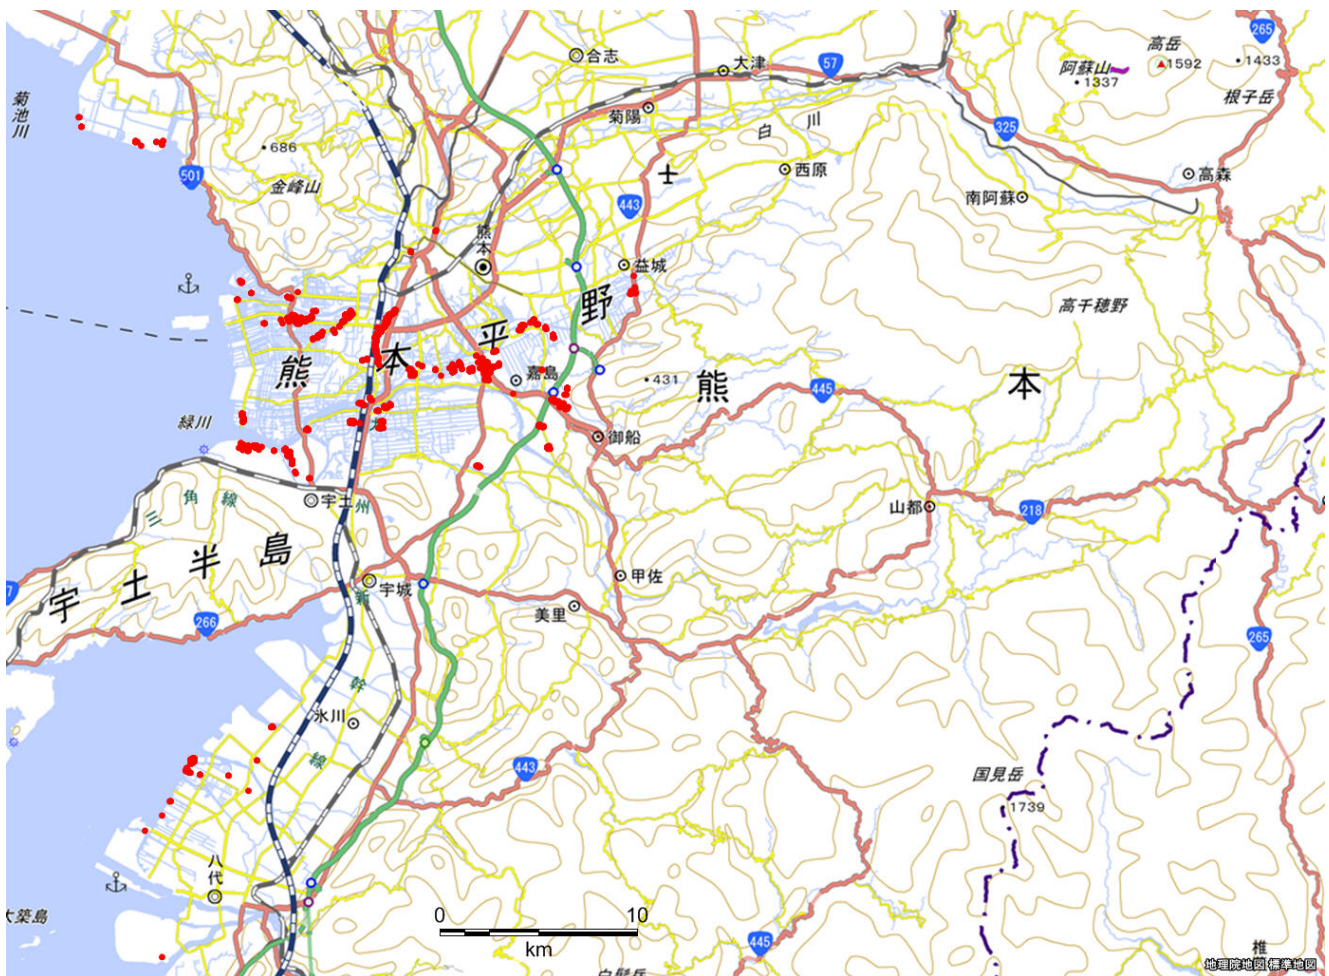
This paper summarizes reconnaissance surveys of liquefaction and its damage to structures during the 2016 Kumamoto Earthquake. The principal findings include: 1) Sand boils observed in eight cities and towns in Kumamoto City and the surrounding areas where seismic intensity 6 minor in the Japan Meteorological Agency Scale was observed during the foreshock, main shock or aftershocks; 2) Geomorphologic units of liquefied sites are reclaimed land, natural levee, back marsh, former river channel and delta along the major rivers in the affected areas including Shirakawa, Midorikawa and their tributaries; 3) Repeated liquefaction was observed at Akitsu, Kumamoto City and Syouwa-doujin-machi, Yatsushiro City where liquefaction took place during the 1889 Kumamoto and 1968 Hyuganada earthquakes, respectively.
