The Coastal Erosion at Omorihama Coast, Hakodate, Hokkaido.

1. Iai Girls' Senior High School

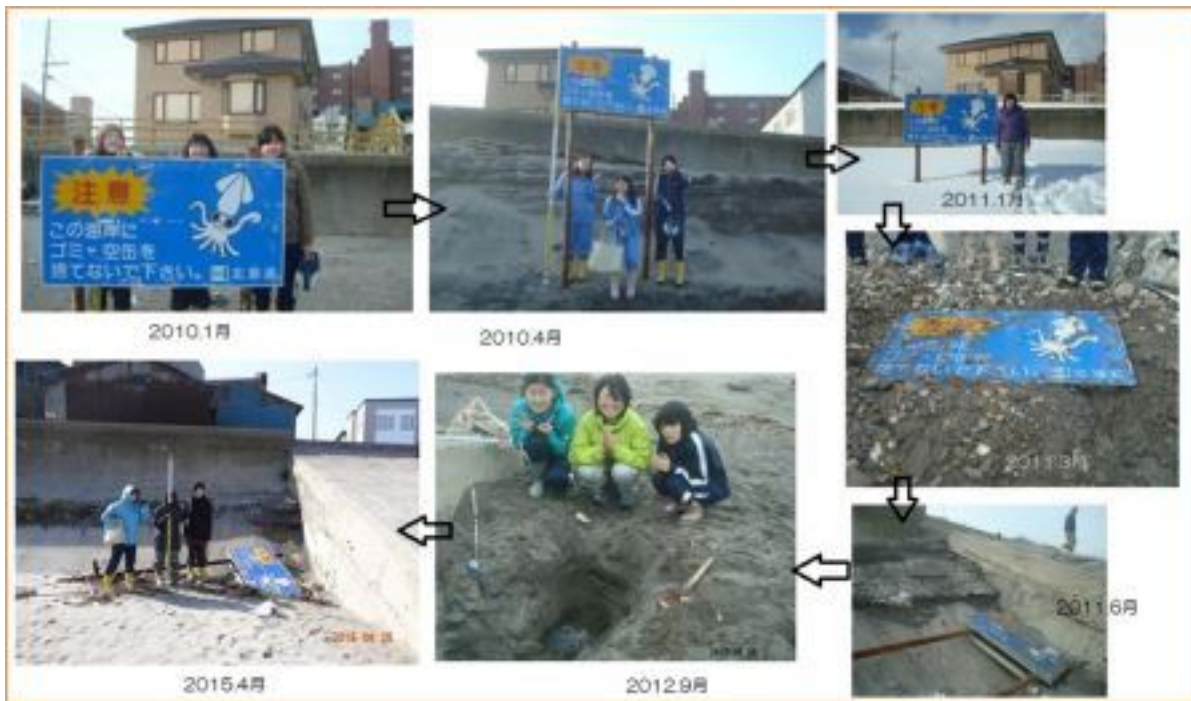
Our club have measured land height above the sea level and observed coastal erosion at Omorihama coast Hakodate city since 2006. At the west part of the coast, the sandy beach was badly eroded in 2010 and 2011 during winter season. A sign board which was put up on the sand was felt down in March 2011 because it had lost foundation sand by Tsunami and windstorm. After that a wave carried sediments on a sign board in summer season and it was buried under the beach. In 2015, it appeared again on the beach because the sand was eroded by a storm surge caused by a bomb cyclone. It is considered that high tide level and strong longshore current cause serious erosion on the beach.
