## The reflective south going current, accompanied by the third wave of Tsunami at Iioka , Asahi City , Chiba Prefecture in 2011.

### 1. The Group of Recording for Tsunami Damage of Asahi City in 2011

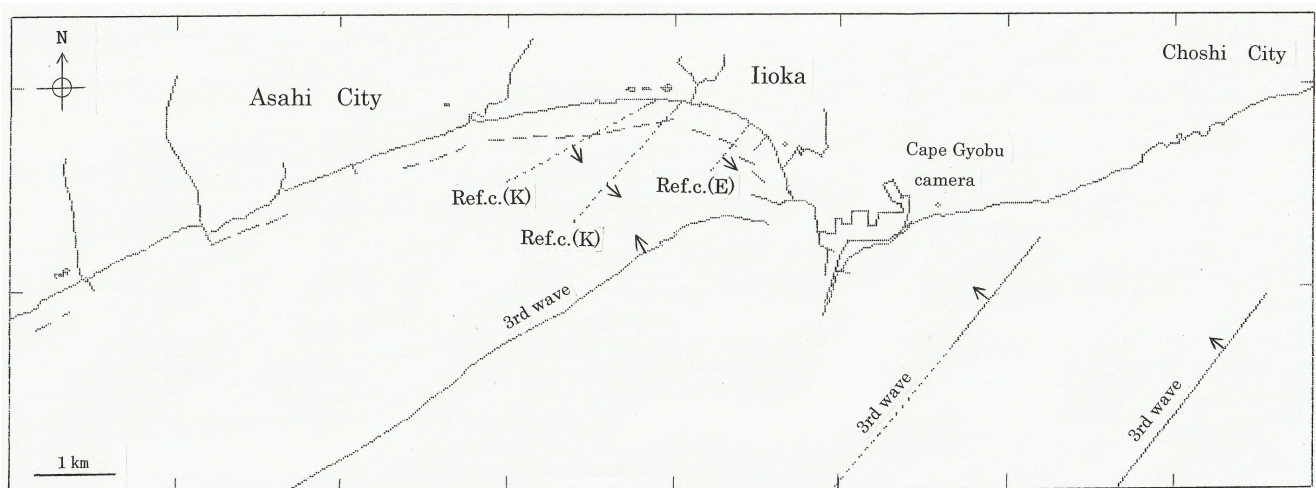
By oblique mono photogrammetry, we calculated the strikes of the wave planes of south going current, and made a wave plane map, which we think proves the eyewitness accounts mentioned above to be right.

**When the third wave of tsunami reached the north coast of Iioka , it was reflected slightly eastward . Then the reflected current went down south along the seawall of west coast of Iioka. After a while, the south going current ran against the succeeding north going current that belonged to the third wave of tsunami. As a result of that collision, the wave height of south going current was increased so much that the wave got over the seawall and destroyed the houses from north to south.**
