## Estimation of co-seismic surface displacement and ground deformation associated with the 2018 Hokkaido Eastern Iburi Earthquake, based on differential InSAR and differential LiDAR DEM analysis.

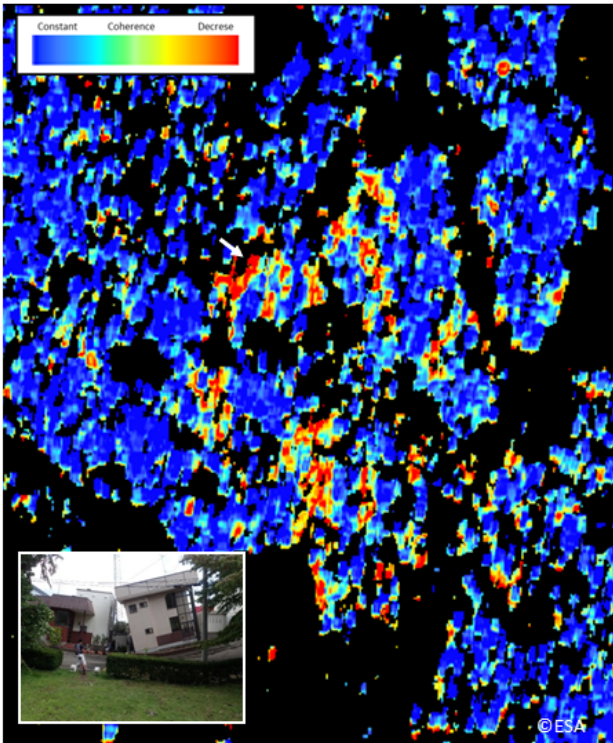
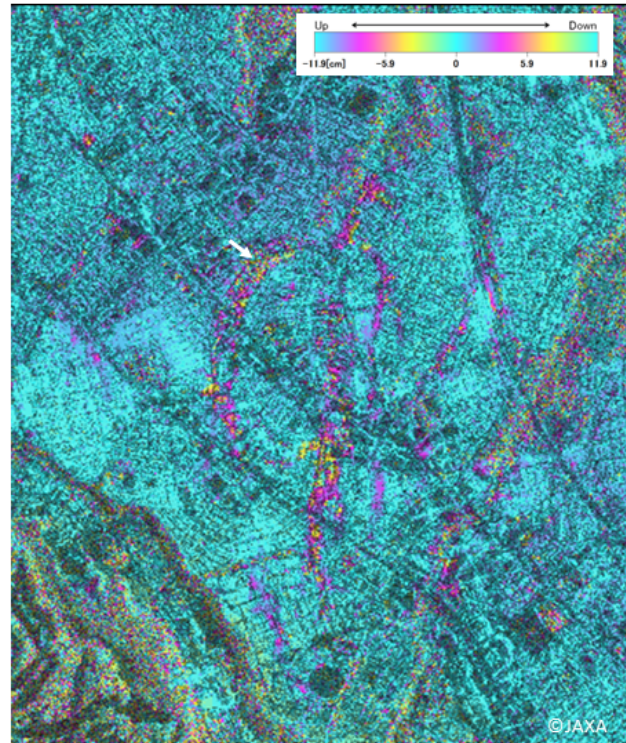
Figure shows an example of Kiyota Ward in Sapporo City where liquefaction occurred. In the interferometry image using Sentinel-1, deviation was discontinuous or shown as noise, so extraction of the deviation was difficult. However, the area which buildings were damaged could be extracted from the coherence change detection.

On the other hand, the degradation of coherence when using ALOS-2 is Low, so the damage area can be extracted from the deviation of the interferometry image as a ground deformation. This difference is thought to be due to the difference in the sensitivity of the observation wavelength band.

For comparison, the particle image velocimetry method was applied to calculate 3-D vectors of co-seismic deformation. The result shows deformation of the housing area, which was developed over the valley that was filled up with soil, agrees with SAR analysis result.
