## The degradation state of the Wareishi Rock Cliff Sculpture based on the multi-view stereo.

\*Nobuaki Kuchitsu<sup>1</sup>, Masayuki Morii<sup>1</sup>, Shuji Sakai<sup>2</sup>, Hiroki Unten<sup>2</sup>

1. Tokyo National Research Institute for Cultural Properties, 2. Toppan Printing Co., Ltd.

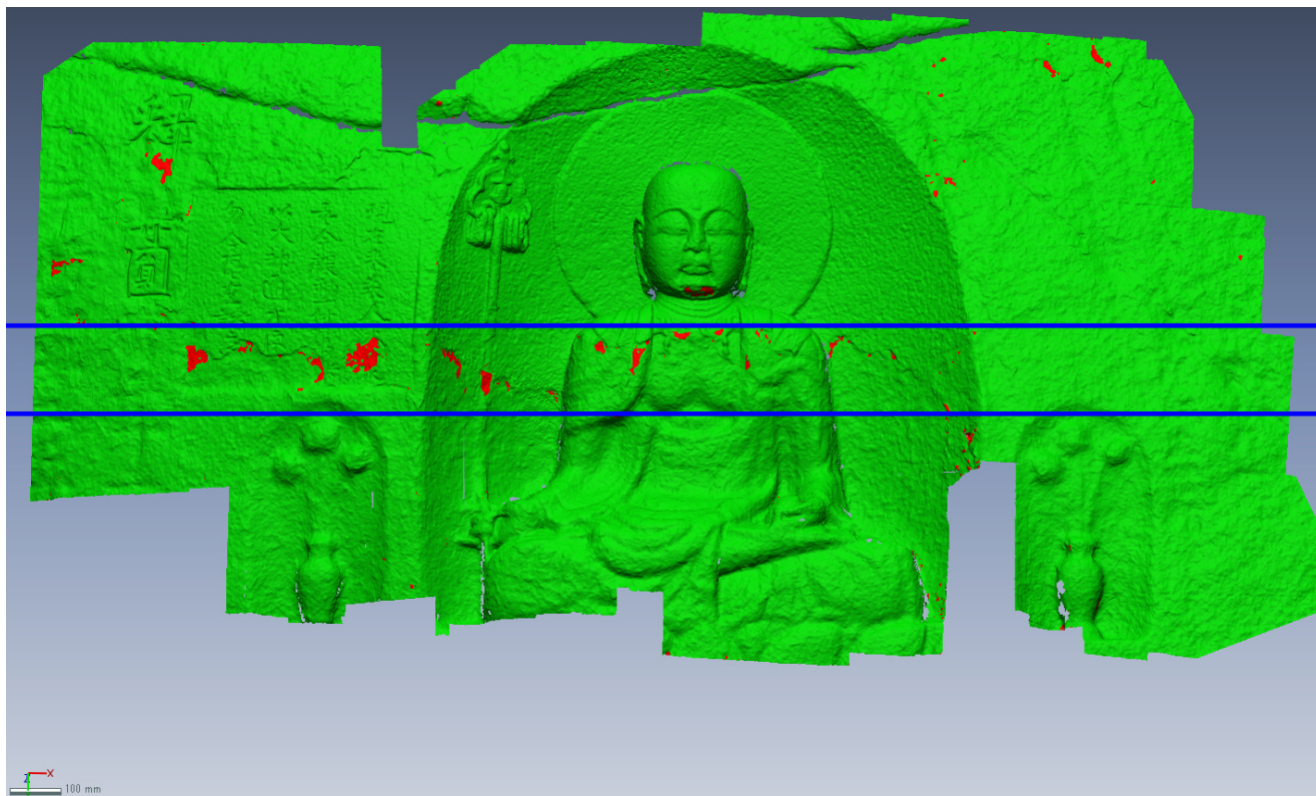
As a result, the difference between the shapes of the Sculpture and the replica was detected mainly on the middle part of the core stone constituting a horizontal belt of ca. 20 cm parallel to the sea level. The total area of the places where more than 3 mm difference was detected constitutes ca. 0.56 % of the whole measured area.

The upper surface of the beltlike deteriorated area almost concurs with that of the darkened area of the present Sculpture, whereas the lower surface of the deteriorated belt with the upper surface of the darkened area of the replica. In other word, the degradation of the Sculpture during these 30 years is detected mainly on the belt between the uppermost lines of algae on the Sculpture at present and at 30 years ago.

essential part for the Sculpture, e.g. on the face. In such a case, some conservation measures may be discussed such as establishing a transparent barricade keeping the Sculpture from the direct wave erosion.
