## Damage investigation activities utilizing Geopark organization for the 2016 Itoigawa Station North Great Fire in Itoigawa City, Niigata Prefecture

1. Fossa Magna Museum, 2. Itoigawa Geopark Promotion Office, 3. Itoigawa Geopark Tourism Guide association, 4. Friends of Fossa Magna Museum

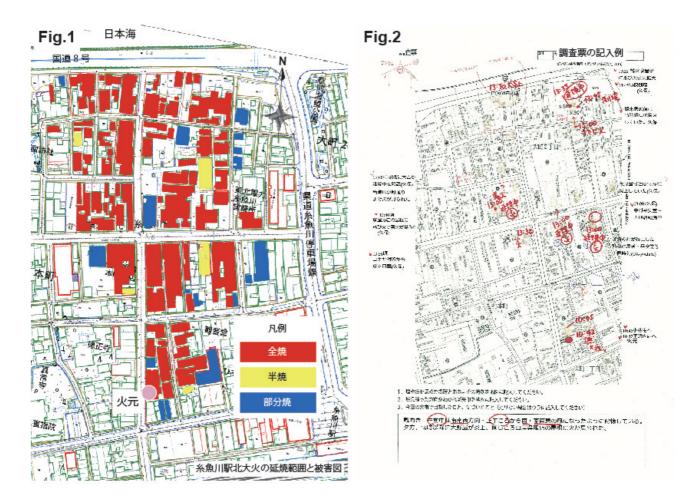
The fire was safely contained at 8:50 p.m. and after continued firefighting efforts it was finally extinguished the following day at 4:30 p.m. 17 people suffered minor to moderate injuries, but in part due to police and the residents' efforts, there were no casualties. 147 buildings were damaged in the fire (120 completely destroyed, 5 half destroyed and 22 partially damaged), including Kaga-no-l, Niigata Prefecture's oldest sake brewery established in 1650; 200 year old restaurant Tsurukiya; and the similarly old inn Heiando Ryokan. Roughly 40,000 square meters were consumed in the fire, making it the worst fire in Japan in the past 20 years (Fig. 1).
