# Potential-Induced Degradation for Thin-Film Si Photovoltaic Modules

Yukiko Hara and Atsushi Masuda

National Institute of Advanced Industrial Science and Technology  
Central 2, 1-1-1 Umezono, Tsukuba, Ibaraki 305-8568, Japan  
Phone: +81-29-861-0532 E-mail: atsushi-masuda@aist.go.jp

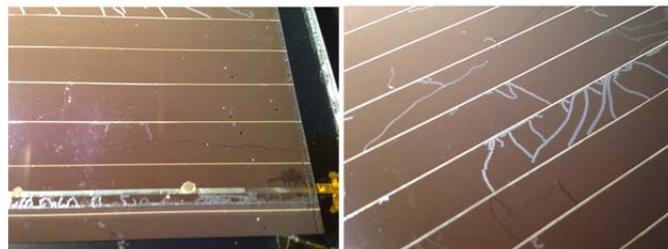
Fig. 2 Photographs of the examples of the delamination observed after PID test over 150 h.

Figure 1 shows the normalized short-circuit current ( $I_{sc}$ ), open-circuit voltage ( $V_{oc}$ ), fill factor (FF) and maximum power ( $P_{max}$ ) as a function of PID test time. All parameters before PID test were normalized to 1.  $I_{sc}$  and FF decrease in the initial stage of the PID test; however, the decrease seems to be saturated. On the other hand,  $V_{oc}$  decreases after PID test over 150 h and no saturation tendency is observed until 300 h. On the other hand, no decrease in shunt resistance was also confirmed by dark current-voltage characteristics. Delamination is also observed after PID test over 150 h, as shown in Fig. 2. Such delamination was also observed for thin-film Si PV modules exposed outside for a few years. The delamination may occur at transparent conductive oxide (TCO) layer between glass substrate and a-Si:H top cell [6]. Dark area in the electroluminescence images was also observed after delamination occurred.

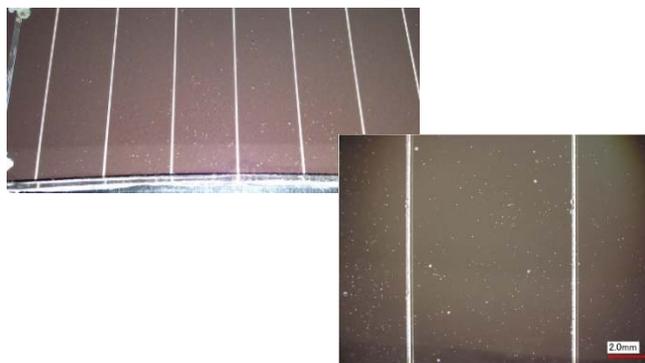
Fig. 4 Photographs of the examples of the spots appearing after the second -1000 V application.

Figure 3 shows normalized  $I_{sc}$ ,  $V_{oc}$ , FF and  $P_{max}$  as a function of PID test time. In this case, voltage of -1000 V and +1000 V were alternately applied. It was found that decrease in  $I_{sc}$  by -1000 V application is completely recovered by +1000 V application. Some PV parameters are over 1 during +1000 V application due to annealing effect at test temperature of 85°C. However, such recovery did not occur after severe PID with delamination. Surprisingly, all of the PV parameters drastically decrease in very short period during the second -1000 V application. Normalized  $P_{max}$  after the second -1000 V application is smaller than normalized  $P_{max}$  by only application of -1000 V for 250 h. Some spots like particles also appear after the second -1000 V application as shown in Fig. 4. Figure 5 shows normalized  $P_{max}$  as a function of test time. In this case +1000 V is applied from the start of the test. During the first +1000 V application  $P_{max}$  somewhat increases due to the annealing effect. Drastic decrease in  $P_{max}$  is observed by the next -1000 V application.  $P_{max}$  again increases by the second +1000 V application. During the second +1000 V application the above-mentioned spots also disappeared. Rapid decrease in  $P_{max}$  by negative voltage application and complete recovery of  $P_{max}$  by positive voltage application are alternately observed as shown in Fig. 5. It was also confirmed by cross-sectional scanning electron microscopy that the origin of the spots are not particles or precipitates but delamination at TCO layer.
