Mapping of Ni/SiN_x/n-SiC Structure Using Scanning Internal Photoemission Microscopy

SiN_x films formed on n-SiC layers have been characterized by using scanning internal photoemission microscopy (SIPM) in metal-insulator-semiconductor (MIS) diode structure. After applying forward-biased voltage stress up to 30 V, the diode was partially degraded. SIPM clearly imaged the degradation pattern with a large photocurrent, which consisted with the microscopy image. These results clarified that the partial degradation induced a leak path with a low energy barrier.

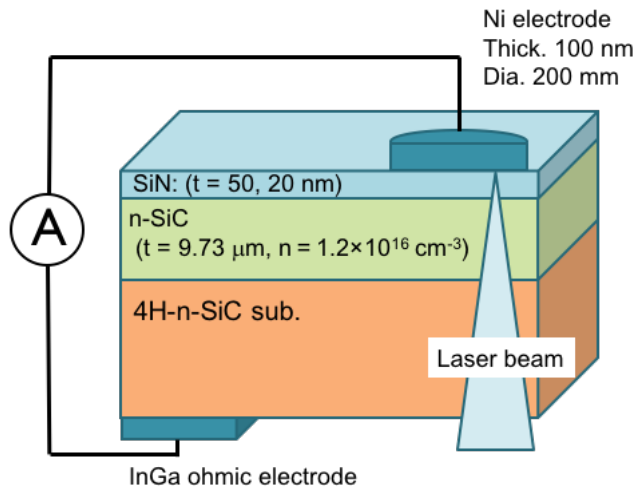
Fig. 1 Device structure of Ni/SiN_x/n-SiC MIS structure.

A 9.73-μm-thick n-SiC ($n: 1.2 \times 10^{16} \text{ cm}^{-3}$) layer was grown on a 4H-n-SiC substrate as shown in Fig. 1. Then, 50- or 20-nm-thick SiN_x layers were deposited by RF reactive sputtering using pure Si target and Ar + N₂ gas mixture. Circular 100-nm-thick Ni contacts (200 μm in diameter) were deposited on the SiN_x surface by the electron beam evaporation. After that, InGa ohmic contacts were deposited on the back surface.

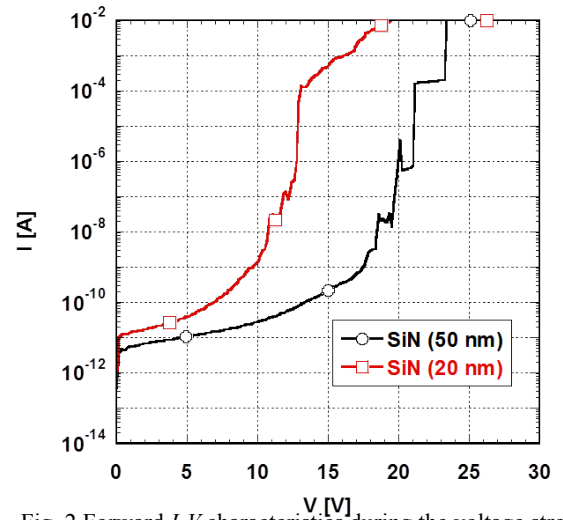
Fig. 2 Forward I - V characteristics during the voltage stress.

We applied forward-biased voltage stress up to 30 V as shown in Fig. 2. For the samples with the 20- and 50-nm-thick SiN_x layers, the current increased sharply at around 13 and 20 V, respectively. These are symptoms of the degradation. Before applying the voltage stress, the surface of the dot was flat in the Nomarski microscope image as shown in Fig. 3(a). After the stress, however we found a variation in surface morphology, where the surfaces consist of rough and flat regions as shown in Fig. 4(a). Because no degradation occurred at the edge of the dot, the SiN_x films have a variation in the breakdown field within the dot.

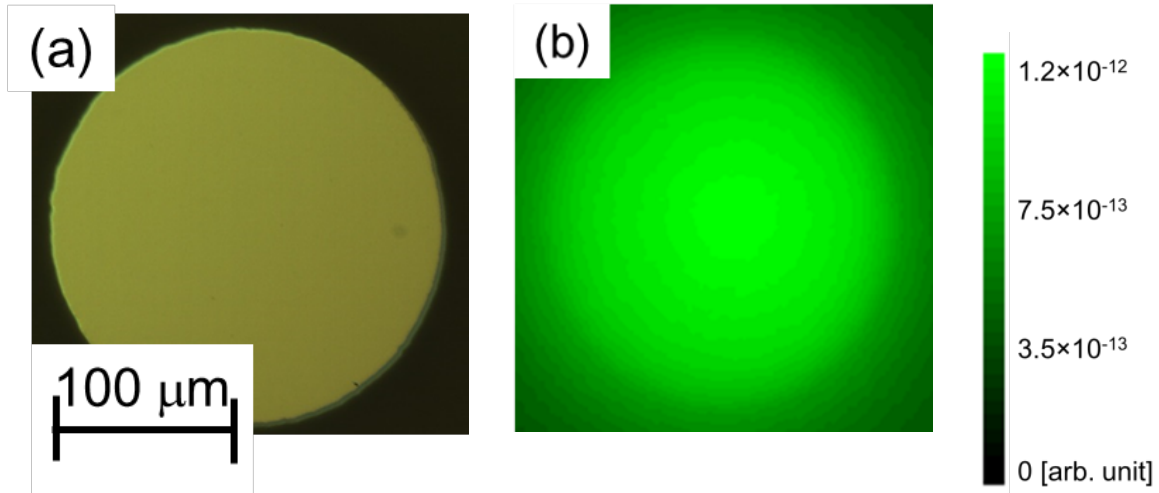
Fig. 3 (a) Nomarski microscope image and (b) photocurrent map of the Ni electrode on SiN_x ($t = 50$ nm) in the as-deposited condition.

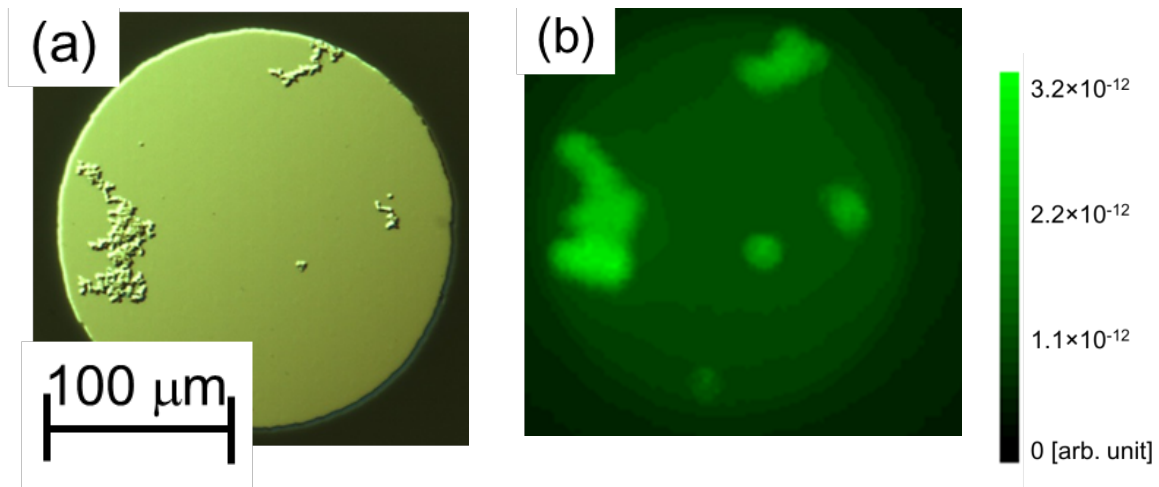
Fig. 4 (a) Nomarski microscope image and (b) photocurrent map of the Ni electrode on SiN_x ($t = 50$ nm) after applying the voltage stress up to 30 V.

We also conducted SIPM measurements for both samples. After the stress, Y increased by 2-3 times in the rough regions (Fig. 4(b)). The Y image is consistent with the microscope image. These results indicate that the SiN_x film was partially degraded and a leak path with a low energy barrier was formed. Therefore, we confirmed that SIPM is also available for degradation of MIS structure.
