Images Obtained by MINERVA-II Rovers of Hayabusa2 Mission and Their Process on the Ground

The authors developed a surface mobile exploration package named “MINERVA-II” for the Japanese asteroid mission “Hayabusa2.” MINERVA-II included twin rovers named “Rover 1A” and “Rover 1B.”

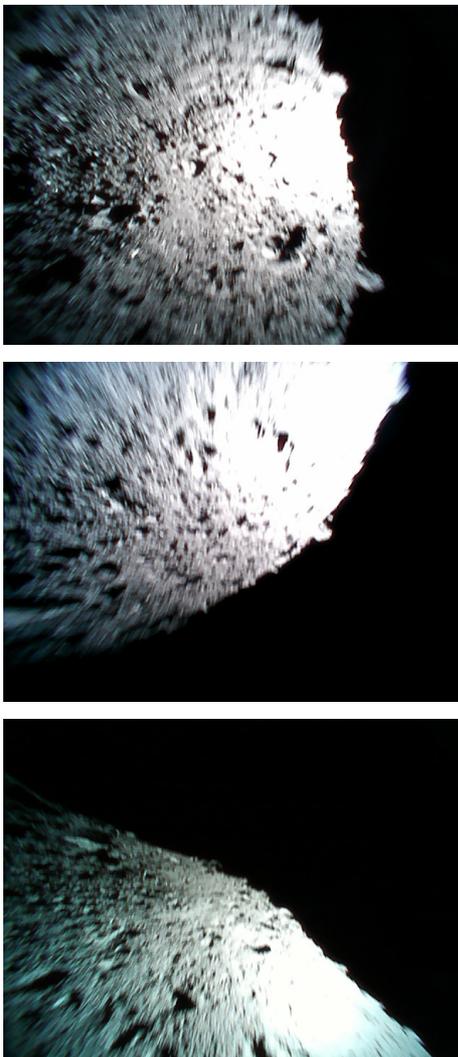
Fig.2 shows three images obtained by Rover 1B during one identical ballistic movement on 7th day. These images clearly showed that the rover hopped from the surface.

Fig. 2: Images obtained by Rover 1B in one identical orbit above the surface

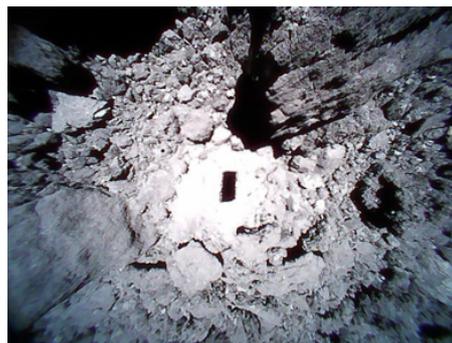
Fig. 3 shows the images obtained by Rover 1A also from above the surface. The shadow of the rover was included in the center of the image and you can calculate the size of the surface features using the images.

Fig. 3: Images obtained by Rover 1A with its shadows in the images
