# Comparative study on shape and distribution of landslides caused by the 2012 Northern Kyushu heavy rainfall and the 2016 Kumamoto earthquake in the Aso region, Kumamoto, Japan

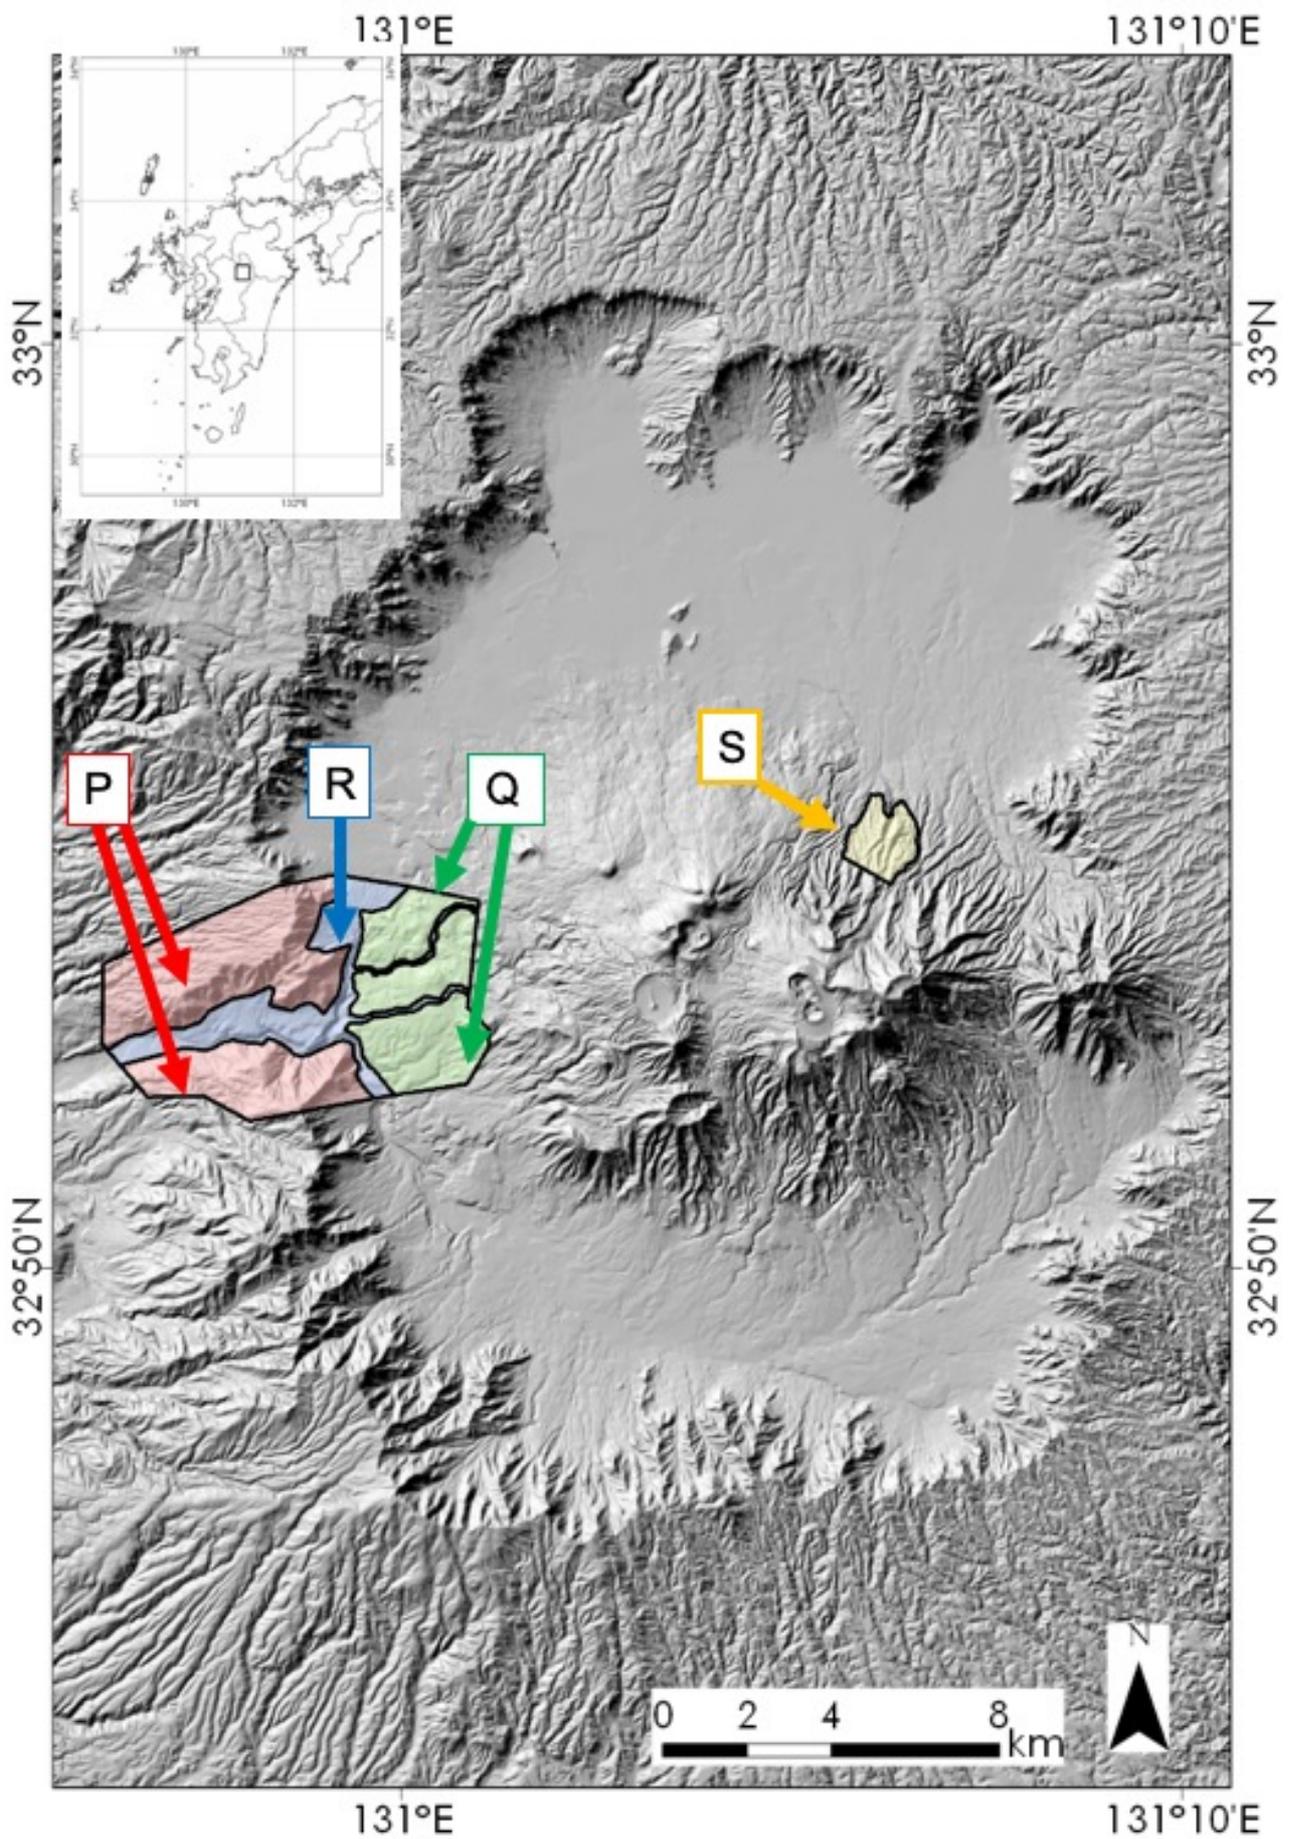
The study areas are the western part of the Aso region and the Sensuikyo region at the northern part of the Central Cones (Fig. 1). The western part was divided into three sites: site P (caldera walls and the outer rim), Q (western part of Central Cones), and R (river terrace and talus) based on geomorphological and geological characteristics. The Sensuikyo region is referred to as site S. This study utilized multi-temporal datasets derived from airborne lidar and photogrammetry using UAV photographs: (i) before the heavy rainfall, (ii) between the heavy rainfall and the earthquake, and (iii) after the earthquake. By using digital elevation data and a sediment transportation map, elevation lowering spots caused by the landslides were identified. Then terrain information and the indexes of shape and spatial distribution were analyzed at the elevation lowering spots.
