2016 Kaikoura (New Zealand) M7.8大地震におけるHundalee断層帯の変動と被害調査

Co-seismic offsets and damage associated with the Hundalee Fault during the 2016 Kaikoura, New Zealand, M7.8 earthquake

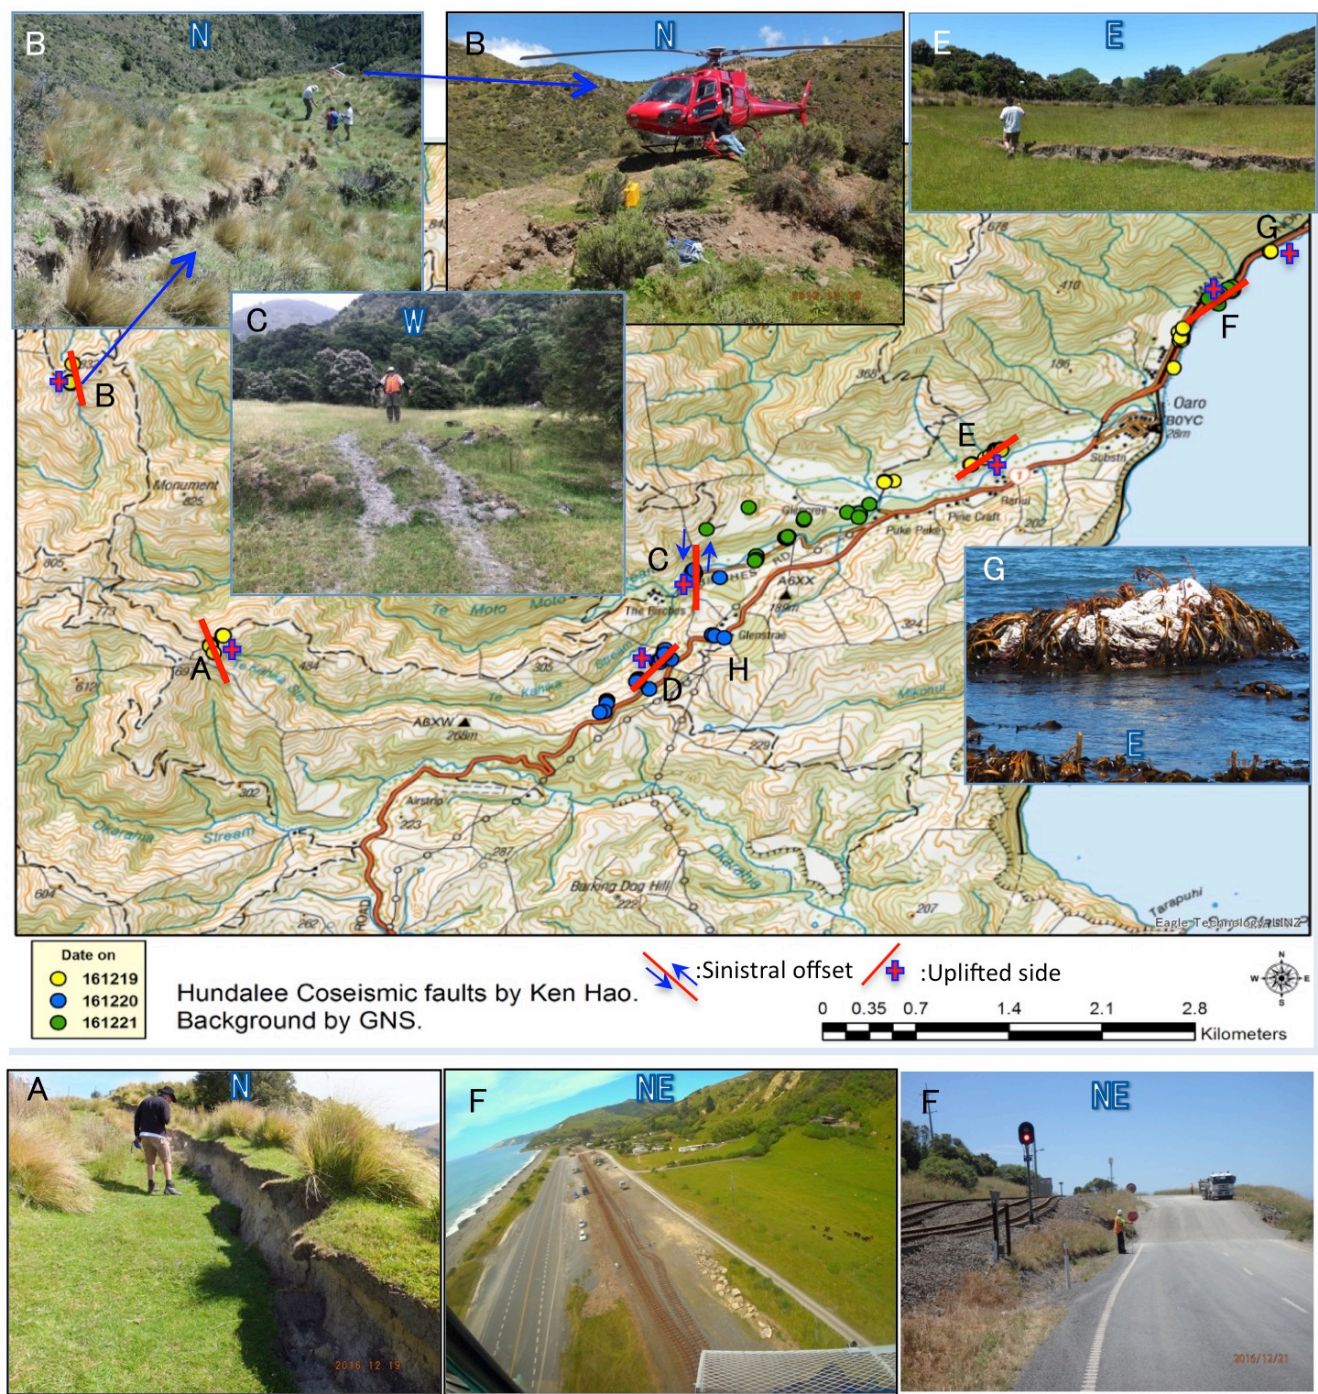
We conducted a field survey on the Hundalee Fault and associated features from 19-21 December 2016 as one of multi-institutional teams. Field investigation started by 5 hours air reconnaissance from a helicopter. At temporary landing sites (site A and B, Figure) on a NNW-SSE fault in mountain terrain, we found up-down relative movement with eastern side uplifted ~1m at A but western side uplifted ~0.6m at B suggested a complex dip-slip movement possibly with some sinistral strike-slip.

On ground survey, co-seismic fault displacements recorded mainly at C, D, E, F and G (Figure). Nearby the previously mapped line of the NE-SW Hundalee Fault on GNS Science geological map, surface rupture had the NW side uplifted at D, F, while a SE side uplift at E, suggests that the Hundalee Fault rupture was complex. The maximum vertical displacement on the Hundalee Fault was ~1.5 m, there accompanied by as much as ~3.7 m dextral offset, as measured across offset road and railway at F. The coast around beach G was uplifted coseismically ~1-2 m. Residence house damaged at H as well as some other houses along the Hundalee Fault.
