FIB Bit Marking Technique for XTEM Analysis of Megabit Memory Failures

N.Nishio, K.Shiotani, M.Kitakata, and M.Mikoshiba
NEC Corporation. 1120 Shimokuzawa, Sagamihara, 229, Japan

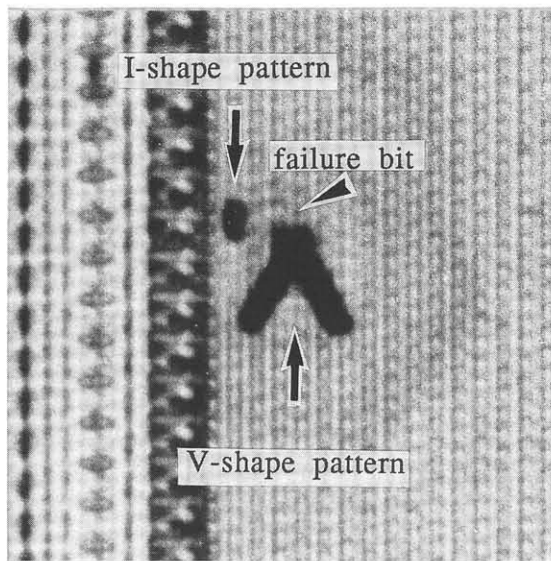
After a retention failure bit on a chip is specified with IC tester, V-shape and I-shape patterns are grooved by using the FIB, as shown in Fig.1. The V-shape pattern is used for a position monitoring during the sample thinning, while the I-shape pattern defines the location of the failure bit cell after the sample preparation is completed. Monitoring the specified cell by SIM(Secondary Ion Microscope) image in FIB machine, V and I patterns were formed in the positions 2-3 μ m apart from the failure cell. The cell-to-mark distance of 2-3 μ m is necessary to avoid FIB induced damages.

Fig.1. Optical photograph of FIB patterns to identify failure bit.
