Gate Oxide Deterioration Caused by Organic Contamination onto the Oxide

Koichi HASHIMOTO, Kyoko EGASHIRA, Miki SUZUKI, Daisuke MATSUNAGA

ULSI Development Division FUJITSU LIMITED 1015, Kamikodanaka, Nakahara-ku, Kawasaki 211, Japan

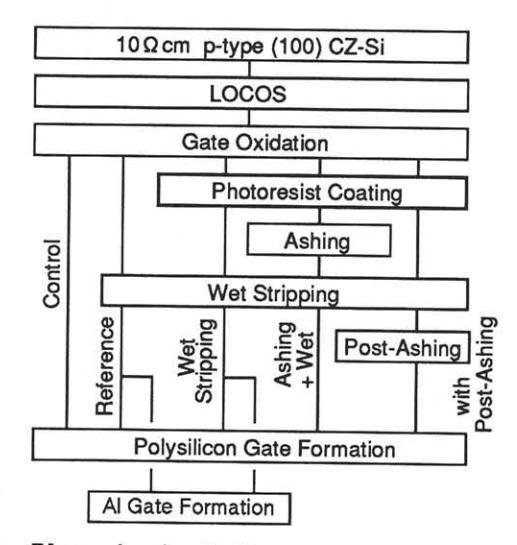
Fig.1 Flow chart of the process used for the sample fabrications in this study. Condition names used in this paper are written vertically.
