Effect of active faults on the water quality of the Ado river and neighboring spring waters in Shiga Prefecture

*Naoji Koizumi¹, Keisuke Ishida¹, Natsuko Oshida¹, Masahiro Maruo¹

1. School of Environmental Science, the University of Shiga Prefecture

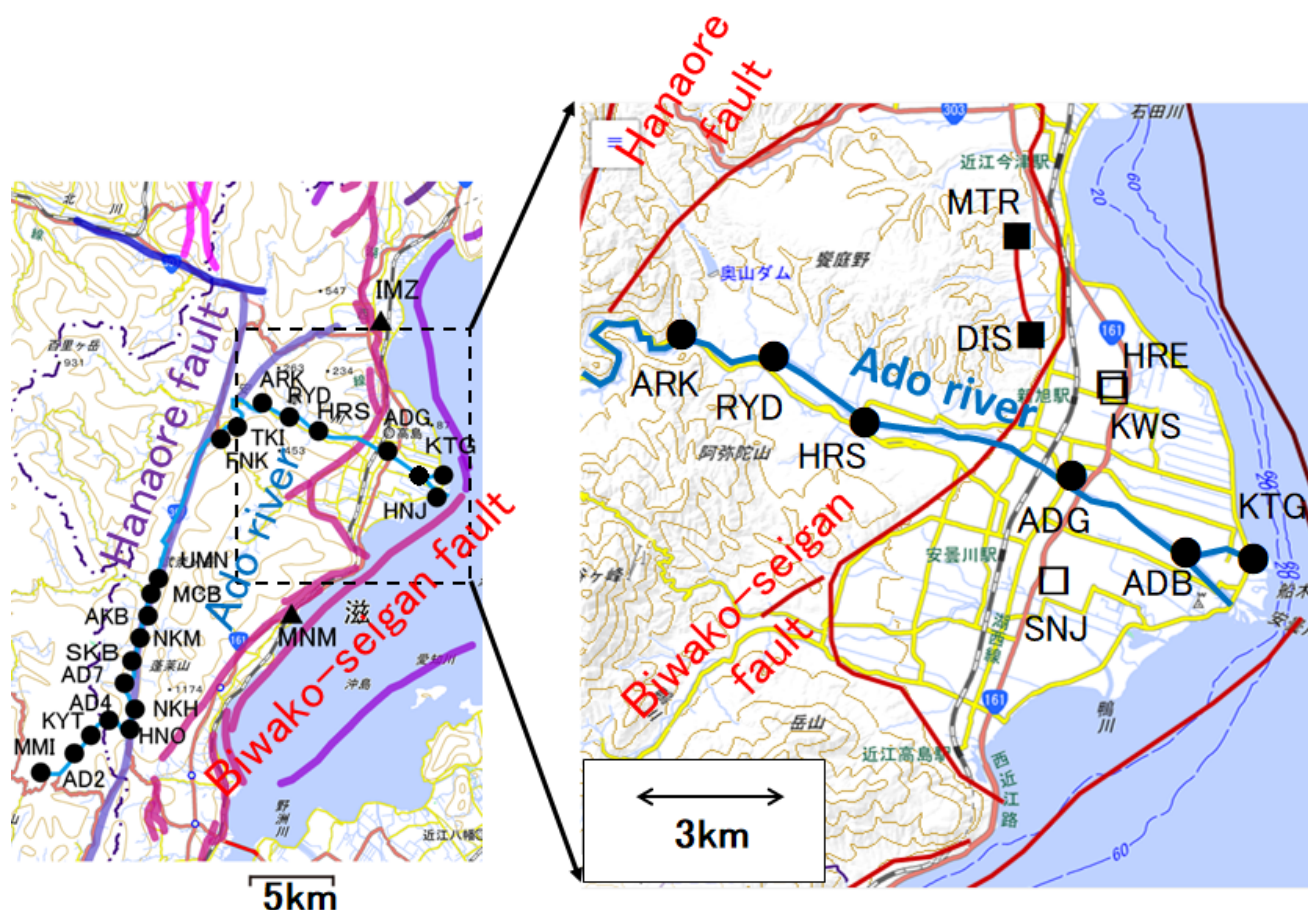
Fig.1:Left: Solid circles indicate the sampling points of the Ado river during the period from August 12 to August 14 in 2018. Solid triangles show meteorological observation stations of JMA. Right: Regular sampling points since April 2018. Solid and open squares indicate fault spring waters and fan spring waters, respectively. Background map is from the active faults database of AIST(AIST, 2020).

During the period from 1996 to 1998, the water quality of the Ado river at ADG in Fig.1 was firstly Ca-HCO₃ type and later turned mainly into NaHCO₃ type or rarely into Na-Cl type (Koizumi et al., 2019). Water quality of the hot springs along the Hanaore fault and Biwako-seigan fault around the Ado river is Na-HCO₃ type and its concentration is several times to 10 times larger than that of river water (Koizumi et al., 2019). Therefore it is considered that the major cation should change from Ca²⁺ to Na⁺ when the effect of the hot spring waters through the faults increases.

We have regularly surveyed the downstream of the Ado river, the fan spring waters and the fault spring waters about once a month since April, 2018 (Fig.1). In this survey, the water quality of the downstream was Ca-HCO₃ type until August 2018. However since September 2018, the water quality have been Na-HCO₃ type. The water quality of two of the fan spring waters, i.e. HRE and KWS in Fig.1, was also Ca-HCO₃ type until August 2018 although it has also been turned into Na-HCO₃ type since September 2018. In the presentation we will report the factors for those water quality changes.
