Making of a detailed DSM of a partially collapsed road embankment and correlation with 3D GPR data

1. Public Works Research Institute

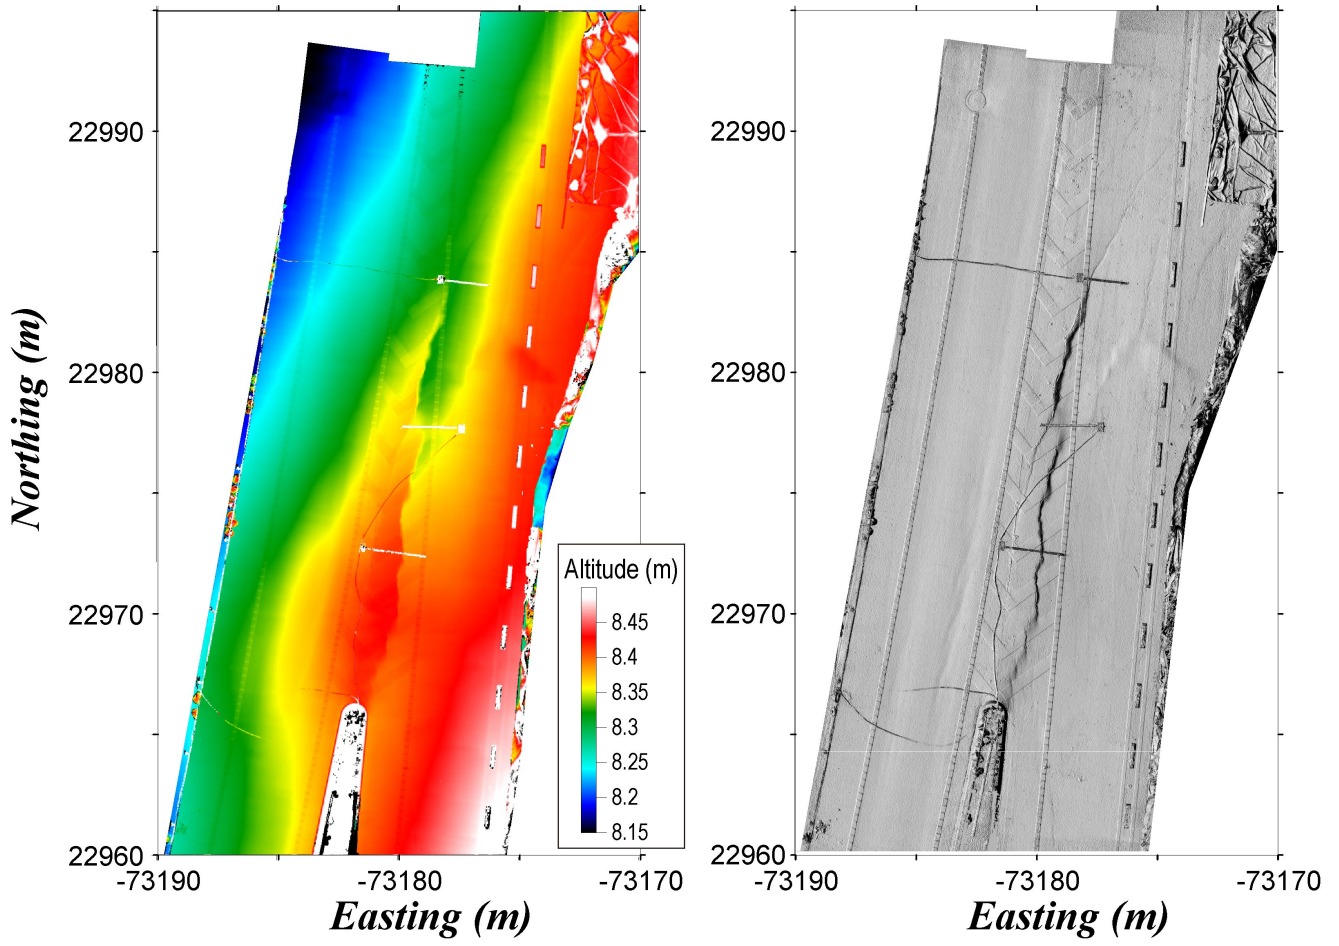
We conducted an urgent but detailed field survey at a site where 8 m high road embankment slope had been partly collapsed by heavy rainfall along with strong motion of 2016 Kumamoto Earthquake 2 months before. The field measurements consisted of high-density surface photogrammetry and near-surface geophysical surveys. We employed a telescopic pole camera system and RICOH GR2 to take digital photographs in the air up to 6 meters. Finally, we made an orthophoto image and a DSM of a road surface which had escaped from collapsing at a spatial resolution of 2.86 mm using a commercial SfM-MVS (structure from motion and multi-view stereo) software package (Agisoft PhotoScan Professional). We used a total of 218 pole camera images and 7 GCPs to create the DSM. In addition, we processed UAV imagery taken on the day after the collapsing to generate a DSM of 2.5 cm spatial resolution of the site. The DSM, which covered 110 m x 90 m area, clearly imaged the embankment collapse and heaving of the ground in front of the failure caused by compression and thrusting. It was helpful to clarify the failure mechanism of road embankment and the role of geotextile-anchored concrete wall set at the foot part of the embankment to avoid entire collapsing of the embankment. Furthermore, we could identify non-tectonic structures from the road surface DSM. Number of cracks and small bulges were traced behind the failure crown, which indicated the co- or post-failure movement of the remained embankment. Then we conducted dense grid GPR survey on the road surface. As a result, cracks extended in the pavement up to 75 cm and the surface pavements were interpreted to be segmented and detached from the underlying road beds. Joint investigation and interpretation of the surface DSM and the near-surface geophysical data was capable to assess the safety conditions of remained road embankment. Namely, which types of restoration works were needed and what extent should be reinforced. In conclusion, combined analysis of surface DSM with the near-surface geophysical survey data is crucial to understand such surface deformation structures as slope failure.
