Damage Islands in Mashiki Town from the 2016 Kumamoto Earthquakes

*Masumi Yamada¹

1. Disaster Prevention Research Institute, Kyoto University

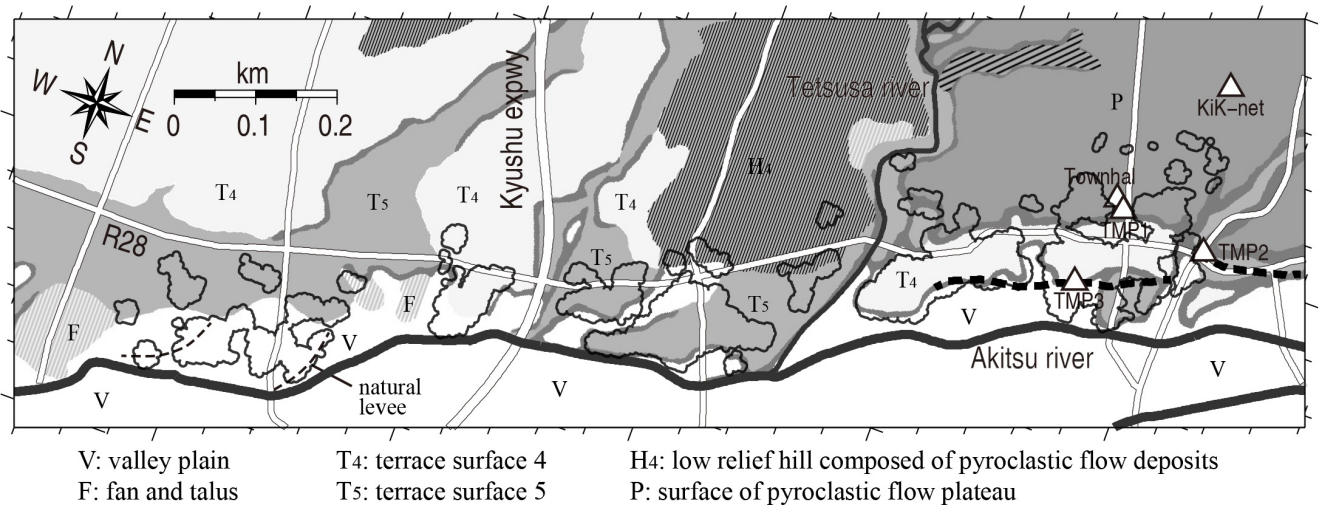
We analyzed aerial photos taken by the Geospatial Information Authority of Japan on the 15th and 16th of April and investigated the distribution of collapsed buildings along the Akitsu river. The photos cover the most severely damaged areas in Mashiki town. The two sets of photos taken between the foreshock and mainshock and after the mainshock, enable identification of the separate damage due to the foreshock and mainshock. The damage distribution is very heterogeneous, and the concentrations of severe damage occur in isolated areas resembling islands. The spatial pattern of the collapsed buildings due to the foreshock and mainshock were similar, but the number of collapsed buildings from the mainshock was 4 to 5 times the number for the foreshock.

The distribution of the collapsed buildings was compared with other information, such as the location of fault surface rupture, geomorphological map, and the location of the older built areas. The surface rupture was observed in the center of Mashiki town. The largest offset was about 40 cm along the southern edge of the concentrated damage area. Since this surface rupture was observed only after the mainshock, it is unlikely that the presence of the surface rupture generated the similar pattern of damage for the foreshock and mainshock in Mashiki.
