Effective KOH Etching Prior to Modified Secco Etching for Analyzing Defects in Thin Bonded SOI Wafers

Kiyoshi Mitani, Hiroji Aga, and Masatake Nakano

Isobe R&D Center, Shin-Etsu Handotai

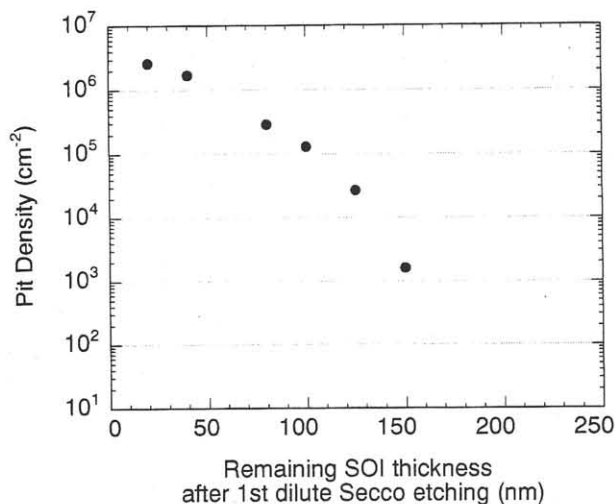
Fig.3 Etch pit density vs. remaining SOI thickness after the first Secco etching.

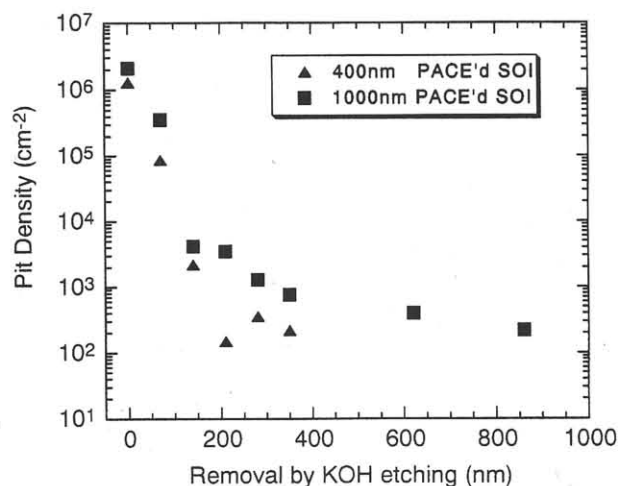
Fig.5 Etch pit density vs. removal thickness of surface SOI layers by KOH.

Figure 5 shows the defect density corresponding to the removal depth of SOI surfaces by KOH. This figure indicated three results. 1) Defects were primarily located in front SOI surfaces with a Gaussian distribution. It indicated that these defects were caused by damages due to energy forced at SOI surfaces, such as coming from the PACE etching or from touch polishing. The polishing scratch pattern really suggested that the touch polishing influenced on the defects. The damage depth was thought to be approximately 300nm. 2) In the area deeper than 300nm from the surface, the defect density was linearly decreased. It indicated that these defects were uniformly distributed in the bulk SOI layers, which implied the presence of grow-in crystal defects. 3) At 1 μ m, where the SOI/BOX interface was located, the defect density was not zero but some positive numbers indicating the presence of defects at the interface.
