Conductive Atomic Force Microscopy Analysis for Local Electrical Characteristics in Stressed SiO₂ Gate Films

Yukihiko Watanabe, Akiyoshi Seko¹, Hiroki Kondo¹, Akira Sakai¹, Shigeaki Zaima² and Yukio Yasuda¹

Toyota Central R&D Labs., Inc
Nagakute, Aichi 480-1192, Japan

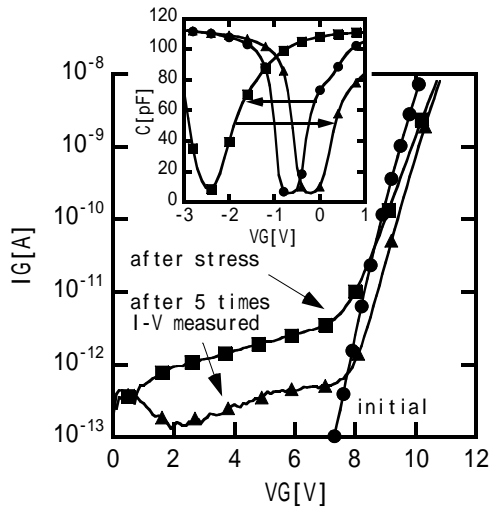
Fig. 1 Results of macroscopic I-V and C-V (inset) measurements for the MOS capacitors under various stress conditions.

Figure 1 shows macroscopic electrical characteristics of the SiO₂ gate films in the actual devices. Large SILC was observed in the I-V curve for the stressed sample. Inset shows simultaneously-measured C-V characteristic for the same sample. Compared with the curve for a non-stressed sample, a large shift to a negative voltage was clearly observed. This shift indicates that holes were trapped in the film due to FN stress. On the other hand, these holes were detrapped when the I-V measurement was repeated. In this case, SILC was observed to decrease.

curve of the hole-detrapped sample shown in the inset of Fig. 1: the SiO₂ film thickness in this sample observed by C-AFM was about a half of that for the macroscopic C-V measurement. These characteristics indicate that at least two types of defects causing the current spots exist in the stressed SiO₂ films; one at which the leakage current is enhanced and the other at which the current is diminished with the applied voltage.

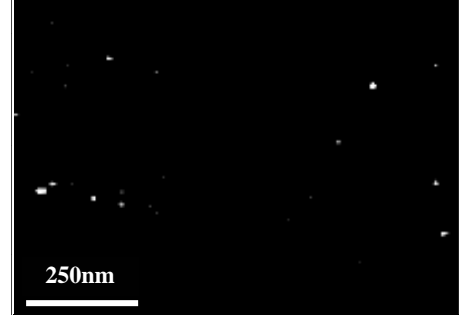
Fig. 3 Current image of a stressed sample taken at a sample voltage of -6 V. A mean current from the spots was 0.52pA.

Figure 2 shows a C-AFM image of the non-stressed sample taken at $V_{\text{sub}} = -6$ V. In the image, no current spots were observed. On the contrary, leakage current spots were clearly observed in the stressed sample, as shown in Fig. 3. A mean value of currents for the observed spots was 0.52 pA at $V_{\text{sub}} = -6$ V. When assuming that these current spots were caused by local thinning of the SiO₂ films, the thickness reduction was estimated to be 0.36 nm. On the other hand, root-mean-square of surface roughness was measured to be 0.29 nm. Thus, the observed current spots do not come from the thickness fluctuation of SiO₂ but explicitly reflect leakage sites which locally generated in the film by FN stress. Moreover, we estimated SiO₂ thickness fluctuation to be 0.16 nm using a background current fluctuation of 0.1 pA. This value was smaller than the observed surface roughness of the SiO₂ film.

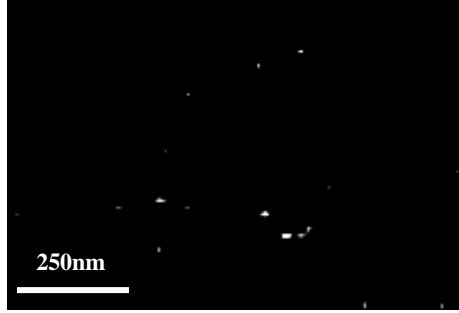
Fig. 5 Current image of a hole-detrapped sample taken at a sample voltage of -7 V. A mean current from the spots was 0.65 pA.

Figure 4 shows a current image of the sample in which holes were confirmed to be detrapped due to the repeated I-V measurement shown in Fig. 1. No current spots were observed. However, when applying a higher voltage up to -7 V to take a current image, spots appear again, as seen in Fig. 5.

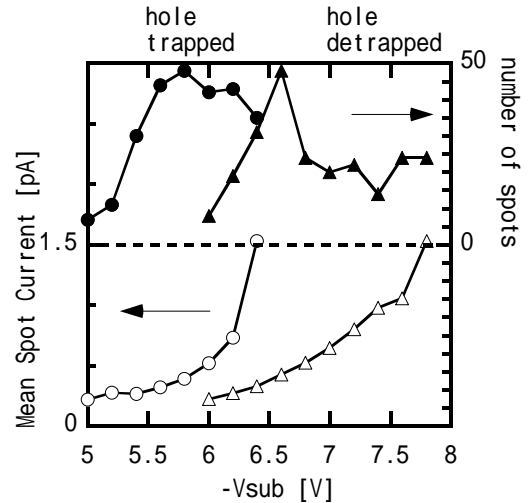
Fig. 6 Voltage dependence of mean currents from the spots and the number of spots. Two samples in which holes are trapped and detrapped are compared.

Figure 6 shows applied voltage dependencies of the number of observable spots and the mean current of the spots when taking current images. Comparison between two samples in which holes are trapped and detrapped, there is a critical difference of a threshold voltage at which the spots start to appear. Furthermore, in both samples, the number of spots initially increases with the voltage to a certain value, then decrease. On the other hand, the spot current was increased with an increase in the applied voltage. The observed positive voltage shift between two samples is about 1 V at 0.5 pA. This value is closely related to a positive voltage shift of about 2 V appeared in the C-V
