Evidence of Electrical and Structural Evolution of Gate Dielectric Breakdown Observed by Conductive Atomic Force Microscopy

Li Zhang and Yuichiro Mitani

Advanced LSI Technology Laboratory, Corporate Research & Development Center, Toshiba Corporation
1, Komukai-Toshiba-cho, Saiwai-ku, Kawasaki, 212-8582, Japan
Phone:+81-44-549-2192; E-mail: Li.Zhang@toshiba.co.jp

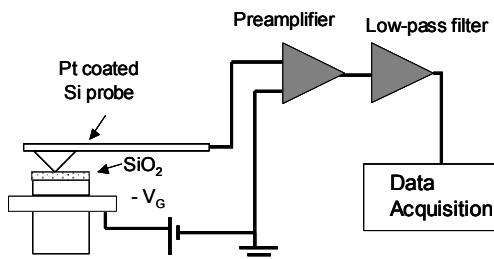
Fig. 1 Schematic of CAFM. The conductive probe acts as a metal-gate electrode. Low-noise preamplifier is used for obtaining ultra-low current.

SiO_2 Gox of 5 nm on n-type Si substrate was used for measurement. A schematic of the circuit of a commercially available CAFM is shown in Fig. 1, using Pt-coated Si probes as gate electrode, where bias is supplied by substrate voltage, which is defined as $-V_G$ here. Current-Voltage ($I-V$) measurements were carried out in vacuum ($< 1 \times 10^{-5}$ Torr), where electrons were injected from n-type Si by FN tunneling into SiO_2 Gox, as shown in the inset of Fig. 2(a). A uniform FN tunneling current fits the simulation results

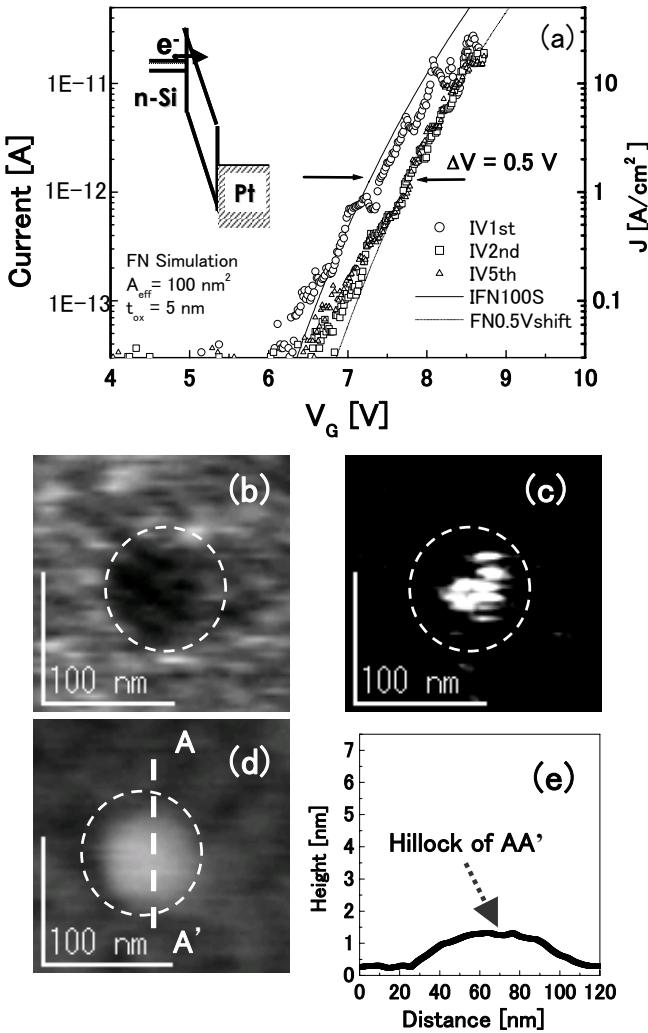
Fig. 2 (a) The $I-V$ results of the 1st, 2nd and 5th ramps of 5 sequential $I-V$ ramps. (b) The subsequent current image at $V_G = 7$ V; Subsequent simultaneous (c) current image and (d) topographical image at $V_G = -8$ V; (e) Topographical profile of the hillock (~ 1.2 nm) along AA' in (d).

Figure 2 shows (a) the $I-V$ results of 5 sequential voltage ramps with a maximum V_G of 8.8 V; (b) the subsequent current image at sensing $V_G = 7$ V; and subsequent simultaneous images of (c) current and (d) topography at opposite polarity sensing $V_G = -8$ V; (e) topographic profile of (d). From Fig. 2(a), the 2nd $I-V$ curve shows a positive shift $\Delta V \sim 0.5$ V against the fresh one, indicating electron trapping occurred during the 1st high field $I-V$ ramp stress. But no obvious further shift was observed during the additional $I-V$ stresses. From the current image in Fig. 2(b) at 7 V, the stressed area has a lower current shown as dark regions, compared to surrounding fresh locations, whereas the same area shows higher current as bright regions in Fig. 2(c) at opposite polarity sensing V_G of -8 V. A possible explanation is that negative charges were trapped at neutral traps during degradation by $I-V$ stress, and the ΔV originated from the flat band shift due to buildup of negative charges in the Gox. Another phenomenon observed in Fig. 2(e) is the topographical change (~ 1.2 nm) of the measured hillock area against surrounding fresh areas in Fig. 2(d), which is found independent of measuring bias polarity, indicating a physical change occurred in addition to an electrical one. It is also found from Fig. 2(b)-(e) that the damaged area is $\sim 8 \times 10^3 \text{ nm}^2$, larger than the contacted area of probe gate ($\sim 100 \text{ nm}^2$), indicating a lateral dispersion of the trap generation during $I-V$ stress.

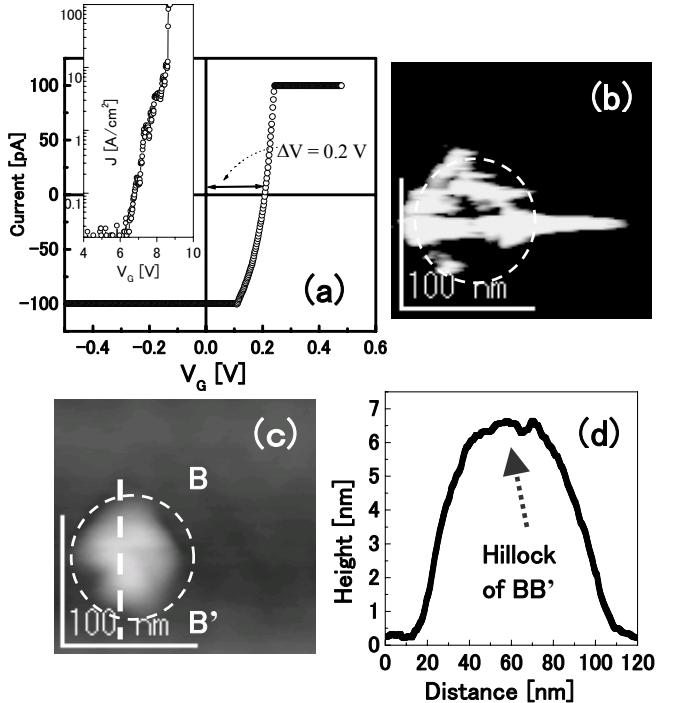
Fig. 3 BD during a single $I-V$ ramp (inset). (a) Consequent post-BD $I-V$ ramp immediately after BD at very low bias; Simultaneous (b) current and (c) topographical images at sensing voltage $V_G = 0$ V; (d) Topographical profile of the hillock (~ 6.3 nm) along BB' in (c).

The BD event was often observed at sufficiently high field ($\sim 15 \text{ MV/cm}$), e.g. as shown in the inset of Fig. 3(a), which was a result of a single ramp of $I-V$. The consequent post-BD $I-V$ ramp in very low voltage region was obtained as shown in Fig. 3(a). An almost ohmic $I-V$ was observed with a shift of V_G to the positive side as $\Delta V \sim 0.2$ V, indicating the existence of negative charges. The subsequent current and topographical images with a sensing

$V_G = 0$ V were obtained as shown in Fig. 3(b) and (c); with the hillock profile as (d). Comparison of Fig. 3(b) and (c) reveals that the detrapping current has a lateral distribution corresponding to the edge of the hillock in (c), indicating local thinning location suffers BD first. In addition, the hillock in Fig. 3(d) is higher (~ 6.3 nm) than that in Fig. 2(e), whereas the lateral propagation of the BD spot is found to be of a size similar to that before BD, namely, ~ 100 nm in diameter, implying a progressive process of degradation and lateral propagation from pre-BD to BD.

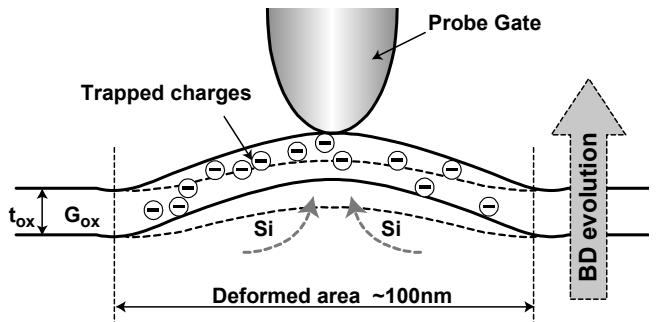
Fig. 4 The BD-evolution mechanism diagram. Si deformation occurs prior to and hastens the BD event. The topographical hillock grows with BD evolution.

The BD-evolution mechanism diagram is depicted in Fig. 4. It is considered that high current density induced local joule heating accompanied by thermal-electrical effects similar to electromigration deformed Si substrate toward the carrier injection direction even before BD. Furthermore, the Si deformation leads to more degradation of G_{ox} by spreading defects laterally to a wider area, facilitating formation of percolation path to trigger a BD.
