## Relative Density Characterization of Patterned Low-k material by VEELS

Yuji Otsuka<sup>1</sup>, Yumiko Shimizu<sup>1</sup>, Naohiko Kawasaki<sup>1</sup>, and Shinichi Ogawa<sup>2</sup>

<sup>1</sup>Toray Research Center, Inc.

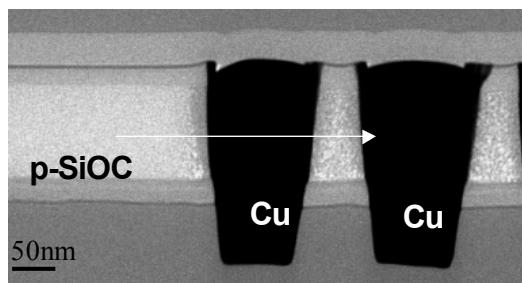
Fig. 1. Bright field STEM image of the patterned p-SiOC film.

Figure 1 shows a STEM image of the patterned structure, and Figure 2 shows composition profiles analyzed along an arrow in Fig.1. Carbon composition gradually decreased close to the TaN side wall in the area of 40nm. Such composition analysis by CEELS is often used for low-k films [4] and is used to estimate the degree of low-k damages. However we could know only the change of composition such as carbon depletion and this approach is not so sensitive for structural changes which might affect electrical and mechanical properties.

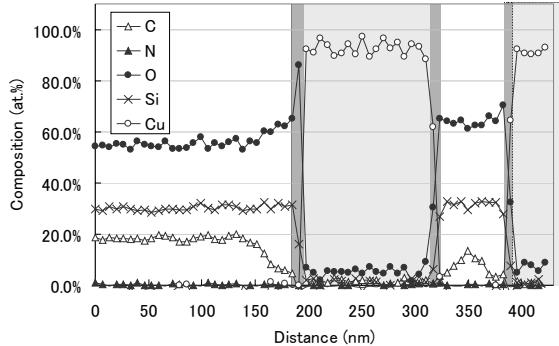
Fig. 2. Compositional line profile of the patterned p-SiOC film. Line is corresponding to the arrow in Fig.1.

Figure 3 shows a relative thickness ( $t/\lambda$ ) profile derived from VEELS at the same line in Fig.1. In composition profiles (Fig.2), the slope of carbon decrease was simple in the range of 40nm however the relative thickness profile was rather complicated, i.e. thickness was firstly decreased at 40-20nm from side wall then increased from 20nm towards the side wall. The inelastic mean free path varies by chemical composition but it does not change too much if the composition changes slightly [2]. Suppose that the inelastic mean free path of p-low-k at each position is constant, the changes of  $t/\lambda$  value might indicate that the density or porosity of the p-SiOC has been changed at the adjacent area of the side wall. Carbon depletion from the p-SiOC during patterning processes such as dry etch might have caused shrinkage of the p-SiOC to increase of density at 0-20nm from the side wall (region A in Fig.3). This shrinkage has secondarily set off the fracture at outside of the dense region (20-40nm from the side wall; region B in Fig.3).

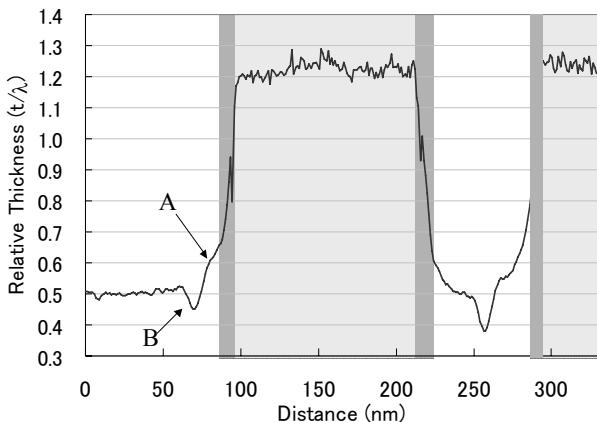
Fig. 3. Relative thickness line profile of the patterned p-SiOC film. Line is corresponding to the arrow in Fig.1.

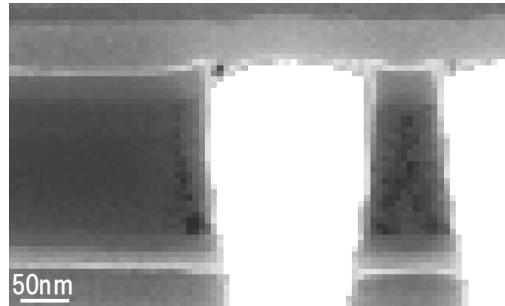
Fig. 4. 2-dimensional relative thickness map of the patterned p-SiOC region.

Figure 4 shows a 2-dimension relative thickness map of the sample. It is clearly seen that the distribution of dense and light regions of the p-SiOC at the adjacent of the TaN/Ta/Cu lines. Notably in a dielectric region between interconnect lines (a right p-SiOC area with a SiO<sub>2</sub> cap layer in Fig.4), a triangular low density region and a line shape high density region is seen at a bottom and a top area, respectively. These changes in density of the p-SiOC might affect the electrical/mechanical reliabilities.

These information of density cannot be obtained by the EELS conventional composition analysis, but uniquely obtained from this proposed method.
