# The running photographic investigation by an automobile for estimating building damages of 2016 Kumamoto earthquakes

It is crucial to develop methods for get a prompt overview of the damage situation soon after the earthquake, in terms of supporting decision-makings quickly. For this reason, we have been developing the Japan real-time information systems for earthquake (J-RISQ).

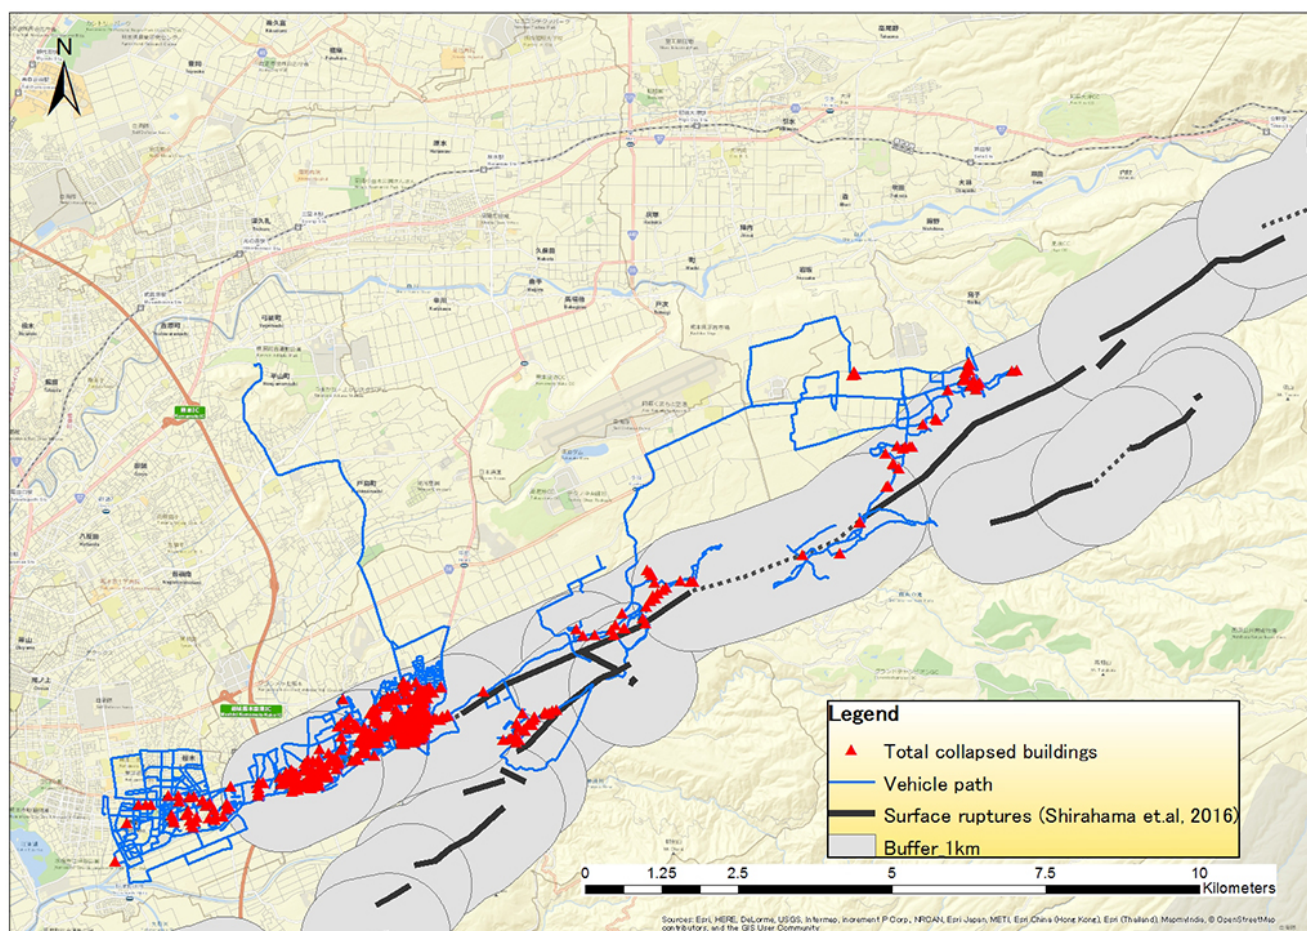
As a result, the distribution of total collapsed buildings are within the rage of 1 km around surface ruptures caused by 2016 Kumamoto earthquakes. These distribution is also coordinate with the damage concentrate area estimated by field investigations and aerial photographs.

We have acquired digital images every 5 meters with 6 cameras installed inside the automobile, additionally, the location and time of these cameras are synchronized with GPS. Then, we have extracted the 7,584 photographs of buildings from 571,700 photos. In the next place, we have chosen 593 total collapsed buildings by the standard of classification chart of the building damage released by Cabinet Office.
