東京電力福島第一原子力発電所炉内状況把握の解析・評価 (104) SAMPSON を用いた 1F 事故発生後 3 週間解析 (3 号機)

Assessment of Core Status of TEPCO's Fukushima Daiichi Nuclear Power Plants

(104) 3 weeks analysis using SAMPSON code (Unit-3)

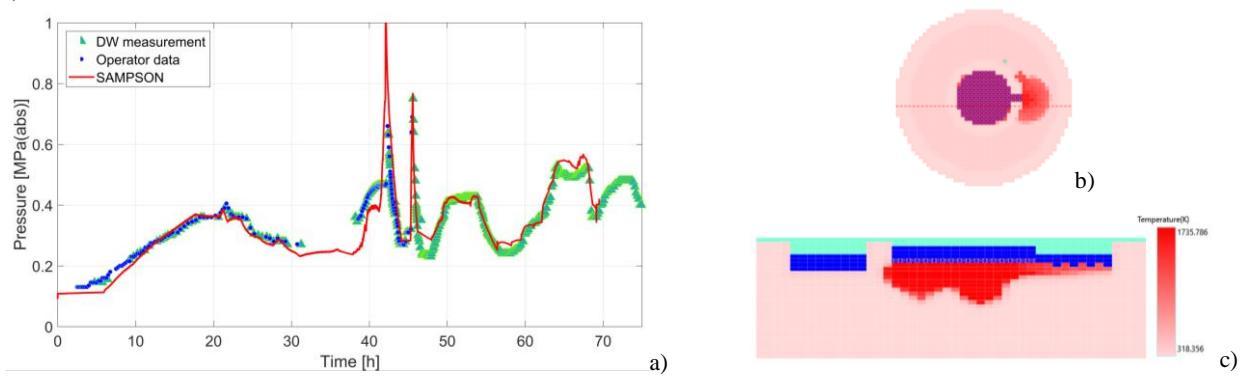
Figure 1 a) DW pressure results by the SAMPSON code, b) debris spread, c) vertical concrete ablation.

In the SAMPSON prediction core degradation starts at around 38h in Figure 1 a), when the PCV pressure increases gradually. Thereafter ADS triggers and PCV pressure is reduced through the S/C area opening (42h). Two debris slumps occur at around 43h, small slump, and 45h, complete core debris relocation. In this calculation only the second large relocation is calculated and the SAMPSON code provides a relatively good agreement of the RPV pressure spike, as well as the PCV pressure. Thereafter the pressure rises after S/C vent closes (47h) because of debris quenching in the lower head as well as water leaking through the downcomer manhole. Sea water is continuously injected through the fire pump until the pressure in the PCV reached around 0.4MPa. Thereafter the pressure is maintained high through water draining from the downcomer quenching the debris. At the time when the RPV reached dry-out conditions, the pressure drops and lower head melts with sudden debris discharge (55h). In sensitivity calculations on the behavior of the MCCI we have realized that a continuous relocation does not reproduce the pressure signature. For this reason we have considered the possibility of discontinuous relocations assuming multiple and subsequent lower head failures. This assumption is found successful to reproduce the pressure trend. Eventually the pressure reaches around 0.5MPa, and the water injection is reduced to zero until, at the onset of water dryout (68h), the PCV pressure reduces to around 0.4MPa driven by drywell head flange leak and drywell leak. Because of this pressure reduction a certain amount of water is transferred from the S/C to the D/W where steam additionally starts to be generated pressure increases again. This process is repeated several times until the pressure is stabilized. At around 70 hours the conditions of the pedestal by the MCCI is presented in Figure 1 b) and c).

From the SAMPSON analysis of Unit 3 it is estimated that a large portion of the core melted and relocated to the lower plenum, which subsequently failed because of lack of cooling. While around small amount of debris is estimated to remain as solid debris in the lower head, a large portion is computed to be discharged gradually to the pedestal, where competing phenomena between gas generation and leak resulted in an oscillatory behavior of the PCV pressure signature which was well reproduced by SAMPSON.
