# Structural Origin of Carrier Trap Levels at SiO<sub>2</sub>/Si Interface

N. Watanabe, A. Omura, H. Nohira and T. Hattori

Department of Electrical & Electronic Engineering, Musashi Institute of Technology,

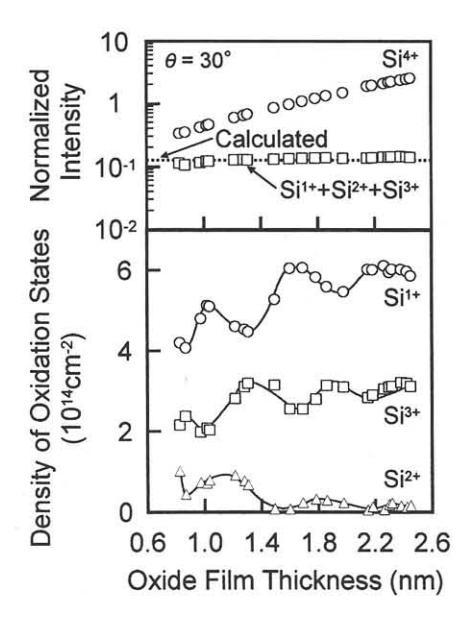
Fig. 1 The Upper part shows normalized spectral intensity of Si<sup>4+</sup> and summation of intensities for all suboxides are shown as a function of oxide film thickness. The dashed line shows the normalized spectral intensity calculated for an abrupt interface. The lower part shows dependence of areal densities of Si<sup>1+</sup>, Si<sup>2+</sup>, Si<sup>3+</sup> and Si<sup>4+</sup> on thickness.

Figure 1 shows the changes in the normalized amount of intermediate oxidation states, so called suboxides and that of Si<sup>4+</sup> with progress of oxidation. Because the total amount of suboxides is in good agreement with that calculated for an abrupt compositional transition, suboxides are localized only at the interface. Although the total amount of suboxides does not change with progress of oxidation, the amount of Si<sup>1+</sup> changes in opposite phase with the amount of Si<sup>3+</sup>. Therefore, the Si<sup>1+</sup> and Si<sup>3+</sup> interface appears alternately with progress of oxidation.[3] Figure 2 shows the interface state densities at and near the midgap of Si for three oxide film thicknesses. For oxide film thicknesses of 1.35 and 1.98 nm, where the amounts of Si3+ take their maximum values, the interface state densities at and near the midgap of Si are almost equal to  $1 \times 10^{13}$  cm<sup>-2</sup>eV<sup>-1</sup>, while for oxide film thickness of 1.62 nm, where the amount of Si<sup>1+</sup> takes its maximum value as shown in Fig. 1, the interface state density near the midgap decrease drastically down to  $1 \times 10^{12}$  cm<sup>-2</sup>eV<sup>-1</sup>. This drastic decrease in interface state density occurs only near the oxide film thicknsess of 1.63 nm as shown in Fig. 3. As shown in Fig. 4, almost the same drastic decrease in interface state density near the midgap appears again only near the oxide film thickness of 2.32 nm, where the amount of Si<sup>1+</sup> takes again its maximum value as shown in Fig. 1. Therefore, the drastic decrease in interface state density near the midgap appears periodically as a result of periodic changes in interface structures and is closely related with the formation of Si1+ interface. It was found from the measurement of surface microroughness of oxide film using non-contact mode atomic force microscope that the protrusions are produced on the oxide surface so as to relax stress produced by the formation of Si<sup>1+</sup> interface.[1] Therefore, the protrusions on the oxide surface indicate the place where interface state density is small. On the other hand, the volume expansion mostly along the interface-plane [1] induced by the formation of Si<sup>3+</sup> breaks a part of Si-Si bonds just below the Si<sup>3+</sup> to produce dangling bonds with density of about 10<sup>12</sup>cm<sup>-2</sup>.

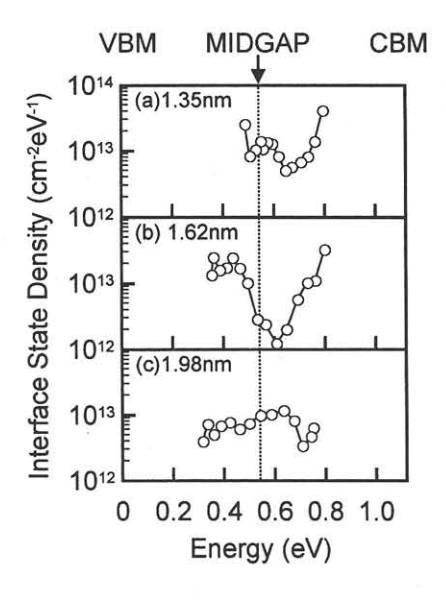
Fig. 2 Interface state densities in the bandgap of Si are shown for three oxide film thicknesses.

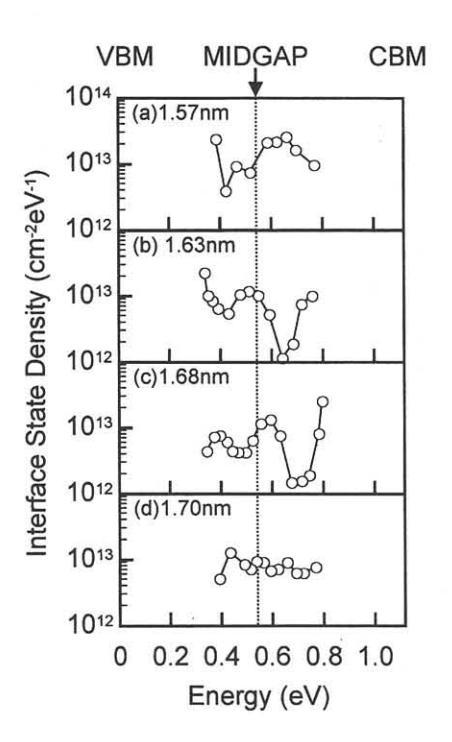
Fig. 3 Interface state densities in the bandgap of Si at and near the oxide film thickness of 1.63nm, where the amount of Si<sup>1+</sup> takes its maximum value.

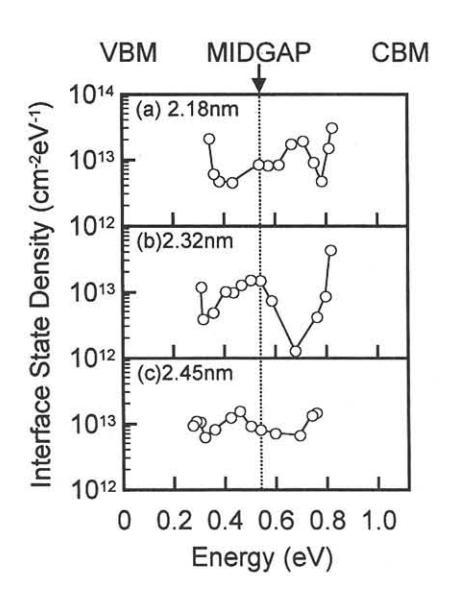
Fig. 4 Interface state densities in the bandgap of Si at and near the oxide film thickness of 2.32nm, where the amount of Si<sup>1+</sup> takes its maximum value.
