# Defect Engineering in Epitaxial Layers over Porous Silicon for ELTRAN<sup>®</sup> SOI Wafers

# Nobuhiko SATO, Shigeaki ISHII, Satoshi MATSUMURA, Masataka ITO, Jun NAKAYAMA, and Takao YONEHARA

ELTRAN project, Canon Inc. 6770 Tamura, Hiratsuka, Kanagawa, 254-0013, Japan

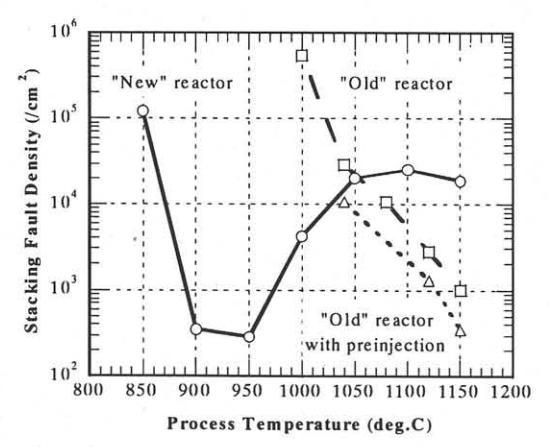
- Fig. 1 Stacking fault density versus prebaking temperatures. □: in barrel type epitaxial reactor (prebaking for 450 sec),
  - $\triangle$ : in barrel type epitaxial reactor with preinjection (prebaking for 450sec), and
  - O: in single wafer processing reactor (prebaking for 120 sec).

Figure 1 shows the prebaking temperature dependence of the stacking fault density. In the "old" reactor, the density was monotonously decreased by raising the temperature<sup>4</sup> from  $5.5 \times 10^5$  /cm<sup>2</sup> (1000°C) to  $1 \times 10^3$  /cm<sup>2</sup> (1150°C). Further reduction to  $3.5 \times 10^2$  /cm<sup>2</sup> was achieved by the preinjection technique, in which a small amount of Si source was introduced during the prebaking to help sealing surface pores. Unfortunately porous Si tended to deform at such high temperature prebaking and it sometimes resulted in difficulty of being etched off.

The "new" reactor gave an different result from the "old" one that the SF density had minimum value of  $2 \sim 3x10^2 / \text{cm}^2$ at relatively low temperature around 950°C, while it was as high as  $10^4 / \text{cm}^2$  in the higher temperature range over 1050°C. The high SF densities at a low-temperature end in both the reactors are presumably due to insufficient removal of the native oxide which would be formed by water or oxygen. On the contrary, the "new" reactor was designed to suppress the inclusion of water and oxygen into the reactors by the loadlock system and ultra clean gas supplying system so that the limiting temperature of the epitaxial growth was lowered.

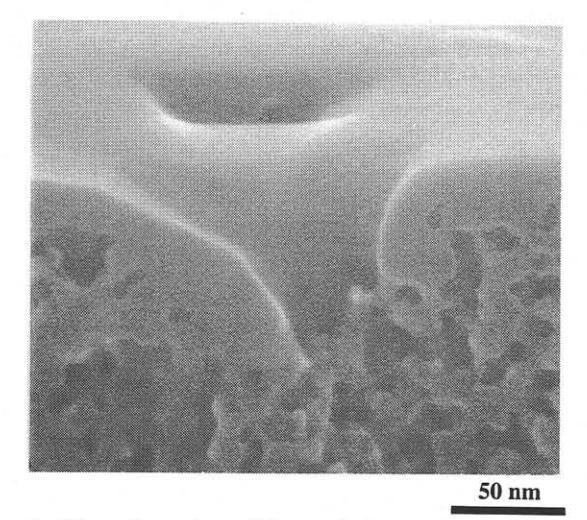
Fig. 4 The oblique view of the residual pore observed by prebaking in the "old" reactor.

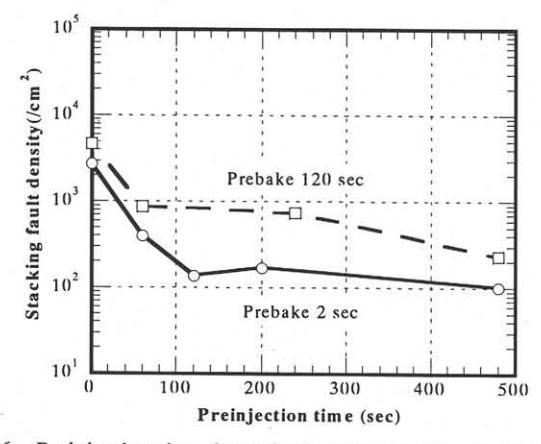
Fig. 6 Preinjection time dependence of the stacking fault density at 950 °C after prebaking for  $2 \sec(\bigcirc)$ , and  $120 \sec(\bigcirc)$ .

The pore enlargement was suppressed by shortening the prebaking time. In addition, the small residual pores after this prebaking were effectively sealed by the preinjection, in which a small amount of Si was supplied at  $3 \times 10^{14}$  atoms/cm<sup>2</sup> sec. Under this condition, the surface diffusion of Si atoms was enhanced to seal the residual pores. As shown in Fig. 6, the SF density was lowered below  $2 \times 10^2$  /cm<sup>2</sup> by 2 second prebaking and the preinjection over 120 sec.

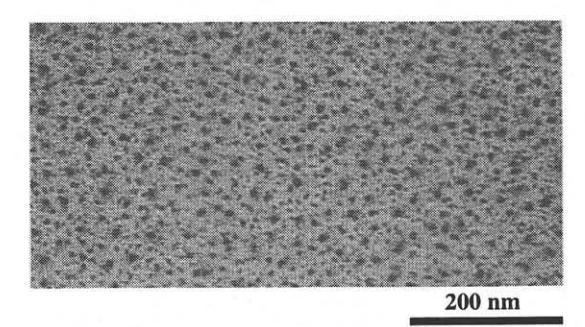
Fig. 2 Surface morphology of the porous Si just before loading in the epitaxial reactor observed by SEM.

°C. We discovered that most pores at the porous surface were sealed by the hydrogen prebaking due to the surface diffusion of Si atoms<sup>3, 4</sup>. The surfaces of the porous Si before and after the prebaking in the "new" reactor were observed by scanning electron microscopy (SEM). The surface pores before the prebaking were ~10 nm in diameter and the density was around  $10^{11}$  /cm<sup>2</sup> as shown in Fig. 2. By prebaking at 1100 °C, the pore density was reduced in five order of magnitude to  $\sim 10^6$ /cm<sup>2</sup>, however, the residual pores were enlarged and mostly caved by coalescence of the adjacent pores as shown in Fig. 3. The surface-migrated Si atoms cannot seal all the pores due to the shortage of Si atoms. Note that the same scales are applied in Fig. 2, 3, and 5. Similar pore enlargement was also observed in case of the "old" reactor as shown in Fig. 4. In contrast, by prebaking at lower temperature of 950 °C, some pores were sealed, but the pore density was still  $10^{10}$ - $10^{11}$  /cm<sup>2</sup> as shown in Fig. 5. In addition, the enlargement of surface pores was mostly suppressed in comparison to the prebaking at 1100 °C (Fig. 3). These results suggest that stacking faults is introduced just above the relatively large residual pores among all the residual pores in the initial stage of the epitaxial growth. Stress localization around the residual pores would also play an important role. In the "new" reactor, less native oxide formation and its easy removal during the prebaking supports the minimization of the SF density around 950 °C.

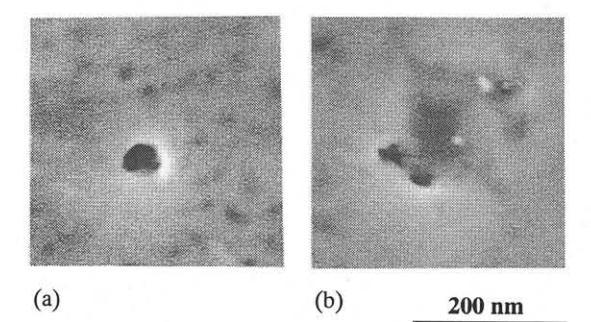
Fig. 3 The residual pores observed after 1100 °C prebaking for 2 sec. (a) enlarged pore, and (b) coalesced pore.

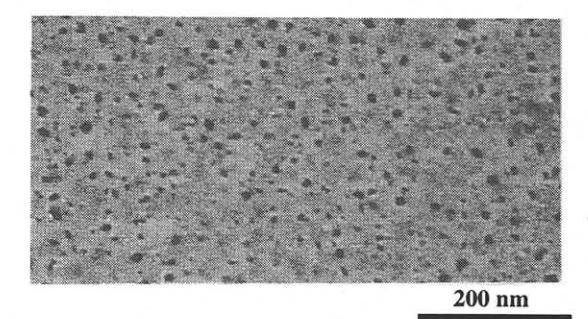
Fig. 5 Surface morphology of the porous Si after 950 °C prebaking for 2 sec.

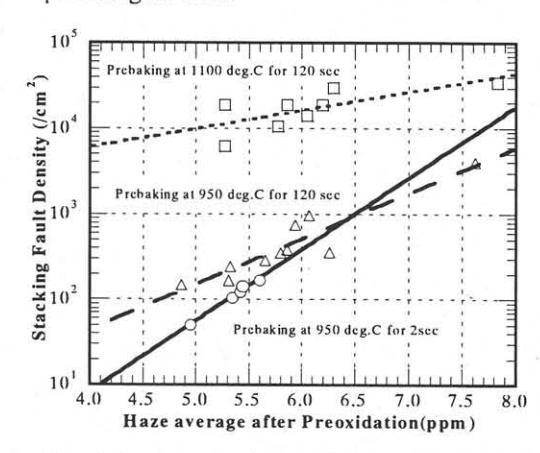
Fig. 7 Correlation between the stacking fault density and the haze of porous Si. Epitaxial growth after prebaking (120 sec) at 1100 °C( $\Box$ ), prebaking (120 sec) at 950 °C( $\triangle$ ), and prebaking (2 sec) at 950 °C( $\bigcirc$ ).

The porous structure also affects on the generation of the stacking faults in the epitaxial layer. It was found that the haze analysis by the laser light scattering particle analyzer such as Surfscan 6420 can monitor the structural difference of the porous Si. The haze is considered to reflect the porous structure near the surface including surface morphology, and was closely correlated to the SF density (Fig. 7). The current lowest SF density was 50 /cm<sup>2</sup> that was achieved by 2 second prebaking and preinjection at 950 °C for the porous Si with the haze of ~4.95 ppm. This epitaxial layer with low defect density was successfully transferred to ELTRAN SOI wafer, because the high etching selectivity was preserved due to low temperature epitaxy.
