A-2-1 (Invited)

Reliability and Electromigration Failure Modes in Dual Inlaid Cu Interconnects

C. Capasso, M. Herrick, M. Gall, D. Jawarani, S. Thrasher, L. Zhao*, and H. Kawasaki

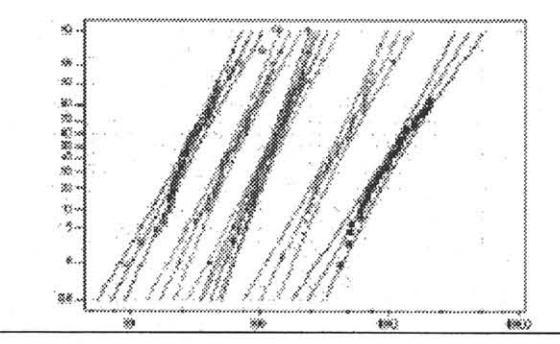
A plot of the cumulative failure probability vs. time to failure (TTF) shows that the electromigration failure distributions are lognormal in nature (Figure 2), similar to the Al(Cu) case [3]. This observation is consistent for all interfaces tested. Another interesting result is the fact that the lognormal sigma or width of the distribution is independent of the temperature with an average value of σ =0.5, indicating that only one failure mode exists. This allows us to use high temperature data for lifetime extrapolations to device operating conditions [4].

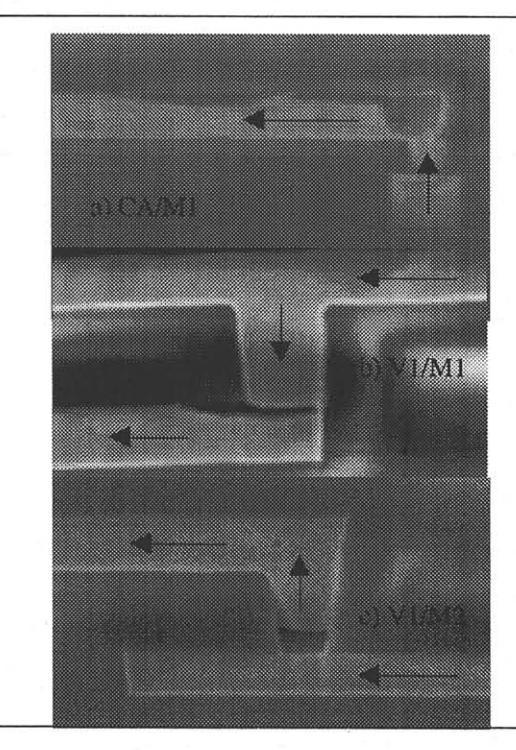
Figure 3: Failure analysis of EM stressed parts: a) CA/M1, b) V1/M1, c) V1M2. The different voids are always due to Cu interface diffusion. The arrows indicate the direction of the electron flow.

Even in the case of similar failure distributions, the failure modes for the different interfaces are controlled by different mechanisms. The CA/M1 interface failure is shown in Figure 3a. The void, forming at the cathode end, apparently evolved by a fast diffusion channel along the Cu interface with the overlaying dielectric. Complete metal depletion above the W contact was necessary to generate a physical failure. A similar behavior is seen at the V1/M1 interface (Figure 3b) where the fast diffusion path along the dielectric is close to the bottom of the via. Thus, often a small amount of depleted Cu is enough to generate an open failure. The mechanism at the V1/M2 interface (Figure 3c) is characterized by a void located at the barrier blocking boundary at the bottom of the via. Here, the Cu is completely surrounded by the barrier, however interface diffusion still seems to be the controlling mechanism, as shown by the void shape in the via.

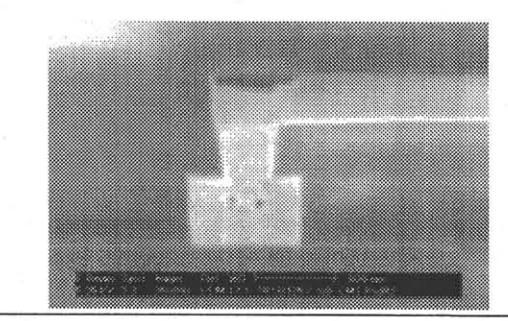
Figure 4: EM induced void formation in a 25um long CA/M1 structure. The void growth has been stopped by the back-stress associated to the Blech effect.

We showed the presence of EM induced back-stress in single inlaid CA/M1 structures. Testing of lines with lengths ranging from 5 to $250 \mu m$ showed that very short lines have infinite lifetimes due to Cu back-pressure effects inhibiting EM-induced void growth. An example is shown in Figure 4. The void in a $250 \mu m$ line created a failure while the void in a $25 \mu m$ line stopped growing under further stress, thus leaving the interconnect operational.
