# **Controlling Cu Corrosion in Single Wafer Cleaning Process**

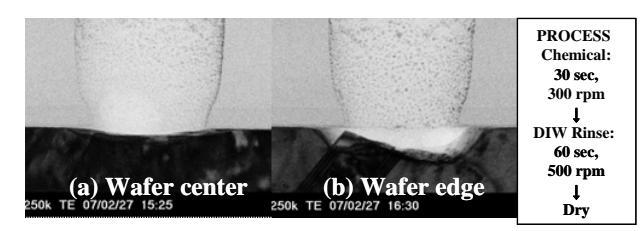
Fig. 1 Cu corrosion in isolated via after wet chemical cleaning to remove polymers.

rinse but no chemical cleaning is shown in Fig. 3. Compared with the wafer in Fig. 1(b), which was cleaned with chemicals followed by a 1-min DIW rinse, corrosion was also observed at the via bottom of the wafer edge. Thus, we examined the effect of dissolved oxygen in DIW on corrosion. The results showed that the Cu etching rate increased as the dissolved oxygen increased (Fig. 4).

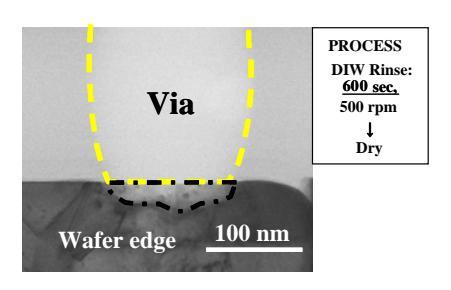
Fig. 3 Cu corrosion after accelerated DIW rinse test.

A TEM image of Cu corrosion of a wafer after a 10-min DIW

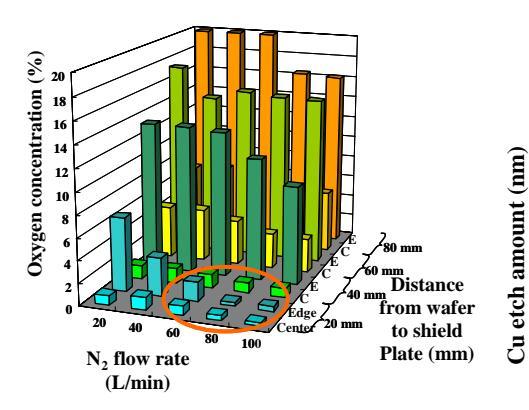
Fig. 6 Oxygen concentration dependency on  $N_2$  flow rate and distance from wafer to shield plate.

We applied a corrosion suppression technique to our cleaning system for mass production use. By decreasing the distance between the wafer and shield plate to less than 20 mm and increasing the N<sub>2</sub> flow rate to more than 60 L/min, we were able to suppress the oxygen concentration in the atmosphere above the wafer to less than 2% (Fig. 6). The Cu etched amount within a non-patterned wafer was evaluated after a 30-min DIW rinse with this condition (Fig. 7). In air, the etched amount increased at the wafer edge, but this was suppressed when the air atmosphere was replaced with N<sub>2</sub> atmosphere. Cu corrosion at the via bottom was also suppressed (Fig. 8).

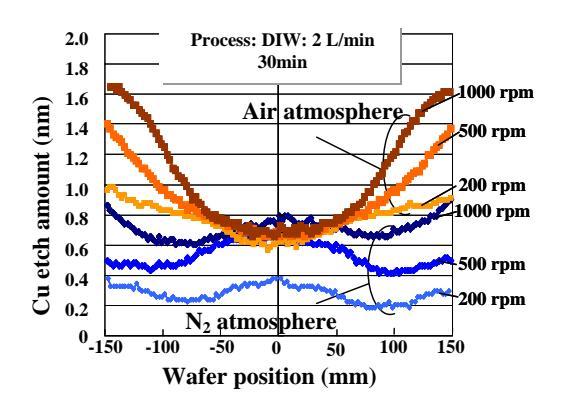
Fig. 9 Cu etched amount dependency on wafer rotational speed and  $air/N_2$  atmosphere.

We also studied the dependence of Cu etching on wafer rotational speed in the air and  $N_2$  atmosphere during rinsing (Fig. 9). The results showed that the etched amount at a wafer edge increased as the rotation speed increased. This is assuming that more oxygen was involved due to the ruffled flow of DIW at the wafer edge caused by high speed wafer rotation [2]. Therefore, we must reduce the dissolved oxygen to prevent Cu corrosion and obtain a good rinse effect at higher wafer rotation speeds.

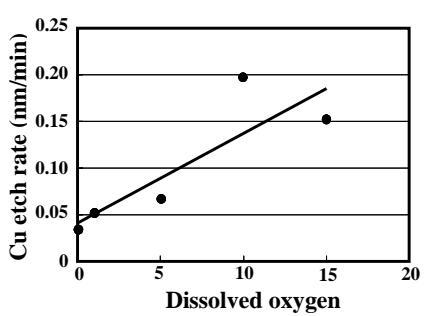
Fig. 4 Cu etch rate dependency on dissolved oxygen in rinse DIW.

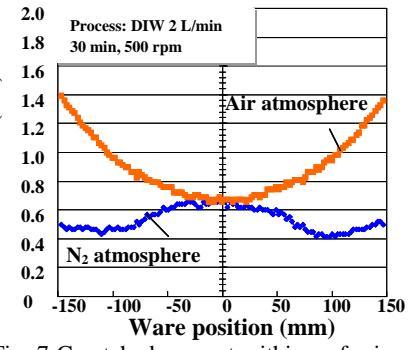
Fig. 7 Cu etched amount within wafer in air and in  $N_2$  atmosphere.

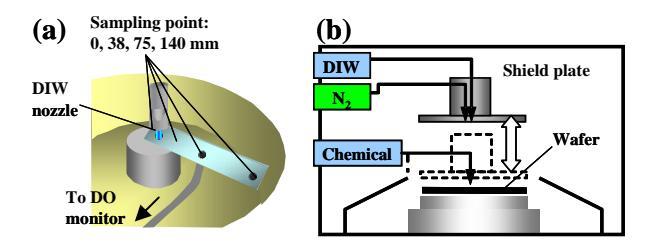
Fig. 2 Schematics of (a) cleaning equipment for measuring dissolved oxygen and (b) cleaning system with shield plate.

Two types of 300-mm single wafer cleaning equipment were used in this work (Fig. 2). One is a simple system developed for cleaning experiments, and the other is a cleaning system for mass production use.

The dissolved oxygen in the DIW was measured in the cleaning test equipment (Fig. 2(a)). First, air was sucked from the DIW and then  $N_2$  gas was dissolved. DIW flows on the plastic board of the equipment from the center to the edge at 1 L/min, which reproduces the actual rinse water flow on a wafer. Four small holes were made in the plastic board at distances of 0, 38, 75, and 140 mm from the nozzle point to sample the DIW through tubes and measure the dissolved oxygen. The process chamber was closed to control oxygen concentration in the atmosphere, and  $N_2$  atmosphere was also available.

A schematic of our cleaning system, in which a rotating shield plate is brought close to a wafer in parallel at distances between 2 and 180 mm during the rinsing and drying steps, is shown in Fig. 2(b). A low oxygen (< 2%) atmosphere was obtained by introducing  $N_2$  gas onto the wafer center through the shield plate.

Next, we investigated the effect of oxygen in the air on the dissolved oxygen in the rinse DIW by using the equipment shown in Fig. 2(a). The dissolved oxygen in the DIW increased to more than 0.6 ppm as the flow distance from the nozzle point increased (Fig. 5). However, it decreased to less than 0.1 ppm when the air atmosphere was replaced with N<sub>2</sub> atmosphere. Therefore, oxygen from the air is thought to dissolve into the DIW for a short moment after the DIW starts to flow on the wafer surface.

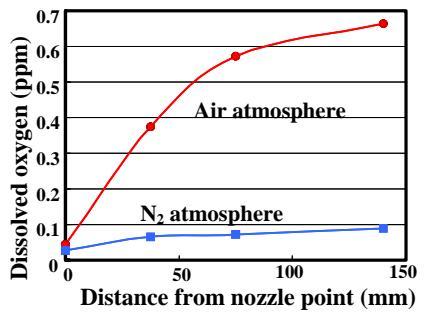
Fig. 5 Dissolved oxygen in rinse DIW dependency on  $air/N_2$  atmosphere and distance from DIW nozzle.

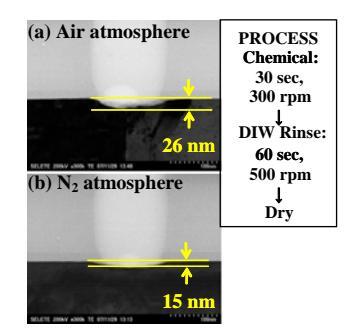
Fig. 8 Cu corrosion at via bottom (a) after cleaning in air and (b) that in  $N_2$  atmosphere.

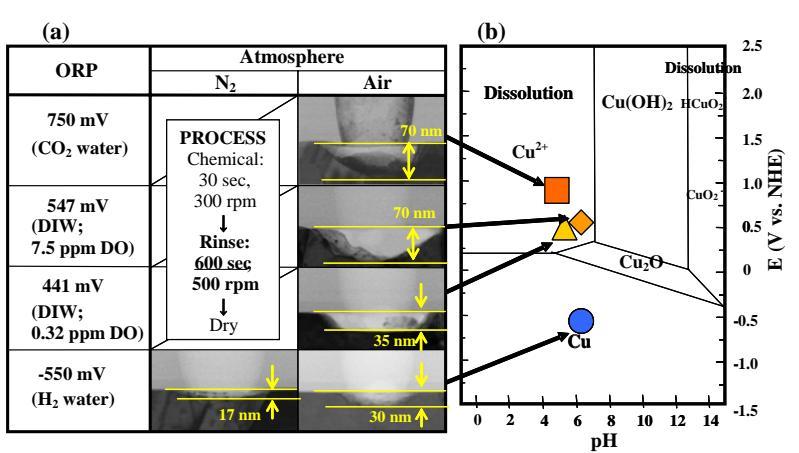
Fig. 10(a) Cu corrosion at via bottom dependency on ORP of rinse DIW and  $air/N_2$  atmosphere and (b) Pourbaix diagram of Cu.

Besides dissolved oxygen, we examined  $H_2$  water with a low ORP [3]. As shown in the Pourbaix diagram (Fig. 10(b)), Cu corrosion at the via bottom was suppressed by wafer with the lowest ORP, -550 mV. Furthermore, when  $N_2$  atmosphere was used during  $H_2$  water rinsing, via-bottom corrosion was minimized. Therefore, not only cleaning chemical damage on low-k film, but also quality control of rinse DIW will become more essential when device patterns are shrunk.
