Recovery of Local Lattice Distortion at the Surface of Thermally-Oxidized 4H-SiC (0001) by Post-Oxidation Annealing

Adhi Dwi Hatmanto and Koji Kita

Department of Materials Engineering, The University of Tokyo 7-3-1 Hongo, Bunkyo-ku, Tokyo, 113-8656, Japan Phone: +81-3-5841-7164 E-mail: hatmanto@scio.t.u-tokyo.ac.jp

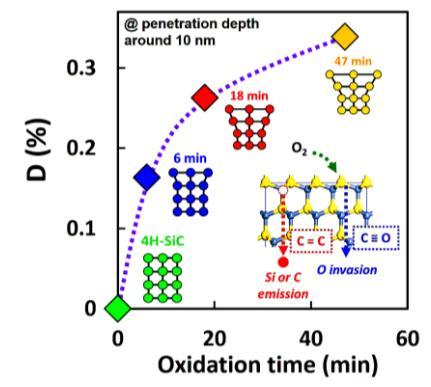
Fig. 1 Relationship between D and oxidation time, together with the schematic illustration of defect-induced lattice distortion at the surface of 4H-SiC.

Lattice distortion at the surface of thermally-oxidized 4H-SiC (0001) was observed as the increase of $(1\overline{1}00)$ m-face interplanar spacing, $d_{(1\overline{1}00)}$. Since the lattice distortion exists locally at the surface region, the remaining defects of thermal oxidation would be considered as the origin of this lattice distortion [2]. **Fig. 1** shows the relationship between D (increase ratio of $d_{(1\overline{1}00)}$) and oxidation time, together with schematic illustration of defect-induced lattice distortion at the surface of thermally-oxidized 4H-SiC. The larger lattice distortion time might be induced by the larger amounts of defects generation.

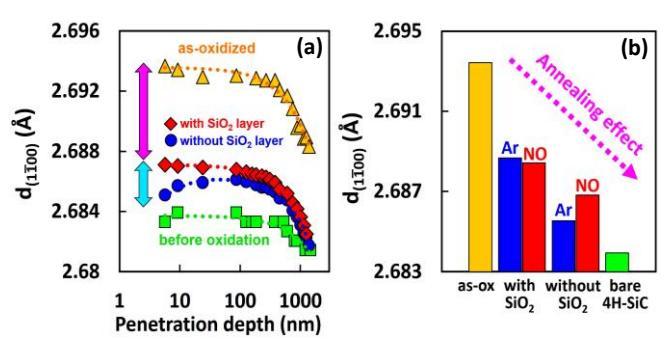
Fig. 2(a) The changes in penetration depth dependence of $d_{(1\overline{1}00)}$ of 4H-SiC with and without SiO₂ by Ar annealing and (b) comparison between Ar and NO annealing on the lattice recovery.

The lattice distortion could not be recovered by SiO_2 removal alone [2], thus the possibility of lattice recovery was then investigated by performing post-oxidation annealing in Ar at 1300 °C. **Fig. 2(a)** shows recovery of the distorted lattice at 4H-SiC surface with and without SiO₂ layer. It

shows that annealing process could significantly recover the distorted lattice, regardless of the existence of SiO₂ layer. However, recovery of the distorted lattice was faster on the 4H-SiC sample without SiO₂ layer. Based on our consideration that the surface distortion would be the result of defect formation, these post-oxidation annealing processes should cause the migration and removal of those accumulated defects in the surface region. Therefore, we speculated that the existence of SiO₂ layer might limit the removal of accumulated defects from the surface of 4H-SiC and resulted in slower recovery process, especially at the shallow region.

Comparison of the impact of Ar and NO annealing on the lattice recovery was shown in **Fig. 2(b)**. Both Ar and NO annealing at 1150 °C could partially reduce the lattice distortion, while the impact was almost the same between the two processes, when the SiO₂ layer remain on the top of 4H-SiC. Furthermore, annealing process of the oxidized 4H-SiC samples without SiO₂ layer resulted in faster recovery, where the Ar annealing shows more significant impact than NO annealing. Based on our consideration above, we speculated the slower lattice recovery in NO was induced by the existence of additional SiO₂ layer formed during nitridation process. This slower recovery might also be induced by additional oxygen invasion from NO molecules into 4H-SiC structure.

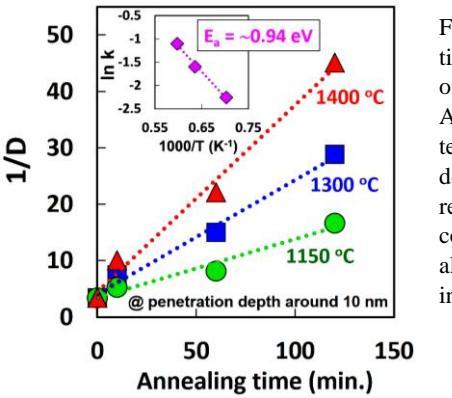
Fig. 3 Annealing time dependence of inverse of D. Annealing temperature (T) dependence of recovery rate constant (k) was also shown in the inset.

Next, we investigated the kinetics of lattice recovery process induced by Ar annealing. Post-oxidation Ar annealing for various time were done at different temperature in order to estimate the activation energy (E_a) of the recovery process. We tried to fit the results into several rate laws, including power law, first, and second order rate law. Then we found that the recovery process seems to follow the second order rate law. Since the recovery rate was proportional to the square of D, plot of 1/D vs annealing time shows good linearity, as shown in **Fig. 3**. The obtained E_a of the recovery process of ~ 0.94 eV suggests that the recovery process is limited by a bond rearrangement or migration process with a relatively low activation energy. One of the possible processes would be the CO emission and migration from Si-O-C structure in 4H-SiC crystal, considering the theoretically predicted energies in Ref. [4], if we assume that such defects are introduced by invading oxygen during thermal oxidation.

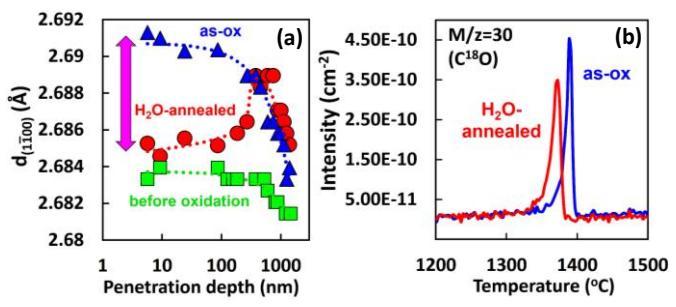
Fig. 4 The effect of H₂O annealing on (a) penetration depth dependence of $d_{(1\bar{1}00)}$ of dry-oxidized 4H-SiC and (b) TDS of C¹⁸O as a measure of oxygen concentration in 4H-SiC. No TDS peak was observed for the before oxidation 4H-SiC sample.

The effect of H_2O annealing (in 90% $H_2O + 10\% O_2$) at 800 °C on the lattice recovery was then investigated. Fig. 4(a) shows that H₂O annealing could partially recover the distorted lattice, especially at the shallow region. Based on our proposed recovery mechanism, H₂O annealing should also induce oxygen-related defects removal from the inside of 4H-SiC structure. In order to confirm that possibility, TDS analysis was done for the oxidized 4H-SiC samples with and without H₂O annealing. In this TDS analysis, oxygen concentration in 4H-SiC was detected as CO. For the sensitivity improvement of CO detection, ¹⁸O₂ and H₂¹⁸O were employed in the samples preparation, and $C^{18}O$ (m/z = 30) desorption was then investigated. TDS results shown in Fig. 4(b) describes that the peak intensity attributed to $C^{18}O$ desorption was lower on H₂O-annealed sample, compared to the sample without H₂O annealing, indicating the lower amount of invading oxygen inside the H₂O-annealed sample. This result supports our proposed mechanism that the lattice distortion was induced by oxygen invasion into 4H-SiC crystal during thermal oxidation, while the lattice recovery involves the migration of that invading oxygen, then emitted from the inside of 4H-SiC crystal as CO molecule.
