Investigation of the Possible Origins of Lattice Distortion at the Surface of Thermally-Oxidized 4H-SiC (0001) based on the Physical Analysis of Remained Byproducts

Adhi Dwi Hatmanto and Koji Kita

Department of Materials Engineering, The University of Tokyo 7-3-1 Hongo, Bunkyo-ku, Tokyo, 113-8656, Japan Phone: +81-3-5841-7164 E-mail: hatmanto@scio.t.u-tokyo.ac.jp

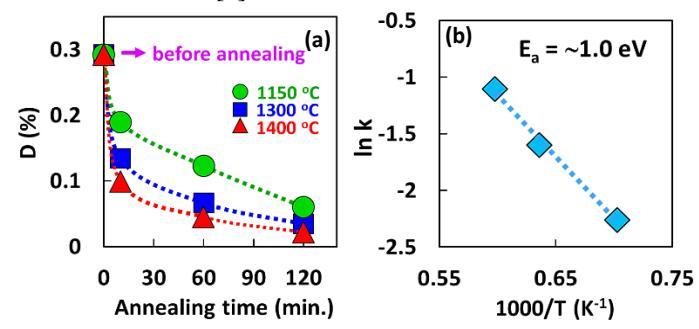
Fig. 1(a) Annealing time dependence of the changes of lattice distortion (*D*) at the surface of thermally-oxidized 4H-SiC and (**b**) temperature dependence of lattice relaxation rate constant (k).

Thermal oxidation induces lattice distortion at the surface of 4H-SiC (0001), observed as the increase of $(1\overline{1}00)$ interplanar spacing, $d_{(1\overline{1}00)}$ [2]. Fig. 1(a) and (b) show

annealing time dependence of the changes of lattice distortion (D, increase ratio of $d_{(1\overline{1}00)}$) and temperature dependence of lattice relaxation rate constant (k), respectively. The Ar annealing for longer time and higher temperature induce more relaxation on the lattice structure of 4H-SiC surfaces [3]. Fig. 1(a) shows that the changes of D are not linearly correlated to the annealing time. We found that the lattice relaxation process seems to follow the second order rate law, because the changes of inverse of $D(D^{-1})$ as a function of annealing time show good linearity (data not shown). From the temperature dependence of the relaxation rate constant (Fig. 1(b)), the estimated activation energy of around 1 eV was obtained, suggests that it might be related to a bond rearrangement or movement process with a relatively low activation energy. We speculated that one of the possible origins of lattice distortion would be the formation of a certain byproducts to be remained at the surface of 4H-SiC wafer after oxidation, while the relaxation might involve the movement of that byproducts then desorbed out from the surface of 4H-SiC [3].

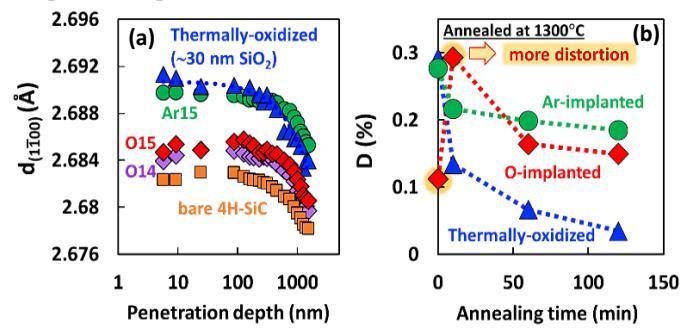
Fig. 2(a) Penetration depth dependence of $d_{(1\bar{1}00)}$ of thermallyoxidized and ion implanted 4H-SiC (0001) and (b) Ar annealing time dependence of the changes of lattice distortion (*D*).

The similarity and difference between the impact of thermal oxidation and ion implantation on the lattice structure of 4H-SiC were then investigated. **Fig. 2(a)** shows the penetration depth dependence of $d_{(1\bar{1}00)}$ of thermally-oxidized sample with ~30 nm-thick SiO₂, O-implanted samples and Ar-implanted samples at the dose of 10^{15} atoms/cm². Ar-implanted sample shows much more significant distortion than O-implanted sample and almost the same as that induced by thermal oxidation to form ~30 nm-thick SiO₂. Since ion bombardment generates interstitial atoms (and vacancies) in the crystals [4] and heavier ions tend to cause higher amount of them, it seems that large number of interstitials atoms at surface region of 4H-SiC could be considered as one of the possible origins of the distortion on the as-implanted samples.

However, a clear contrast between Ar- and O-implanted samples are observed when we investigated the effect of Ar annealing on the lattice structure of 4H-SiC. Annealing at the temperature of 1300°C was performed after total oxide removal in diluted HF. Annealing time dependence of lattice distortion on Ar-implanted, O-implanted, and thermallyoxidized 4H-SiC samples are shown in Fig. 2(b). Annealing resulted in partial lattice relaxation on Ar-implanted and thermally-oxidized 4H-SiC (note that the lattice of Arimplanted sample is more difficult to be relaxed). On the other hand, annealing for 10 min induces much more significant lattice distortion on O-implanted sample. Our speculation of this significant increase is the possibility of oxygen invasion into 4H-SiC lattice, since annealing could induce the migration of interstitial atoms. The more significant distortion at the surface of O-implanted sample should be induced mainly by the O-related structure in the lattice (for example: Si-O-C structure), not by the interstitial atoms generated by ion bombardment as expected in Arimplanted sample. CO

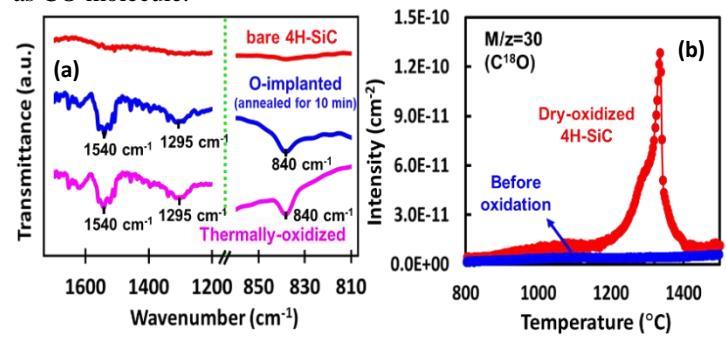
Fig. 4 (a) FTIR-ATR spectra of thermally-oxidized and implanted 4H-SiC and (b) TDS spectra of $C^{18}O$ as a measure of oxygen concentration in 4H-SiC. The data for the as-received wafer are also shown for comparison in both (a) and (b).

TDS and FTIR analysis were then performed to support our consideration. **Fig. 4(a)** shows the FTIR spectra of 4H-SiC sample before and after oxidation/implantation, measured with ATR mode using Ge prism with 45° incidence angle. FTIR spectra of the oxidized/implanted sample shows in common, the absorption at the wavenumber of around 840, and 1540 cm⁻¹, whereas the wafer before 1295 oxidation/implantation does not show the peaks in those wavenumbers. Those peaks are related to Si-O bending, C-O stretching, and conjugated C=O asymmetric stretching vibration [6], respectively, suggesting that oxygen remained in 4H-SiC after oxidation and oxide removal. TDS was then performed for the 4H-SiC samples before and after oxidation (after oxide removal) in isotope ¹⁸O₂ ambient (0.7 atm) at 1300°C for the sensitivity improvement. In this TDS analysis, oxygen concentration in 4H-SiC was detected as $C^{18}O(m/z)$ 30) desorption. TDS results shown in Fig. 4(b) describes that the high intensity peak attributed to C18O desorption was observed only on thermally-oxidized sample, indicating the existence of oxygen inside 4H-SiC after oxidation. These results support our proposed mechanism that the lattice distortion was induced by oxygen invasion into 4H-SiC crystal during thermal oxidation, while the relaxation involves the migration of that invading oxygen, then emitted as CO molecule.
