## Evaluation of Propagation Losses in Corrugation-Reduced GaAs/AlGaAs periodically-inverted Waveguides

Shumin Wang, Tomonori Matsushita, Takashi Matsumoto, Shigeki Yoshida and Takashi Kondo

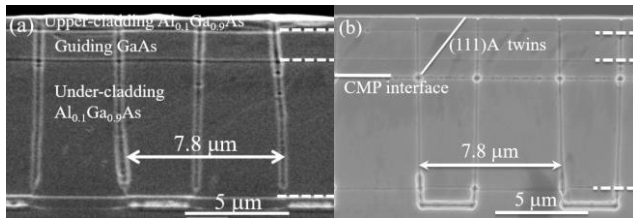
Fig. 1 Cross-sectional SEM images of the waveguides fabricated without CMP process (a) and with CMP process (b).

were formed by chemical etching. The spatial-inversion periods were 7.8  $\mu\text{m}$ . We used 1.2 g/l INSEC-NIB ( $\text{NaClO}$ ) solution as a scribe to perform CMP. Figure 1 shows cross-sectional SEM images of the strain-etched waveguides. In the waveguide fabricated with CMP process (CMP waveguide), CMP interface was clearly observed in the under-cladding layer. Figure 2 shows AFM images of the fabricated waveguides. The estimated corrugation heights on the interfaces between guiding and cladding layers of the CMP waveguide and the waveguide fabricated without CMP (non-CMP waveguide) were 8 nm and 19 nm, respectively.

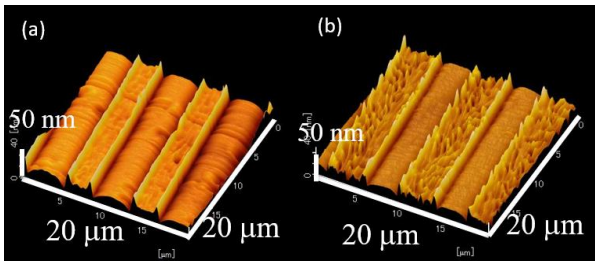
Fig. 2 Surface AFM images of the waveguides fabricated without CMP process (a) and with CMP process (b).

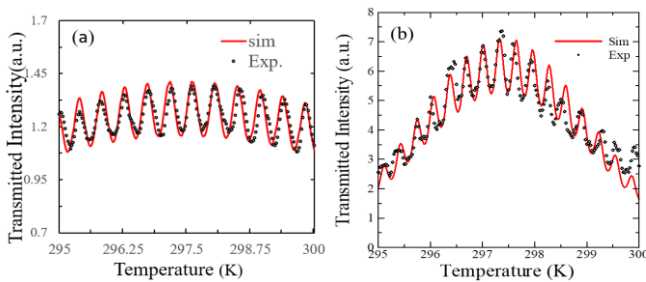
Fig. 3 Temperature-dependence of transmitted light intensities at 1.064 μm (TM polarization) for the waveguides fabricated without CMP process (a) and with CMP process (b).

We measured propagation losses for TM-polarized 1.064  $\mu\text{m}$  pump and TE-polarized 1.55  $\mu\text{m}$  signal by using Fabry-Perot method. Figure 3 shows temperature dependent transmittance at 1.064  $\mu\text{m}$  where interference fringes due to multiple reflections in the waveguide are superimposed on a single peak curve exhibiting a change in beam coupling efficiency. The estimated propagation losses of the non-CMP and CMP waveguides are 19 dB/cm and 12.6 dB/cm, respectively. By introducing CMP process, the propagation loss at 1.064  $\mu\text{m}$  was reduced as expected. Figure 4 shows transmittance spectra of the waveguides measured around 1.55  $\mu\text{m}$ . The estimated propagation losses were 1.3 dB/cm and 4.5 dB/cm for non-CMP and CMP waveguide, respectively. Although the corrugation height was reduced in the CMP waveguide, the propagation loss at 1.55  $\mu\text{m}$  was increased.

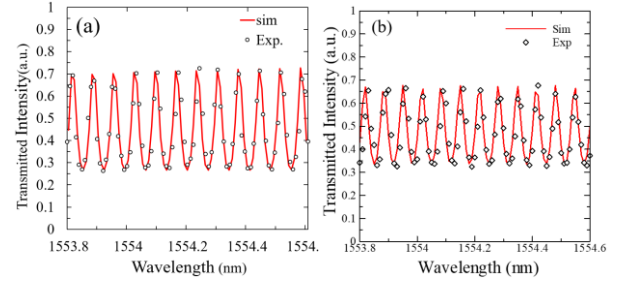
Fig. 4 The transmitted-intensity spectra around 1.55 μm (TE polarization) of the waveguides fabricated without CMP process (a) and with CMP process (b).

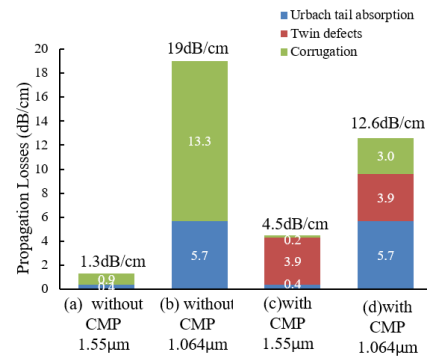
Fig. 5 Bar charts of propagation losses of the waveguides fabricated without CMP process (a)(b) and with CPM process (c)(d). (a) and (c) are measured at 1.55 μm (TE polarization), and (b) and (d) are measured at 1.064 μm (TM polarization).

Origins of propagation losses can be classified as follows. Figure 5 shows bar charts of classified propagation losses. The propagation loss of the CMP waveguide at 1.55  $\mu\text{m}$  is dominated by light scattering by corrugations. Since the scattering loss is proportional to wavelength to the minus fourth power and corrugation height squared, the scattering losses can be estimated for another waveguide and wavelength as shown in Fig. 5. The propagation loss in non-CMP waveguide at 1.064  $\mu\text{m}$  is dominated by large scattering and the residual loss can be attributed to absorption in the Urbach tail. We speculate that the additional losses in the CMP waveguide (3.9 dB/cm at 1.55  $\mu\text{m}$  and 1.064  $\mu\text{m}$ ) are due to twin defects which are clearly seen as slanted lines in Fig. 1 (a). These twin defects are produced by inadequate treatment/growth procedure resulting in three-dimensional growth in the early stage of the regrowth process of the under cladding layer. We have to improve MBE regrowth process on the AlGaAs CMP
